**ACCIDENT**

<b>Aircraft Type and Registration:</b>	Parrot Anafi	
<b>No &amp; Type of Engines:</b>	4 electric motors	
<b>Year of Manufacture:</b>	2020 (Serial no: P1040505AA0K000249)	
<b>Date &amp; Time (UTC):</b>	19 February 2021 at 1400 hrs	
<b>Location:</b>	Highlands Road, Fareham, Hampshire	
<b>Type of Flight:</b>	Commercial Operations (UAS)	
<b>Persons on Board:</b>	Crew - None	Passengers - None
<b>Injuries:</b>	Crew - N/A	Passengers - N/A
<b>Nature of Damage:</b>	Battery and front left propeller arm detached, both front propellers damaged.	
<b>Commander's Licence:</b>	Other	
<b>Commander's Age:</b>	34 years	
<b>Commander's Flying Experience:</b>	11 hours (of which 11 were on type) Last 90 days - 5 hours Last 28 days - 4 hours	
<b>Information Source:</b>	Aircraft Accident Report Form submitted by the pilot and further enquiries by the AAIB

**Synopsis**

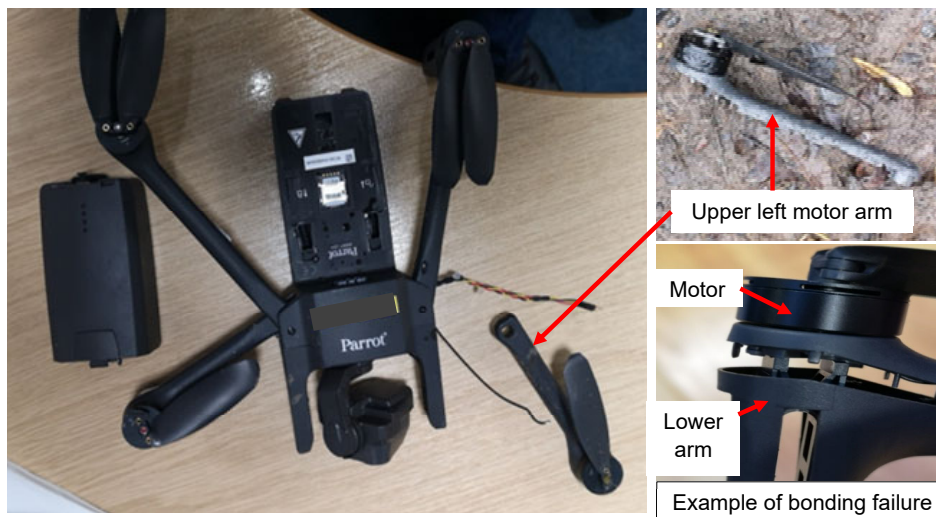
**Figure 2**

## Aircraft examination

Recovered aircraft, battery, and motor arm plus an example of bonding failure

If separation of the two halves of the front left propeller arm had occurred in flight, it is likely the upper arm containing the motor and propeller would have lost rigidity allowing the arm to bend and twist unpredictably due to a combination of lift and gyroscopic forces from the propeller and vibration from the motors. The increased bending and twisting would have resulted in variations in the direction of thrust produced by the front left propeller. The UA's flight control system may have been unable to compensate for this resulting in the repeated loss of control. It is also possible that these forces caused the lower half of the arm to fail and break away from the UA during its return to the launch point.

Failure of the bonding between the upper and lower halves of the front left propeller arm may have caused loss of control of the aircraft and resulted in a collision with nearby trees. The UA has been repaired by the manufacturer together with a further three of the operator's aircraft that were discovered with similar bonding problems.

The manufacturer has notified the UK operators of a further five Anafi USAs that may have similar propeller arm bonding problems, to inspect the bonding and return the aircraft to their supplier for replacement propeller arms if the bonding problem is present.
