ACCIDENT

Aircraft Type and Registration:	Vans RV-7, G-CDME	
No & Type of Engines:	1 Superior XP-IO-360-A1A2 piston engine	
Year of Manufacture:	2006 (Serial no: PFA 323-14151)	
Date & Time (UTC):	28 February 2021 at 1400 hrs	
Location:	Farm strip near Goose Green, West Sussex	
Type of Flight:	Private	
Persons on Board:	Crew - 1	Passengers - None
Injuries:	Crew - None	Passengers - N/A
Nature of Damage:	Moderate damage to engine and mount, propeller, canopy, rudder, fin and spats	
Commander's Licence:	Private Pilot's Licence	
Commander's Age:	53 years	
Commander's Flying Experience:	2,743 hours (of which 300 were on type) Last 90 days - 3 hours Last 28 days - 1 hour	
Information Source:	Aircraft Accident Report Form submitted by the pilot and further enquiries made by the AAIB

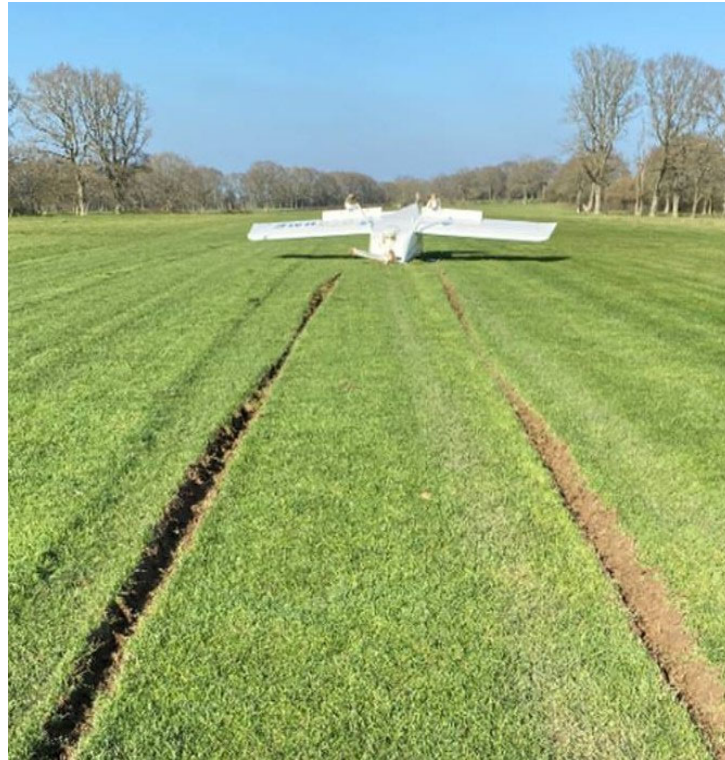
Approximately 140 m into its landing roll on a grass runway, the aircraft encountered an area of soft ground. The wheels and spats sank in and caused a rapid deceleration during which the tail rose, the propeller dug in and the aircraft over-ended onto its back. The pilot was tightly strapped in but was able to exit the aircraft uninjured. The cause of this accident was the sudden increase in drag created by the wheel and spats clogging with soil.

Figure 1
Tracks made by the aircraft wheels

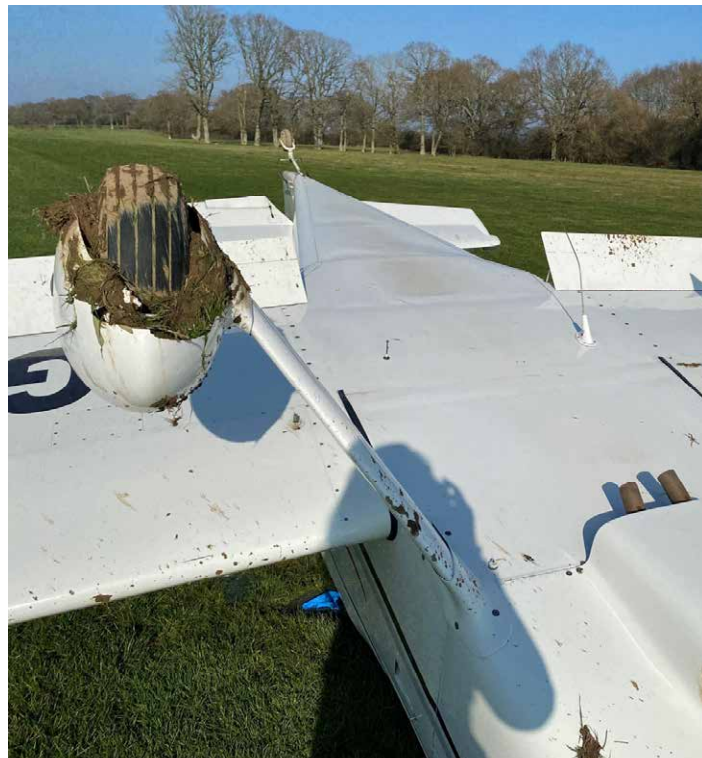
Figure 2
Contamination and damage to one of the wheel spats
(pictures courtesy of the pilot)

The cause of this accident was the sudden deceleration of the aircraft due to the increased drag created by the mainwheels and spats as they became clogged with soil. The tail started to rise and the propeller contacted the ground and dug in; the speed and momentum of the aircraft resulted in the aircraft nosing-over.

CAA Safety Sense Leaflet 12 – ‘*Strip Flying*’ includes a note to remind pilots to ensure that the wheel spats are clear of mud and grass and that temporary removal of the wheel spats must be agreed with the CAA regional office.

As part of the safety promotion and safety education service to pilots across GA, there will be reminders to pilots to inspect wheel spats and to consider ground conditions at grass strips as part of the aircraft loss of control focus.
