## ACCIDENT

<b>Aircraft Type and Registration:</b>	Robinson R44 Clipper I, G-CLIO	
<b>No &amp; Type of Engines:</b>	1 Lycoming O-540-F1B5 piston engine	
<b>Year of Manufacture:</b>	2000 (Serial no: 742)	
<b>Date &amp; Time (UTC):</b>	17 December 2020 at 1530 hrs	
<b>Location:</b>	Private landing site, Holmfirth, North Yorkshire	
<b>Type of Flight:</b>	Private	
<b>Persons on Board:</b>	Crew - 1	Passengers - 2
<b>Injuries:</b>	Crew - 1 (Minor)	Passengers - 2 (Minor)
<b>Nature of Damage:</b>	Tail rotor shaft fractured, tail rotor damaged, damage to skids and belly of the aircraft	
<b>Commander's Licence:</b>	Private Pilot's Licence	
<b>Commander's Age:</b>	50 years	
<b>Commander's Flying Experience:</b>	108 hours (of which 108 were on type) Last 90 days - 2 hours Last 28 days - 1 hour	
<b>Information Source:</b>	Aircraft Accident Report Form submitted by the pilot and further enquiries by the AAIB

## Synopsis

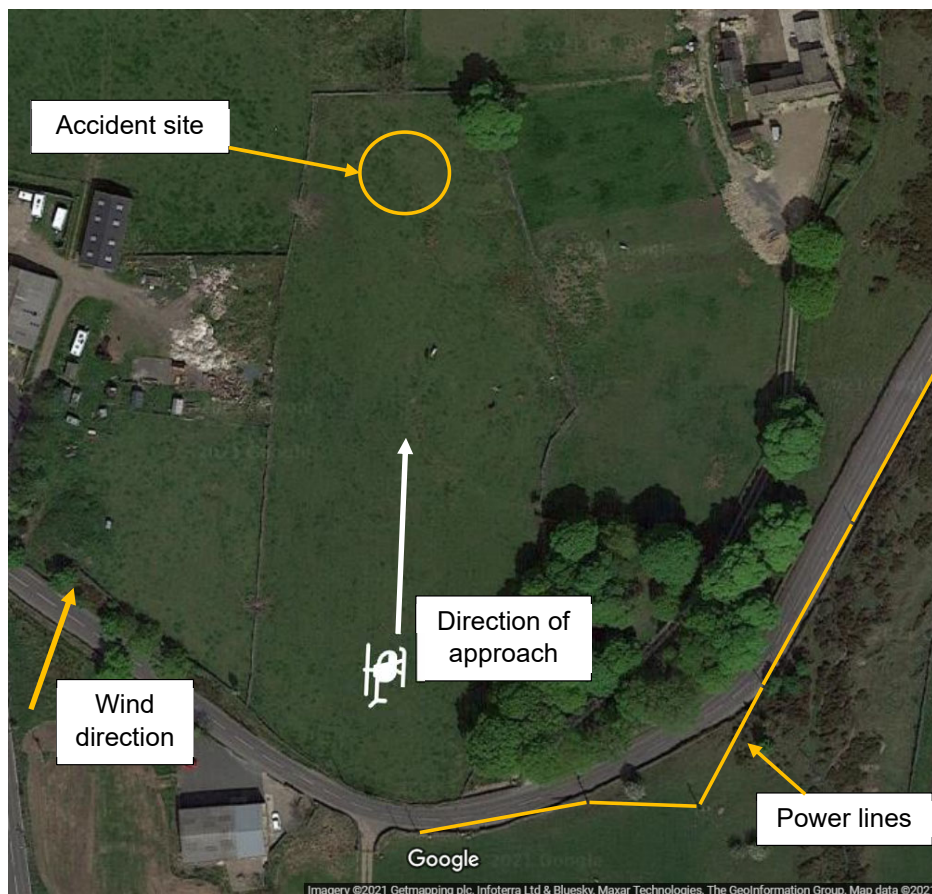
**Figure 1**

The aircraft had landed in a part of the field where the ground was undulating, sloping and boggy. To the east and west of the field were ridge lines with a wind turbine situated to the south and power lines positioned to the south and south-east (Figure 1).

Landing field showing power lines, wind direction and crash site

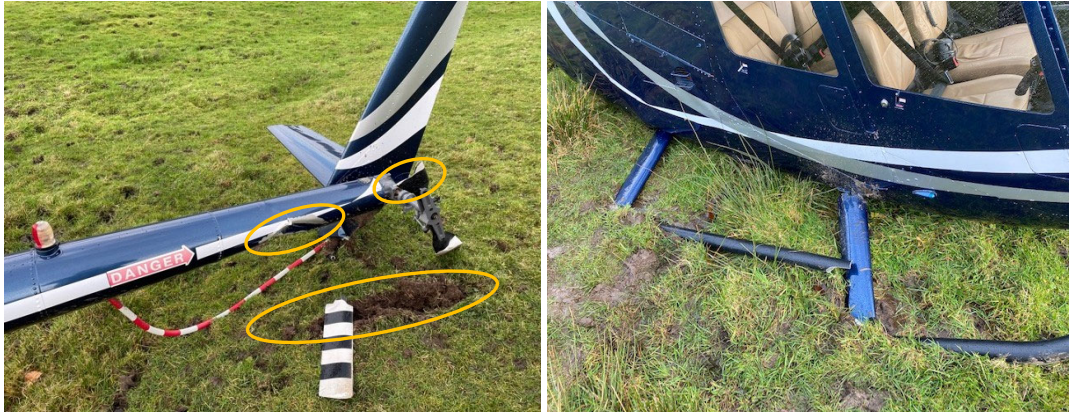
**Figure 2**

There were ground impact marks directly below the tail rotor where the blades had hit the soft, grassed surface. The tail rotor blades were bent and twisted and one of them had broken off near the root.

The vertical stabiliser, tail rotor guard and tail skid were damaged and disrupted. A large hole had been made in the left side of the tail boom where the tail rotor had punctured the skin and struck the tail rotor shaft, which had sheared. The landing skids were bent upwards and outwards and were partially disrupted (Figure 2). There was evidence of yielding of the cockpit seat structure and keel panels, and the lower belly of the aircraft was damaged.

Tail and tail rotor damage, ground impact marks and disrupted landing gear skids
