ACCIDENT

Aircraft Type and Registration:	Piper PA-28-181, G-JANT	
No & Type of Engines:	1 Lycoming O-360-A4M piston engine	
Year of Manufacture:	1983 (Serial no: 28-8390075)	
Date & Time (UTC):	30 April 2021 at 1814 hrs	
Location:	Bolt Head Airfield, Kingsbridge, Devon	
Type of Flight:	Private	
Persons on Board:	Crew - 1	Passengers - 3
Injuries:	Crew - None	Passengers - None
Nature of Damage:	Damage to fuselage, both wings, undercarriage and propeller	
Commander's Licence:	Private Pilot's Licence	
Commander's Age:	37 years	
Commander's Flying Experience:	143 hours (of which 73 were on type) Last 90 days - 11 hours Last 28 days - 6 hours	
Information Source:	Aircraft Accident Report Form submitted by the pilot

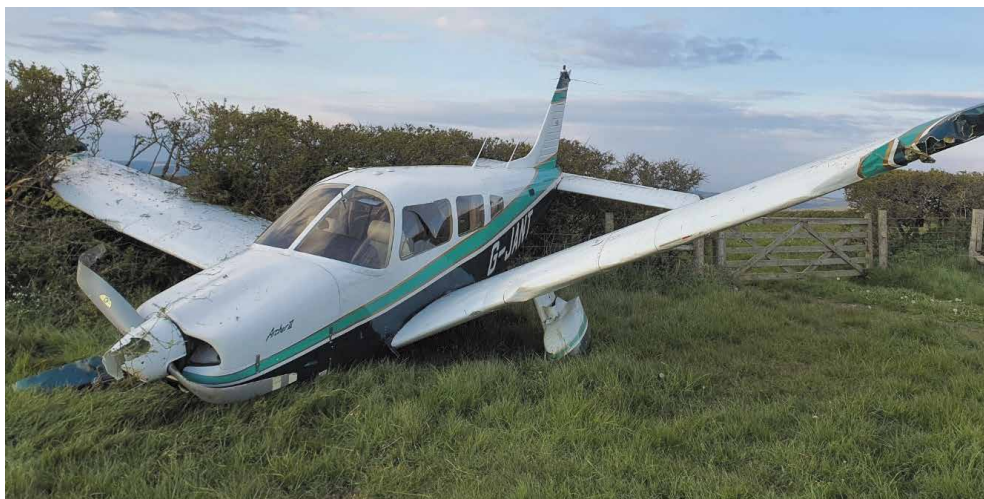
Figure 1

On the next approach, with full flap selected, the pilot slowed the aircraft from a 70 kt approach speed, flared and touched down about 50 m beyond the threshold. After bouncing once, the brakes were progressively applied to slow the aircraft on the damp grass. The pilot sensed that the aircraft was not slowing as anticipated so released and pumped the brakes, but without much apparent effect. Seeing the 4 ft high wire boundary fence about 150 m ahead, the pilot decided to go around. Two stages of flap were selected, and full power applied. The pilot allowed the aircraft to accelerate for "as long as possible" before pulling back on the stick. As the aircraft became airborne the pilot "possibly heard the stall warner and so pushed forward slightly to gather speed". However, the aircraft's landing gear contacted the fence and a second 4 ft high wire fence 2 m beyond, after which the nosewheel and right landing gear became detached. The aircraft came to a stop after sliding for about 300 m into a further field boundary fence (Figure 1).

Final resting position of G-JANT
(used with permission)
