SERIOUS INCIDENT

Aircraft Type and Registration:	DA 42 NG, G-HAKA	
No & Type of Engines:	2 Austro E4-C piston engines	
Year of Manufacture:	2015 (Serial no: 42.N158)	
Date & Time (UTC):	8 December 2020 at 1020 hrs	
Location:	Leeds Bradford Airport, West Yorkshire	
Type of Flight:	Private	
Persons on Board:	Crew - 1	Passengers - 1
Injuries:	Crew - None	Passengers - None
Nature of Damage:	None	
Commander's Licence:	Commercial Pilot's Licence	
Commander's Age:	45 years	
Commander's Flying Experience:	2,013 hours (of which 930 were on type) Last 90 days - 44 hours Last 28 days - 16 hours	
Information Source:	Aircraft Accident Report Form submitted by the pilot, operator's safety report and further enquiries by the AAIB

Synopsis

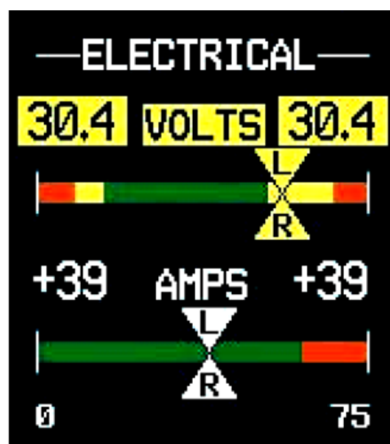
Figure 1

A voltmeter shows the main busbar voltages on a horizontal scale, Figure 1. Under normal operating conditions, with both alternators switched ON, the displayed voltages will show the alternator output. If an alternator is switched OFF, the respective voltmeter will show the main battery voltage, because the affected busbar will now be powered by the battery. If both alternators are switched OFF, both voltmeters will show the main battery voltage. The status of the alternator switches is not shown on the G1000.

Schematic showing the voltmeter and ammeter displays on the G1000
(Schematic from the manufacturer's AFM)

The G1000 display system does not depict the alternator switch status and has two voltmeters, one for each of the main busbars. If the alternator switches are OFF, the voltmeters continue to show the busbar voltage, which will be the main aircraft battery voltage. Furthermore, if the alternator switches are in the OFF position and the engines are running, the ammeters will show a current demand because the alternators will be supplying electrical power to the alternator control units, fuel pumps, ECUs and ECU back-up batteries. This could potentially reinforce the belief that the alternators are switched ON when they are OFF.
