SERIOUS INCIDENT

Aircraft Type and Registration:	Cessna F177RG, G-AYSY	
No & Type of Engines:	1 Lycoming IO-360-A1B6 piston engine	
Year of Manufacture:	1971 (Serial no: 26)	
Date & Time (UTC):	7 September 2020 at 1500 hrs	
Location:	Leicester Airport	
Type of Flight:	Private	
Persons on Board:	Crew - 1	Passengers - 1
Injuries:	Crew - 1 (Minor)	Passengers - 1 (Minor)
Nature of Damage:	Damage to the nose landing gear, propeller and engine	
Commander's Licence:	Light Aircraft Pilot's Licence	
Commander's Age:	31 years	
Commander's Flying Experience:	105 hours (of which 76 were on type) Last 90 days - 20 hours Last 28 days - 12 hours	
Information Source:	Aircraft Accident Report Form submitted by the pilot

Synopsis

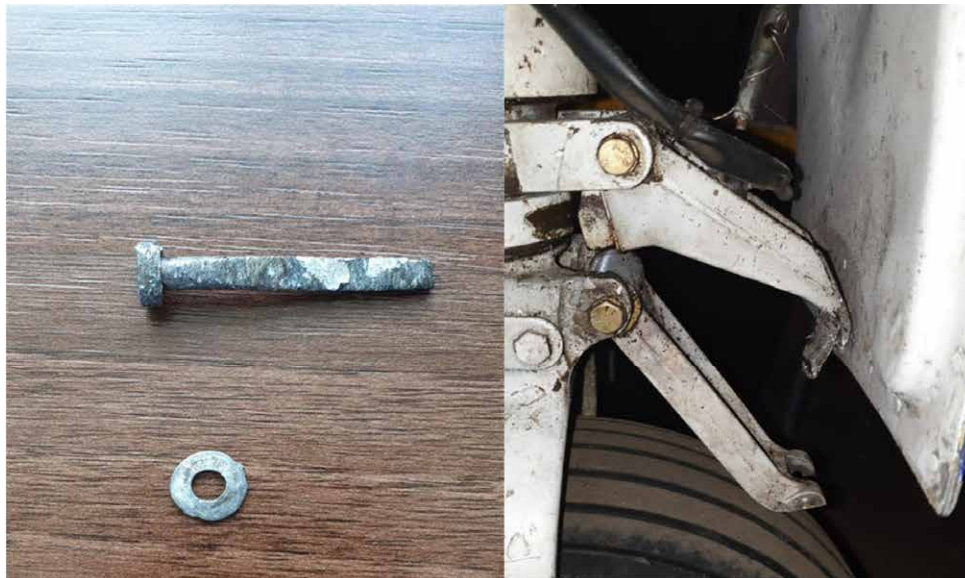
Figure 2

After the landing a bolt was recovered from the runway which was identified as the nose gear centre torque link bolt. This bolt had been in contact with the runway surface after the nose gear collapse and as a result suffered significant damage. The nut from the bolt was also missing. There was also corresponding runway contact damage to the nose gear torque link. These were the only two parts of the nose gear that were found to have sustained damage, and they are shown in Figure 2. Their positions in the nose gear assembly are shown in Figure 3.

Centre torque link bolt (left) and torque link (right)
(used with permission)

The nose gear centre torque link bolt was recovered from the runway, which together with the torque link had suffered damage from contact with the runway. These were the only two parts of the nose gear to have been damaged. After the aircraft was recovered to a maintenance facility, the nose gear was checked with no further faults found.

After landing, and as the aircraft slowed on the runway, the nose gear collapsed. The damage found to the centre torque link bolt and the torque link was attributed to being in contact with the runway and was considered unlikely to have been a causal factor in the accident. No other components of the nose gear were found to be faulty and a test of the retraction/extension system worked correctly. Given the lack of further structural damage to the nose gear, it is likely that the nose gear mechanical over-centre lock was not fully extended, either due to a technical fault or because the gear was retracted inadvertently after landing. It was not possible to determine what caused the collapse of the nose gear.

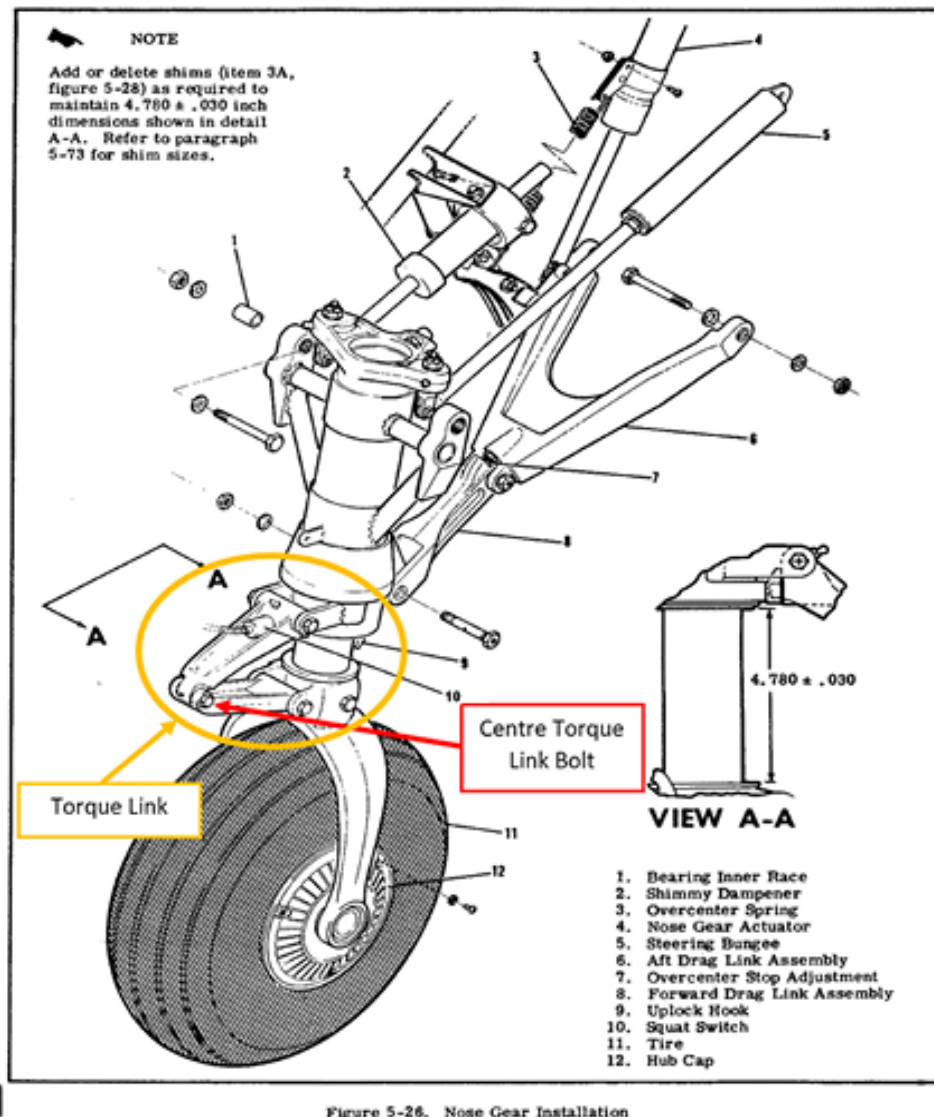
Figure 3

Nosewheel diagram from the Maintenance Manual showing the torque link and bolt
(© Textron Aviation)
