**ACCIDENT**

<b>Aircraft Type and Registration:</b>	Cessna 310Q, N25XL	
<b>No &amp; Type of Engines:</b>	2 TCM 10-470-VO piston engines	
<b>Year of Manufacture:</b>	1974 (Serial no: 310Q)	
<b>Date &amp; Time (UTC):</b>	17 January 2021 at 1354 hrs	
<b>Location:</b>	Belfast International Airport	
<b>Type of Flight:</b>	Private	
<b>Persons on Board:</b>	Crew - 1	Passengers - None
<b>Injuries:</b>	Crew - None	Passengers - N/A
<b>Nature of Damage:</b>	Substantial damage to aircraft and minor scrape damage to runway surface and runway edge lighting	
<b>Commander's Licence:</b>	Commercial Pilot's Licence	
<b>Commander's Age:</b>	58 years	
<b>Commander's Flying Experience:</b>	1,590 hours (of which 900 were on type) Last 90 days - 5 hours Last 28 days - 1 hour	
<b>Information Source:</b>	Aircraft Accident Report Form submitted by the pilot

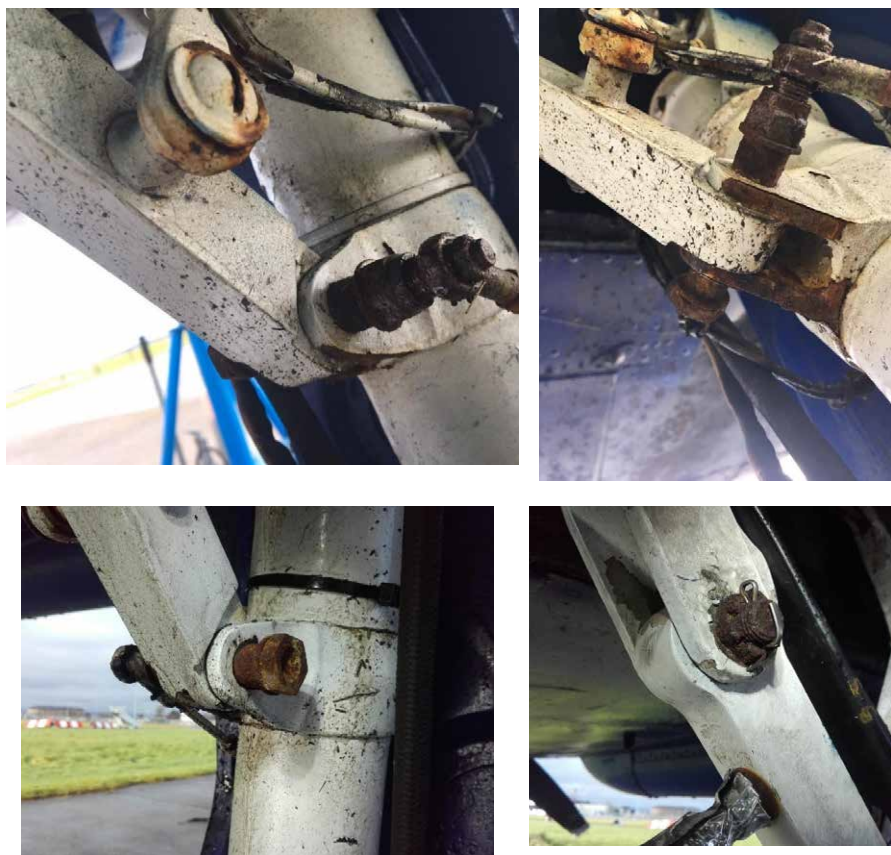
**Figure 2**

The AAIB has previously reported on other similar events to this type of aircraft<sup>1</sup> where lack of lubrication and/or freedom of movement of the landing gear mechanism pivot joints was a factor.

Images showing condition of right main landing gear mechanism pivot joints
