## ACCIDENT

<b>Aircraft Type and Registration:</b>	Boeing A75L300 'Stearman', G-CGPY	
<b>No &amp; Type of Engines:</b>	1 Lycoming R-680-E3B piston engine	
<b>Year of Manufacture:</b>	1945 (Serial no: 75-5303)	
<b>Date &amp; Time (UTC):</b>	23 June 2020 at 1420 hrs	
<b>Location:</b>	Culmhead, Somerset	
<b>Type of Flight:</b>	Commercial	
<b>Persons on Board:</b>	Crew - 1	Passengers - 1
<b>Injuries:</b>	Crew - None	Passengers - None
<b>Nature of Damage:</b>	Damage to wingtip and fuselage	
<b>Commander's Licence:</b>	Commercial Pilot's Licence	
<b>Commander's Age:</b>	57 years	
<b>Commander's Flying Experience:</b>	17,219 hours (of which 12 were on type) Last 90 days - 9 hours Last 28 days - 8 hours	
<b>Information Source:</b>	Aircraft Accident Report Form submitted by the pilot and additional enquiries by the AAIB

## Synopsis

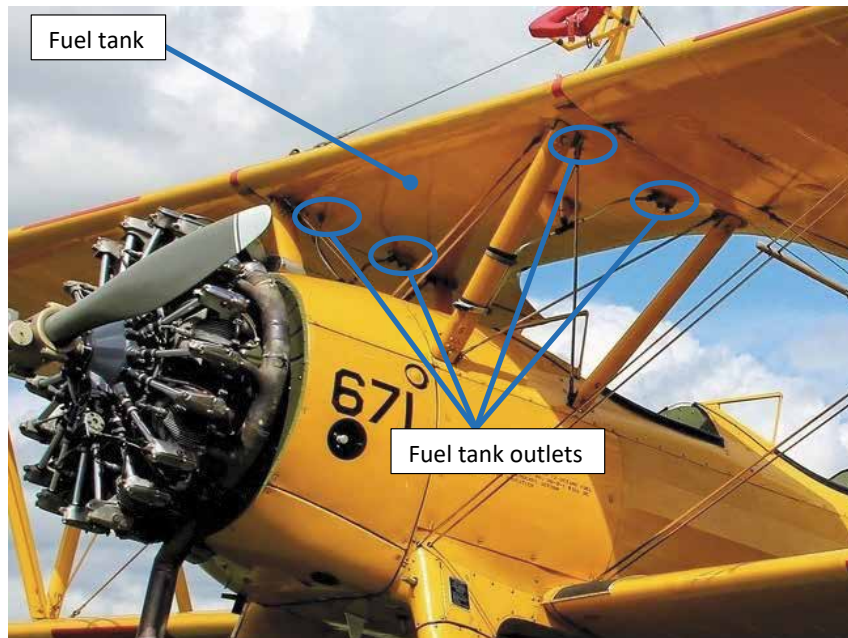
**Figure 2**

Fuel is gravity fed to the engine from a tank within the centre of the upper mainplane. There are four outlets from the tank (Figure 2). Pipes are connected to each outlet, which join forward to aft before entering the fuselage at the front supports. The left and right pipes join aft of the firewall before going to the engine as a single pipe. Fuel should therefore be available to the engine throughout the pitch and roll range provided positive g is maintained.

G-CGPY's *'Pilot's Flight Operating Instructions'* specified a fuel tank capacity of 46 USG (174 litres), and its *'Weight and Centre of Gravity Schedule'* described all of this as usable. The CAMO stated that momentary fuel starvation of the feed sumps was considered possible in some attitudes at low fuel levels.

Fuel tank and fuel pipes from tank of G-CGPY (image used with permission)
