SERIOUS INCIDENT

Aircraft Type and Registration:	Avro 652A Anson T21, G-VROE	
No & Type of Engines:	2 Armstrong Siddeley Cheetah 17 piston engines	
Year of Manufacture:	1950 (Serial no: 3634)	
Date & Time (UTC):	4 July 2020 at 1252 hrs	
Location:	Shobdon Aerodrome, Leominster, Herefordshire	
Type of Flight:	Private	
Persons on Board:	Crew - 1	Passengers - 1
Injuries:	Crew - None	Passengers - N/A
Nature of Damage:	No damage	
Commander's Licence:	Private Pilot's Licence	
Commander's Age:	76 years	
Commander's Flying Experience:	7,642 hours (of which 69 were on type) Last 90 days - 18 hours Last 28 days - 9 hours	
Information Source:	Aircraft Accident Report Form submitted by the pilot and further enquiries by the AAIB

Synopsis

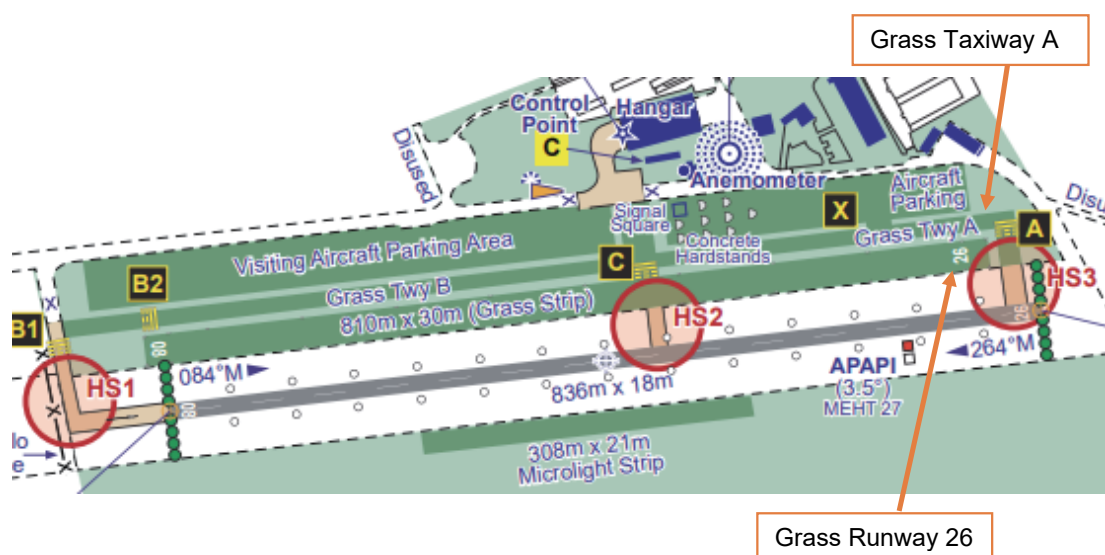
Figure 1

The pilot stated that shortly before the aircraft reached the aerodrome boundary, a gust of wind displaced it to the right. It subsequently landed on unprepared grass adjacent to the runway¹. The aircraft completed its landing roll on grass Taxiway A (Figure 1).

Extract from Shobdon's Aerodrome Chart²

The AFISO reported that during the time G-VROE made its approach to Shobdon there were no other aircraft in the air or manoeuvring on the ground, but that some aircraft were parked in both of the aircraft parking areas (Figure 1). He had flown himself that day and recalled the wind being "a bit gusty".
