# **Annual Safety Review 2020**

Air Accidents Investigation Branch  
Farnborough House  
Berkshire Copse Road  
Aldershot  
Hampshire  
GU11 2HH.

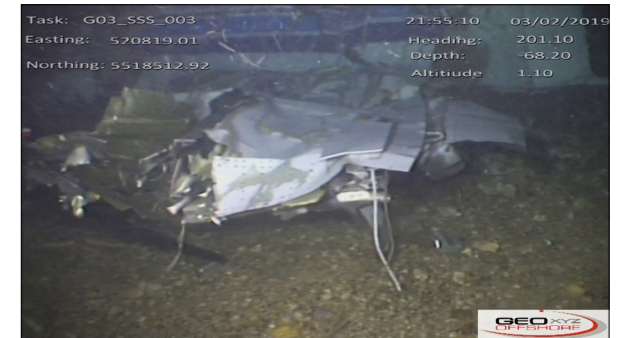
The accident occurred on 21 January 2019 at 2016 hrs. The wreckage was located on 3 February 2019 on the seabed approximately 22 nm north-north-west of Guernsey, within 100 m of the last secondary radar point recorded by the radar at Guernsey and at a depth of 68 m. There was one body present in the wreckage, which was recovered. The body was subsequently identified as that of the passenger.

View looking at remains of inner wing

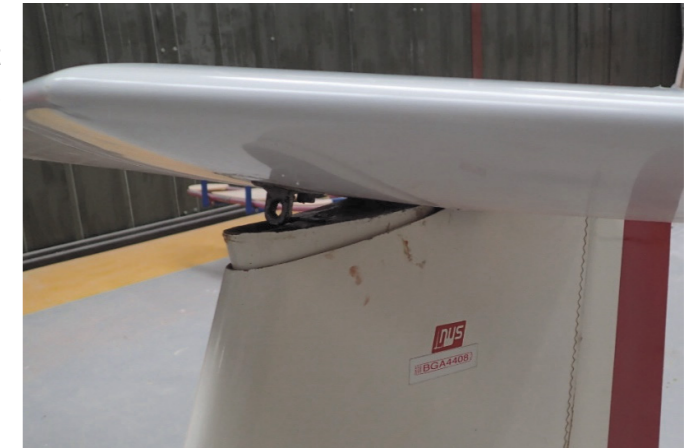
The glider was undertaking an aerotow launch to the west at Gwernesney Airfield which was operated by the resident gliding club. During the early stages of the ground roll the horizontal tailplane (tailplane) detached from G-DDGX and fell to the ground. Club members assisting with the launch signalled for the takeoff to be aborted but the message did not reach the aerotow tug pilot; the accident pilot did not appear to hear or see the stop signals either. The glider became airborne and climbed rapidly, before the tow cable released and the aircraft's nose dropped. The glider descended steeply and struck the ground nose first. It came to rest inverted pointing in an easterly direction. First responders extricated the pilot from the aircraft before he was airlifted to hospital. He died five days later from complications related to injuries sustained in the accident.

Rear tailplane mechanism partially engaged, front fitting disengaged

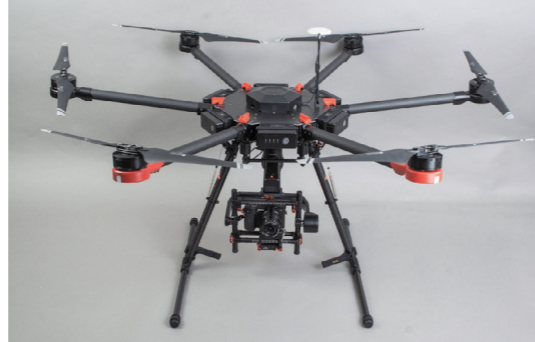
The UAS, a DJI M600 Pro, was being operated in an automated flight mode to survey a construction site when a GPS-compass error caused the aircraft to revert to a flight mode that required manual control. By the time that the pilot and observer realised that it was not responding to the return-to-home (RTH) function, visual line of sight was lost when the aircraft drifted with the wind beyond a line of trees. It subsequently collided with the roof of a house before falling into the property's rear garden. No persons were injured.

M600 series aircraft  
The accident aircraft was fitted with three GPS antenna

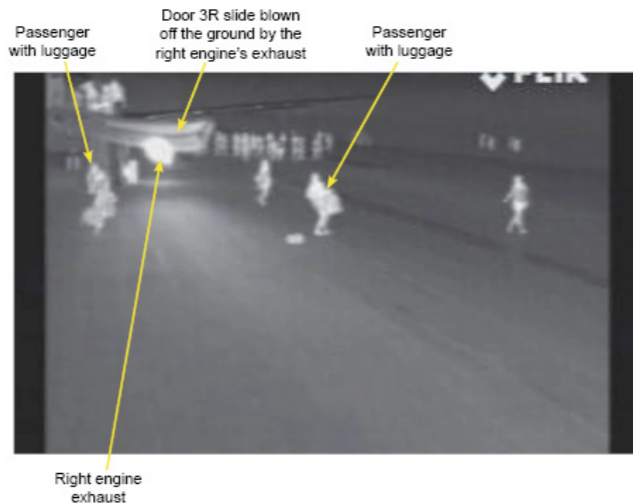
The aircraft was on a scheduled flight from London Stansted Airport to Vienna International Airport, Austria. Shortly after the takeoff roll was commenced it was rejected, due to a contained failure of the left engine, and the aircraft was brought to a stop on the runway. Just as the flight crew were about to taxi the aircraft off the runway, an evacuation was commanded by the Senior Flight Attendant. The investigation identified several factors that contributed to this decision. Ten passengers were treated for minor injuries that occurred during the evacuation and there was a risk of serious injury due to one of the engines running during the evacuation. The operator has taken several safety actions, principally based around the training of its flight attendants. Two Safety Recommendations regarding passenger evacuation have been made in this report.

RFFS infrared CCTV showing some passengers leaving with baggage

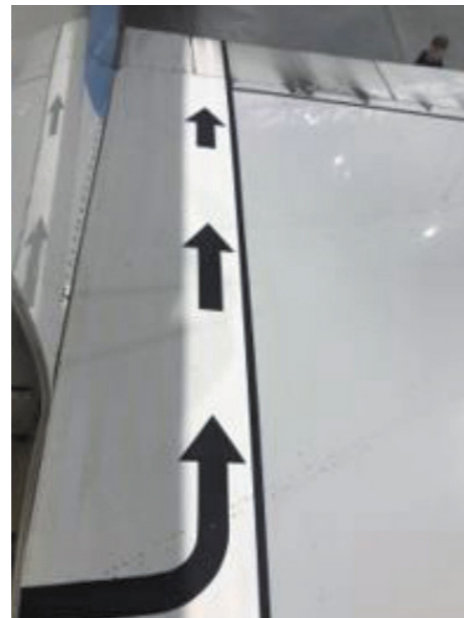
Despite the presence of a marked exit route on the wing with a non-slip surface, many passengers who exited via the overwing exits reported being uncertain where to go once out of the aircraft. Overwing exit route markings are not always readily identifiable and may be even less so in darkness. Poor weather conditions or the presence of smoke could also hinder identification of an exit route. It is apparent that the issue of ambiguous overwing escape route markings that resulted in previous AAIB Safety Recommendations 2002-42 and 2010-007 still exists.

Overwing exit escape route markings on E195 (view towards wing trailing edge)

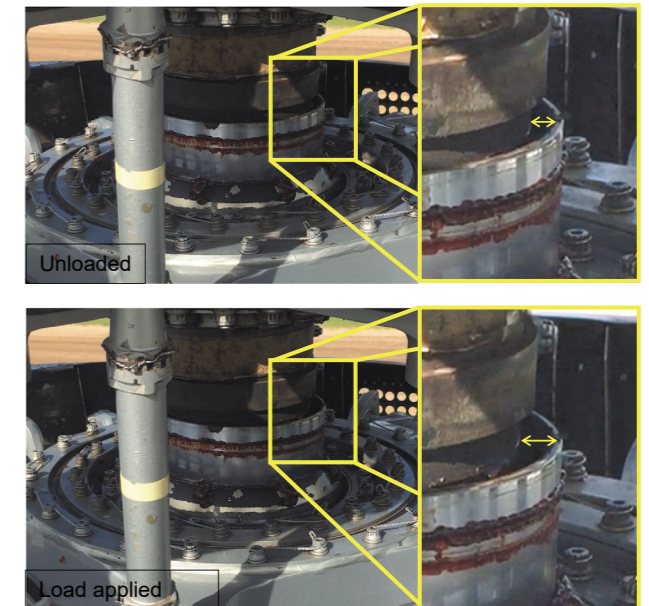
Despite the seizure, the investigation determined that full fore/aft travel of the cyclic control could still be achieved which indicates that this is not a reliable indication that the swashplate is free to move. During pre-flight checks by maintenance engineers and the flight crew, the flight control servo system checks were not completed to the full extremes of travel. With a seized swashplate, the rotor blades changed pitch due to flexing of the guide tube and the blade movement was incorrectly identified as a positive confirmation of control authority. There was no confirmation by external observation of the main rotor and swashplate operation during the limited range pre-flight checks.

Stills from video of another S-61 showing levels of guide tube deflection when cyclic was applied to a seized swashplate

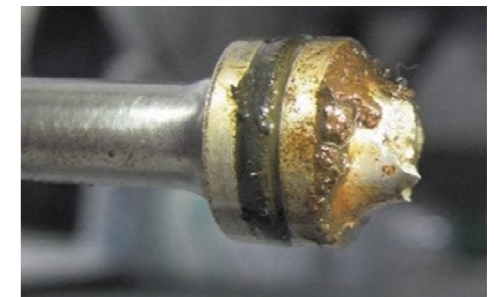
Following this accident, where longitudinal control of the helicopter was lost at low level, it was discovered that a tie bar within a main rotor actuator had fractured. This fracture was caused by the reduction in area of the tie bar through the propagation of a crack initiated by pitting corrosion. It is highly probable that the corrosion pits were caused by the accumulation of salt moisture in the end of the actuator, which had penetrated into the actuator through a gap.

Material adjacent to tie bar fracture surface

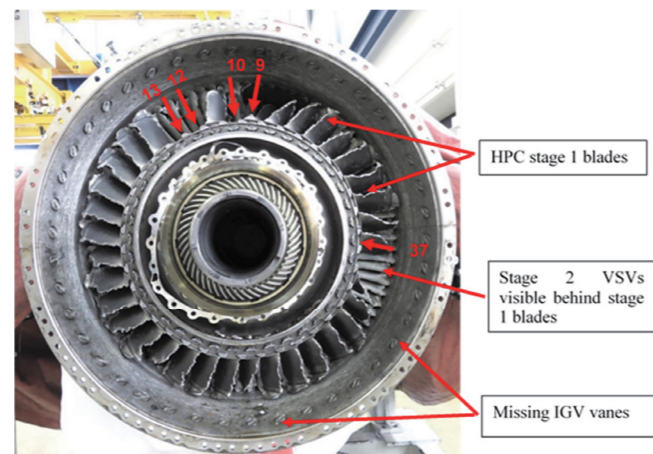
The left engine experienced a contained engine failure. All the damage found in the engine was consistent with the release of one or more high-pressure compressor stage 1 blades as a result of high-cycle fatigue arising from aerodynamic excitation of the blades. A single inlet guide vane lever arm, which had been improperly assembled in the connecting link on the inlet guide vane actuation ring, was identified as the source of the stimulus that resulted in the blade release.

HPC module showing missing IGVs and damaged stage 1 blades

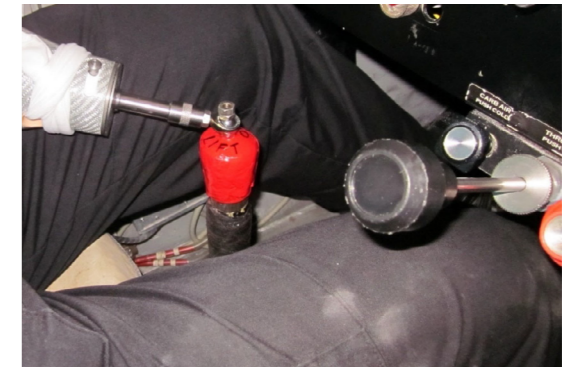
Prosthetic adapter in use

The pilot has since modified the interface between the prosthetic adapter and the aircraft control column. The UK CAA has amended the medical certification pathway for pilots with musculoskeletal disability to include an engineering assessment of interface between any prosthesis and the aircraft flying controls.

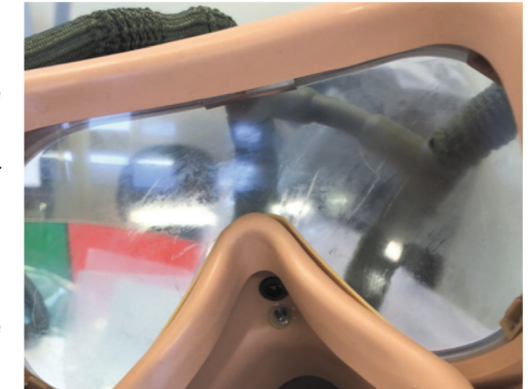
Co-pilot's mask showing fogging and marks on internal lens

The aircraft manufacturer has added a cleaning procedure for the TRU in the Aircraft Maintenance Manual. The operator has added a practical demonstration on the use of the mask and its selectors during its recurrent training cycle.

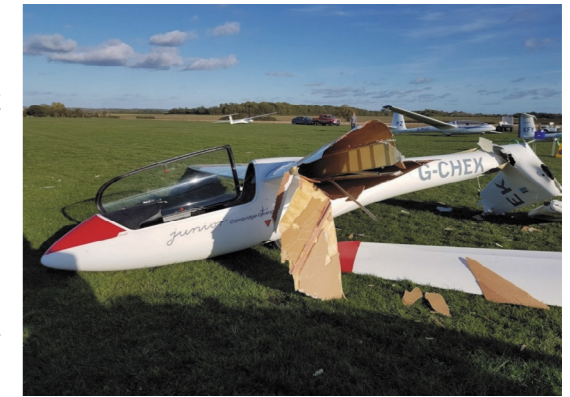
Damage to the tail and left wing of an SZD-51 glider caused by G-ROYC

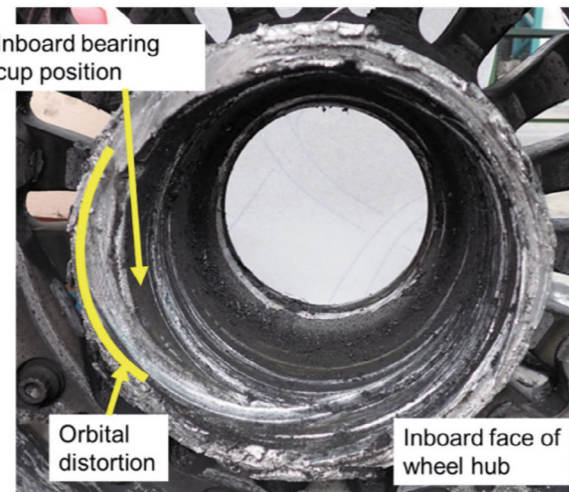
Hub damage around the inboard bearing cup area

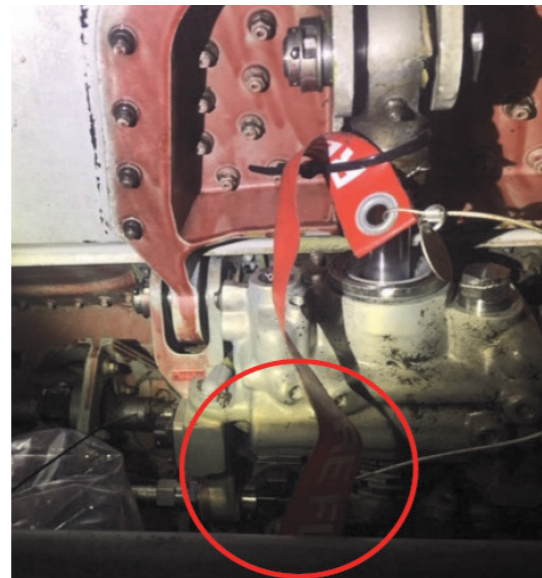
Spoiler maintenance key and flag as found on arrival

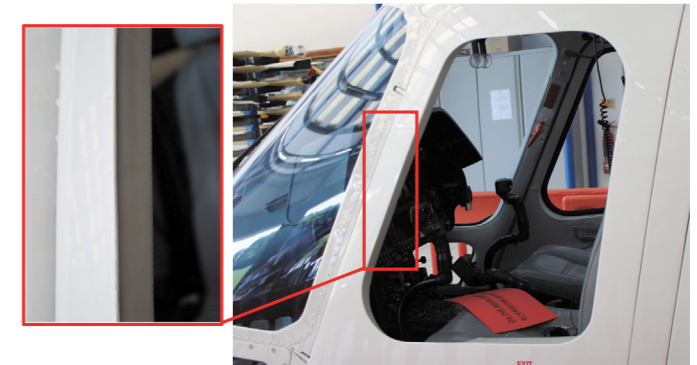
Window aperture of left cockpit door, showing no evidence of adhesive
