Annual Safety Review 2020

Air Accidents Investigation Branch
Farnborough House
Berkshire Copse Road
Aldershot
Hampshire
GU11 2HH.

Foreword

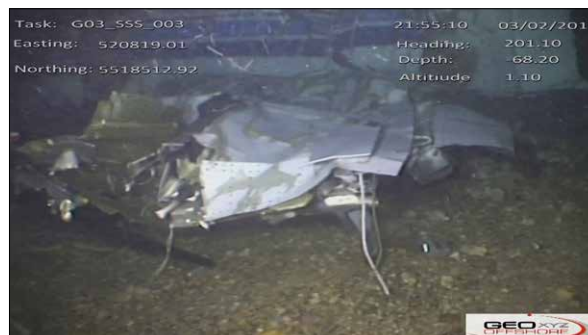
The accident occurred on 21 January 2019 at 2016 hrs. The wreckage was located on 3 February 2019 on the seabed approximately 22 nm north-north-west of Guernsey, within 100 m of the last secondary radar point recorded by the radar at Guernsey and at a depth of 68 m. There was one body present in the wreckage, which was recovered. The body was subsequently identified as that of the passenger.

View looking at remains of inner wing

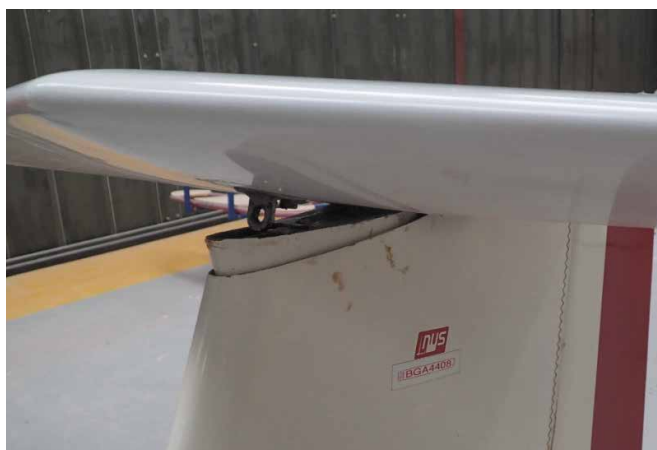
The glider was undertaking an aerotow launch to the west at Gwernesney Airfield which was operated by the resident gliding club. During the early stages of the ground roll the horizontal tailplane (tailplane) detached from G-DDGX and fell to the ground. Club members assisting with the launch signalled for the takeoff to be aborted but the message did not reach the aerotow tug pilot; the accident pilot did not appear to hear or see the stop signals either. The glider became airborne and climbed rapidly, before the tow cable released and the aircraft's nose dropped. The glider descended steeply and struck the ground nose first. It came to rest inverted pointing in an easterly direction. First responders extricated the pilot from the aircraft before he was airlifted to hospital. He died five days later from complications related to injuries sustained in the accident.

Rear tailplane mechanism partially engaged, front fitting disengaged

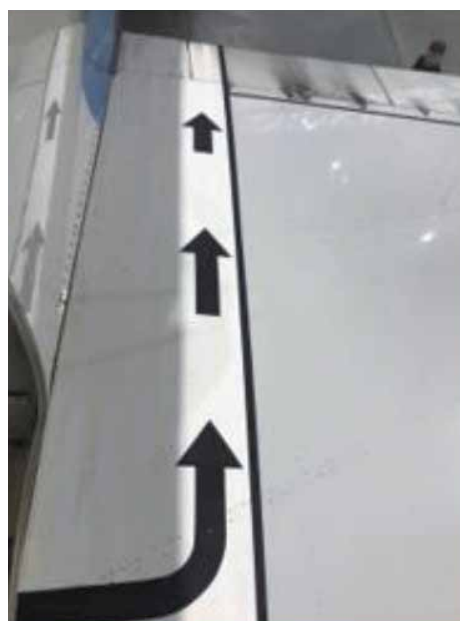
Overwing exit escape route markings on E195
(view towards wing trailing edge)

Four Safety Recommendations are made relating to the certification requirements for overwing exit markings and the height requirement for overwing exits to be equipped with an assisted means of escape.

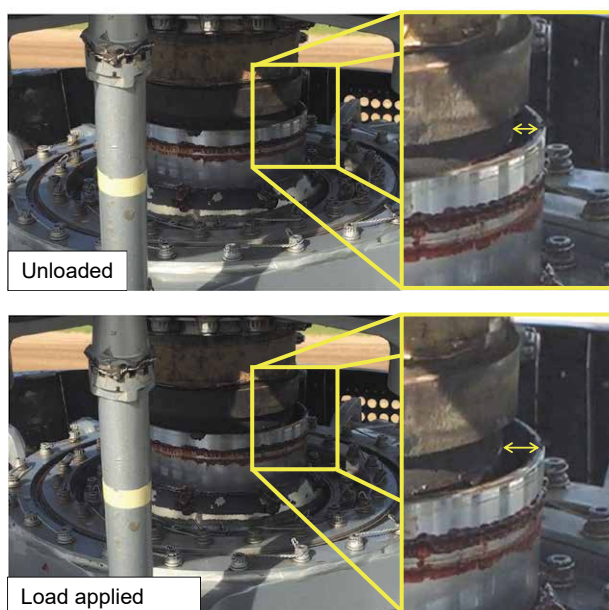
Despite the seizure, the investigation determined that full fore/aft travel of the cyclic control could still be achieved which indicates that this is not a reliable indication that the swashplate is free to move. During pre-flight checks by maintenance engineers and the flight crew, the flight control servo system checks were not completed to the full extremes of travel. With a seized swashplate, the rotor blades changed pitch due to flexing of the guide tube and the blade movement was incorrectly identified as a positive confirmation of control authority. There was no confirmation by external observation of the main rotor and swashplate operation during the limited range pre-flight checks.

Stills from video of another S-61 showing levels of guide tube deflection when cyclic was applied to a seized swashplate

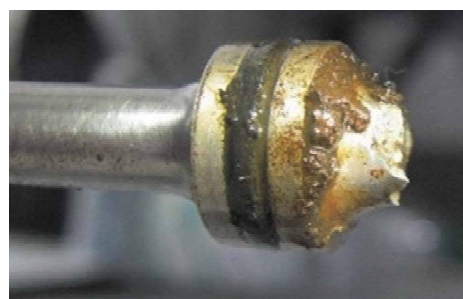
Following this accident, where longitudinal control of the helicopter was lost at low level, it was discovered that a tie bar within a main rotor actuator had fractured. This fracture was caused by the reduction in area of the tie bar through the propagation of a crack initiated by pitting corrosion. It is highly probable that the corrosion pits were caused by the accumulation of salt moisture in the end of the actuator, which had penetrated into the actuator through a gap.

Material adjacent to tie bar
fracture surface

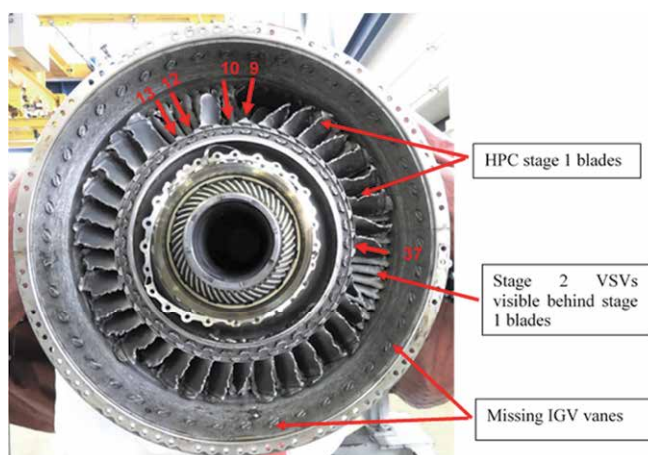
The left engine experienced a contained engine failure. All the damage found in the engine was consistent with the release of one or more high-pressure compressor stage 1 blades as a result of high-cycle fatigue arising from aerodynamic excitation of the blades. A single inlet guide vane lever arm, which had been improperly assembled in the connecting link on the inlet guide vane actuation ring, was identified as the source of the stimulus that resulted in the blade release.

HPC module showing missing IGVs and damaged stage 1 blades

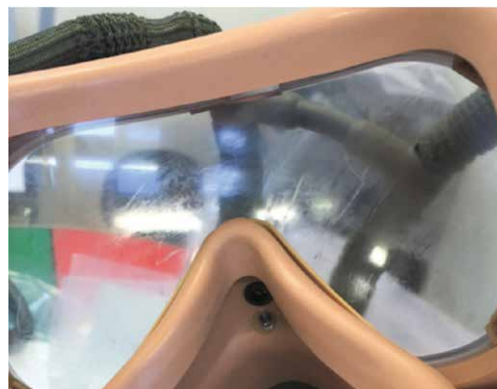
Co-pilot's mask showing fogging and marks on internal lens

The aircraft manufacturer has added a cleaning procedure for the TRU in the Aircraft Maintenance Manual. The operator has added a practical demonstration on the use of the mask and its selectors during its recurrent training cycle.

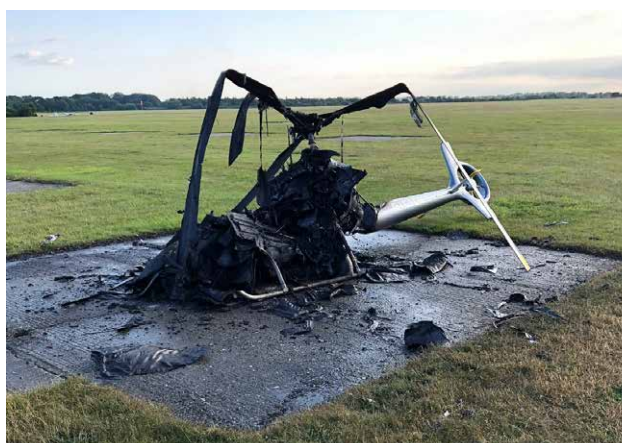
The helicopter caught fire shortly after landing because the heat generated from a short circuit in the engine compartment ignited a nearby carbon fibre structure. The short circuit was made between the cable that connected the output of the alternator to the starter relay and the aluminium air baffle through which the cable passed. It is likely that the cable clips that should have held the cable as it passed through the baffle were either not present or, most likely, incorrectly fitted. The upward movement of the engine as a result of the clutch disengagement was sufficient to allow the unsecured cable to contact the unprepared edge of the aluminium baffle, allowing the insulation to be cut and initiate the short circuit.

G-CILR prior to being moved

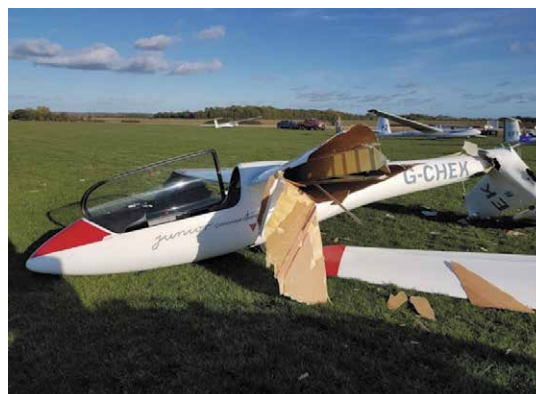
Damage to the tail and left wing of an SZD-51 glider caused by G-ROYC

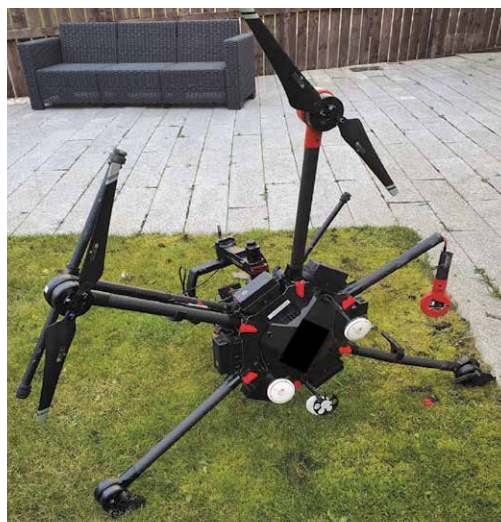
The aircraft after falling into the garden

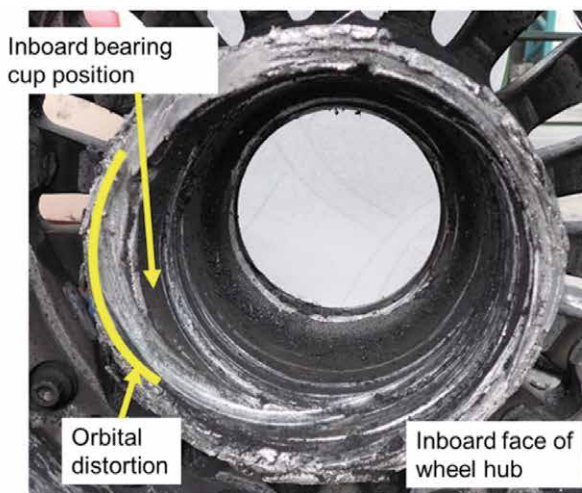
Hub damage around the inboard bearing cup area

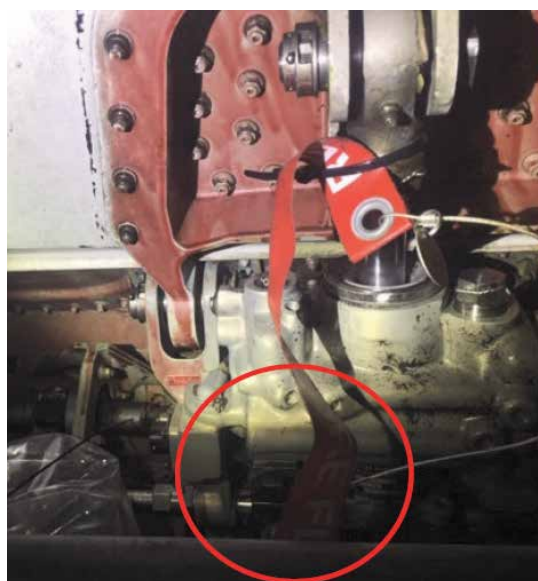
Spoiler maintenance key and flag as found on arrival

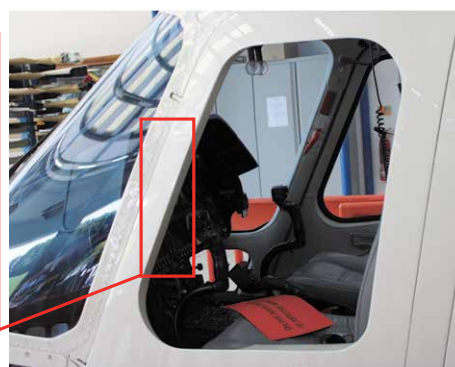
Window aperture of left cockpit door, showing no evidence of adhesive

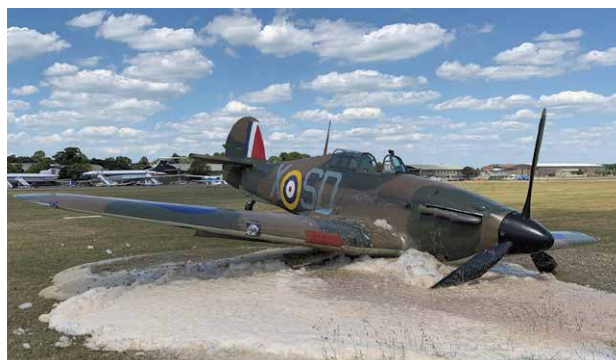
G-HRLI after the accident and application of fire-suppressing agent
