Rail Accident Investigation Branch

Rail Accident Report

Derailment at Blackpool Pleasure Beach 6 July 2006

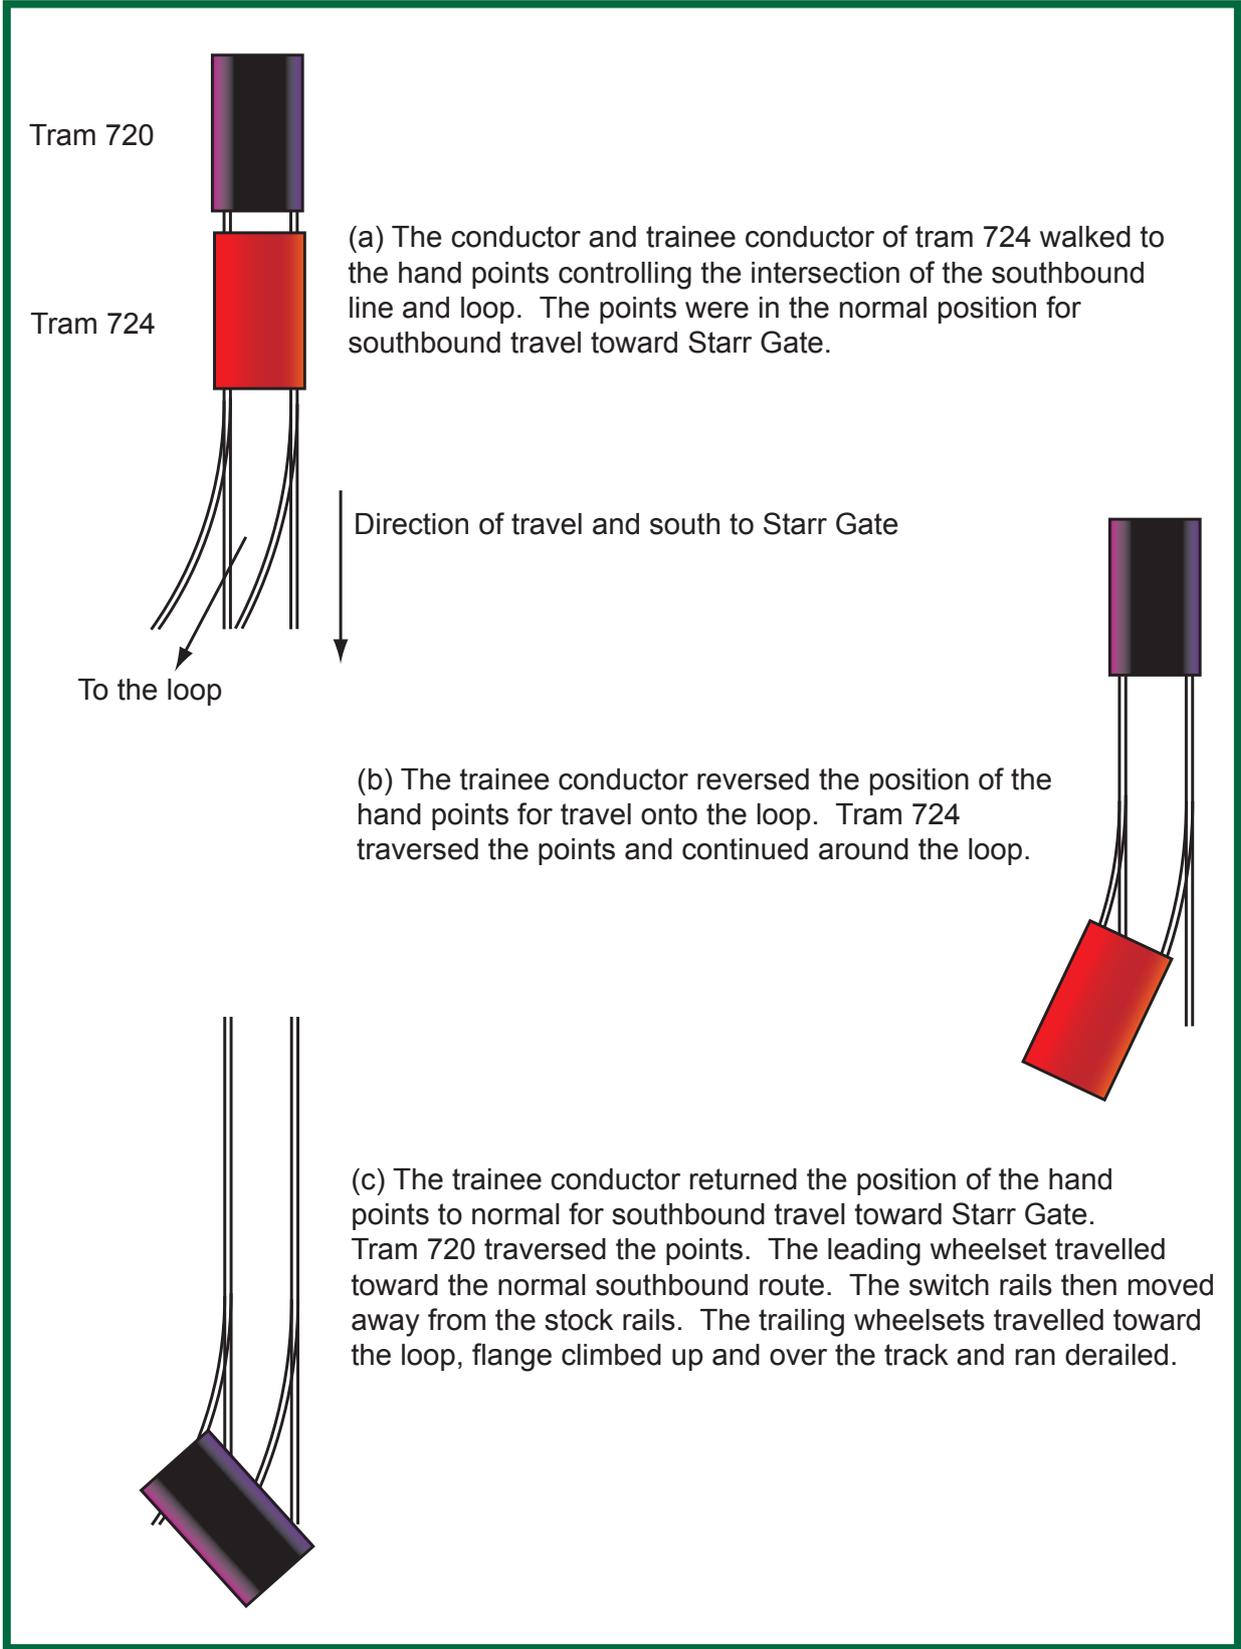
Figure 3: Sequence of events during the incident

- 21 Tram 720 traversed the points. The leading wheelset travelled toward the normal, southbound route. The switch rails then moved away from the *stock rails* and the trailing wheelsets travelled toward the loop, *flange climbed* up and over the track and ran derailed. See Figure 3 for the sequence of events.

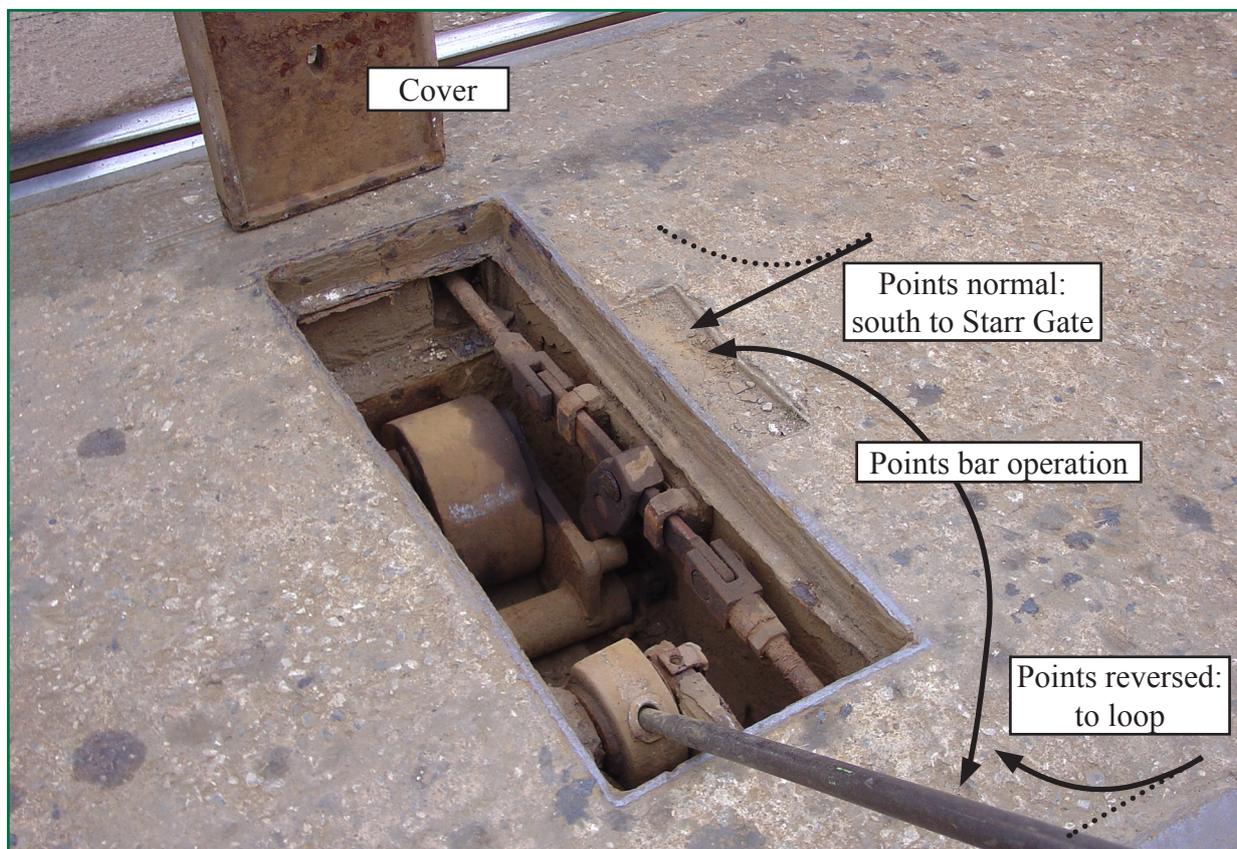
Figure 4: Operation of hand points using a points bar (cover removed)

- 25 BTS custom and practice for operating the hand points mechanism is as follows:
- a points bar is inserted into a slot in the mechanism cover;
 - the points bar is pulled or pushed until the switch rails locate against the stock rails;

- the points bar is removed and then used to lever within the space between both pairs of stock and switch rails to confirm that the switch rails are satisfactorily located (Figure 4).

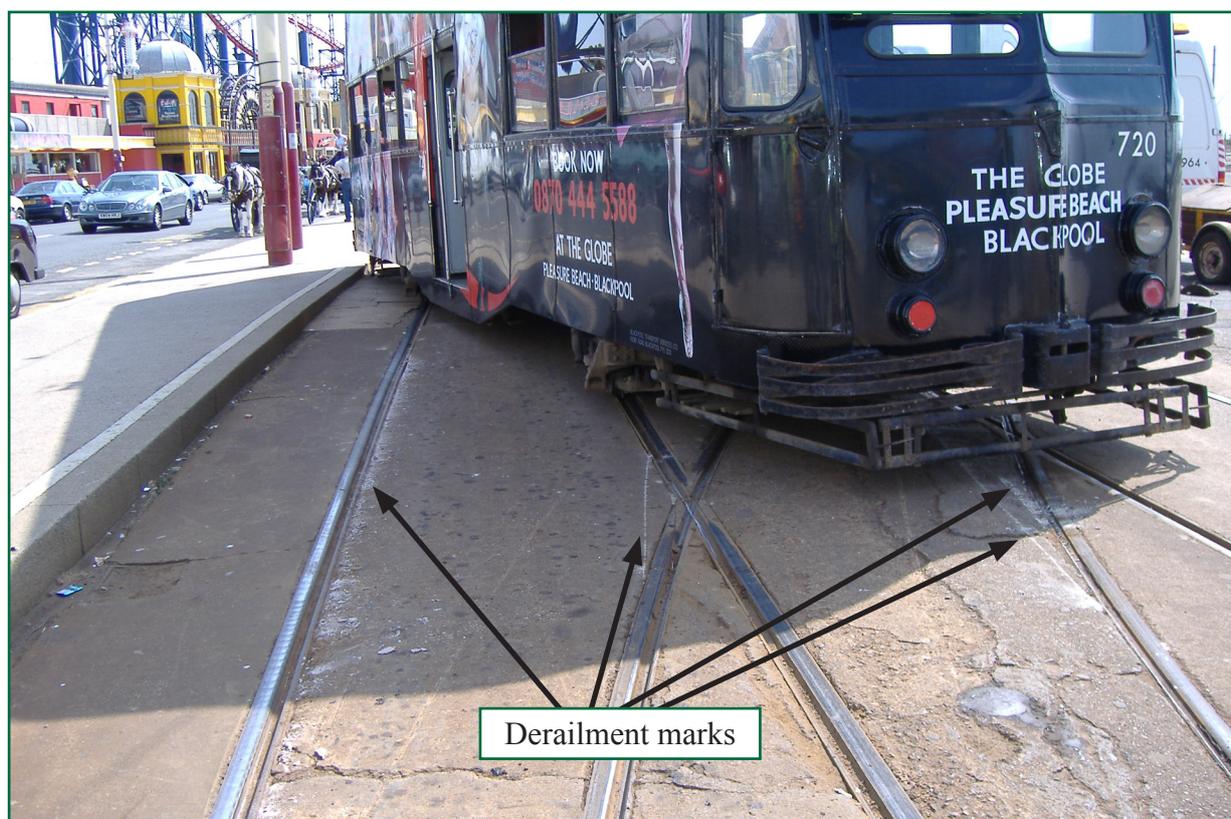
Figure 5: Tram 720 from the rear and derailment marks in the concrete

- 30 Tram 720 was examined after the incident and no faults were found, nor was there evidence of any abnormal operation in traffic immediately prior to the incident. Therefore the condition of tram 720 was considered neither causal nor contributory to the incident.
- 31 The switch and stock rails were examined after the incident and no faults were found. Therefore the condition of the infrastructure was considered neither causal nor contributory to the incident.
- 32 Indentation marks were found on both switch tips. The marks corresponded with the tram wheel profile and were separated by a distance that corresponded with the back to back dimension of the tram wheels.
- 33 Derailment marks in the concrete corresponded with the paths taken by the trailing wheelsets after they had flange climbed from the loop track and ran derailed (Figure 5).

- 34 The position of the tram post-derailment and the marks on switch rails and concrete confirmed that the immediate cause of the derailment was the trailing wheelsets travelling toward the loop after the leading wheelset correctly travelled toward the normal, southbound route.

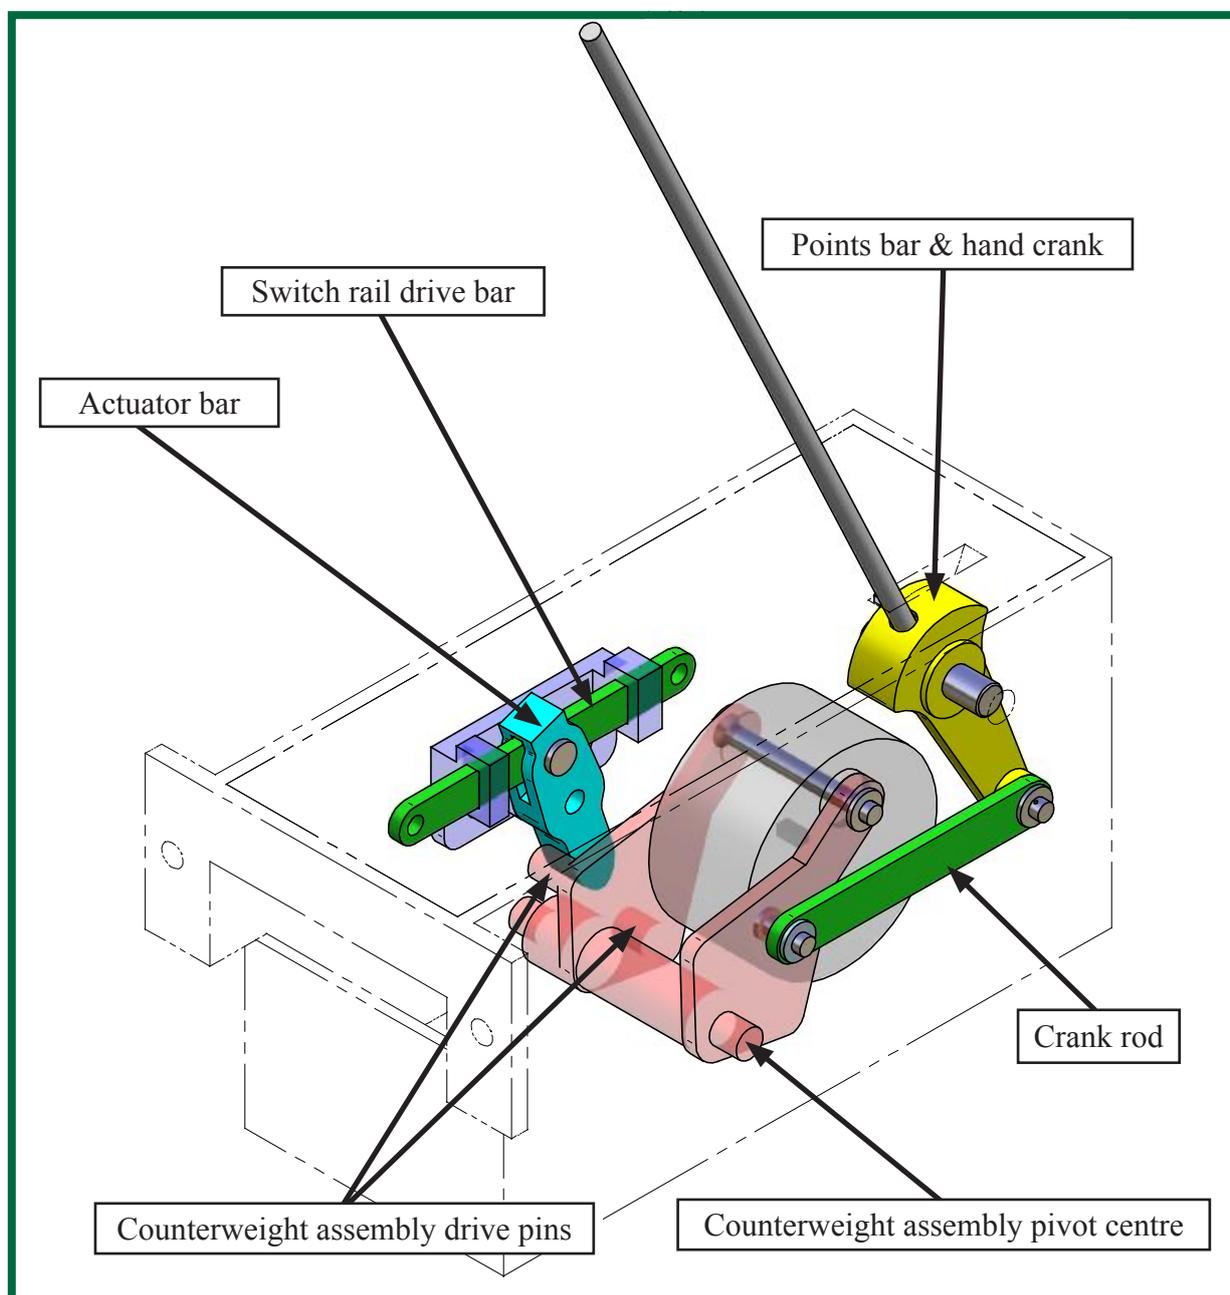
Figure 6: The components of the hand points operating mechanism

- 35 The hand points are operated by a manually levered mechanism. The components of the hand points mechanism are shown in Figure 6.
- 36 The switch rails are moved by the drive bar via connecting rods and are held in position by the counterweight lying fully over its pivot centre.

- 37 The RAIB testing undertaken after the incident demonstrated that the switch rails could be closed against the stock rails with the counterweight held by friction and not lying fully over its pivot centre. In this unstable state, a disturbance can cause friction to be overcome, the counterweight to move and the switch rails to open away from the stock rails in either normal or reverse positions (Figure 7). The causal factor of the derailment was that the hand points mechanism had not been correctly returned to the normal position and was in an unstable state before the passage of tram 720.

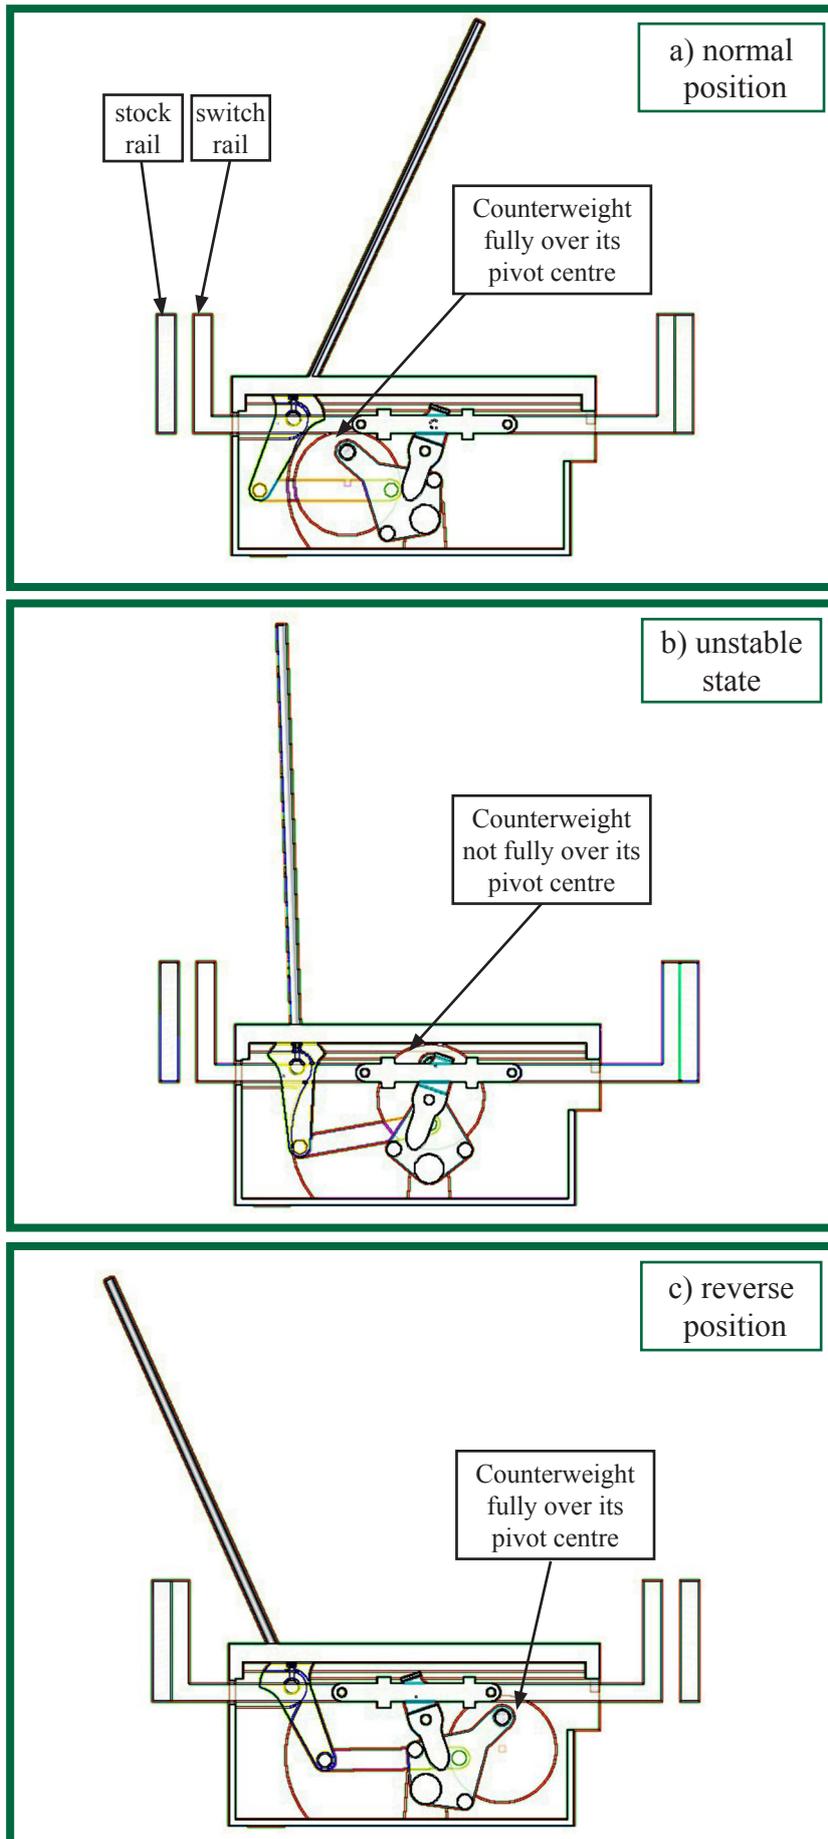
Figure 7: The hand points mechanism under operation

- 38 The conductor and trainee conductor found that the hand points were stiff to operate before the incident despite the mechanism and switch rail motion being clean and free from debris. This was confirmed by a BTS induction trainer who had operated the hand points mechanism while instructing trainees the day before the incident and by RAIB testing undertaken after the incident.

- 39 The mechanism becomes less stiff in operation after lubrication with water. This was perceptible when the mechanism was operated repeatedly during testing, first in the dry condition and then in the water lubricated condition. A manufacturer of this type of hand points used in this location would not require lubrication of the mechanism with oil or grease because the lubricant would bind with sand and grit and promote wear.

- 1 Blackpool Transport Services should develop and document a method of hand points operation to ensure that the mechanism is not placed in an unstable state (paragraph 55).
- 2 Blackpool Transport Services should put in place a system to ensure that the method identified in Recommendation 1 above is correctly trained at induction and applied in day to day operations by staff throughout their employment (paragraph 55).
