Near miss with track workers at Llandegai tunnel, Llandygái, Gwynedd, 13 February 2021

Summary of the incident

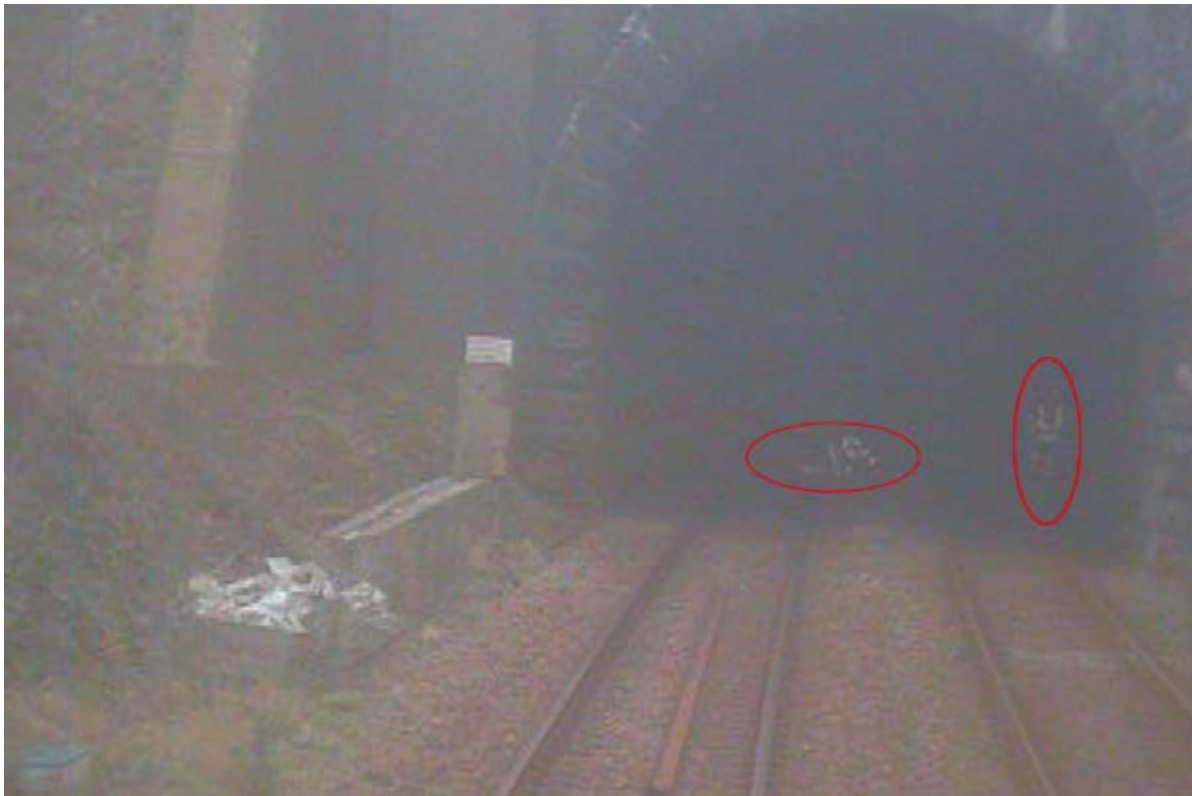
The train involved was 1D12, the 10:25 hrs passenger service from Shrewsbury to Holyhead. It was travelling close to the maximum permissible line speed of 75 mph (120 km/h). The driver sounded the horn on sighting the work group. The group had just entered the tunnel on the down line (the line used by trains heading west) and were using a long pole to remove icicles from the water deflection sheeting on the tunnel roof. The COSS heard the horn, turned and saw the train approaching them. He shouted that they were on the wrong line and managed to get to safety on the other line. The other track worker tried to do the same but fell over. He then managed to roll into the space between the tracks. The driver saw that the track worker was across the right-hand running rail of the down line, and immediately applied the emergency brake and sounded the horn again. CCTV from the train showed that the track worker managed to crawl clear with about a second to spare. No-one was injured, but those involved were badly shaken.

CCTV image from the approaching train (image courtesy of Transport for Wales)

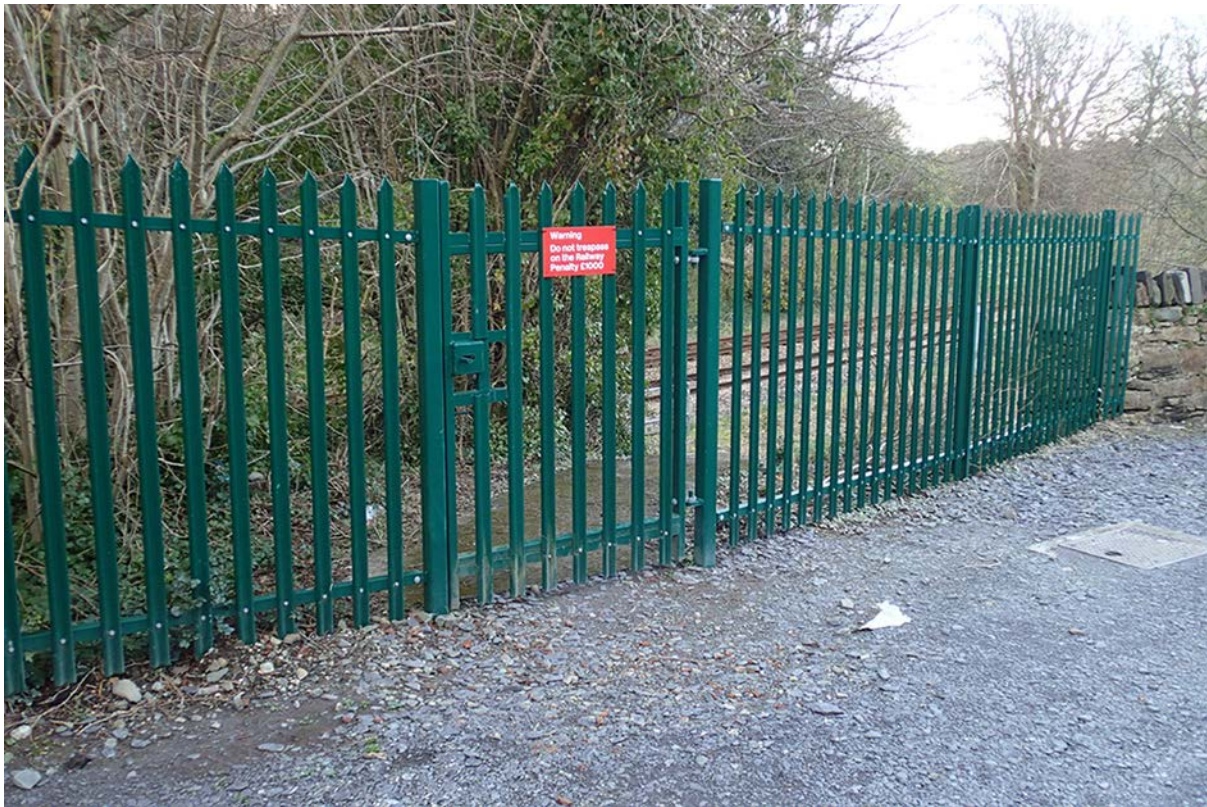
The entry for the Blake & Arnold access point in the hazard directory correctly showed the nearest track as the down line, and not the up line as it was at Llandegai tunnel access point. However, their misunderstanding about their actual location caused them to enter the tunnel from the wrong direction and work on the down line, while believing that they were protected from approaching trains.

Neither the COSS nor the track worker had previously been to Llandegai tunnel access point. When the track worker visited the tunnel in 2019 he had gained access using the Blake & Arnold access point.

Local residents explained that the boundary fence and gate at the Blake & Arnold access point were only installed in recent years. This is consistent with their condition. However, no signage had been provided identifying the location or the lines present.

Blake & Arnold access point

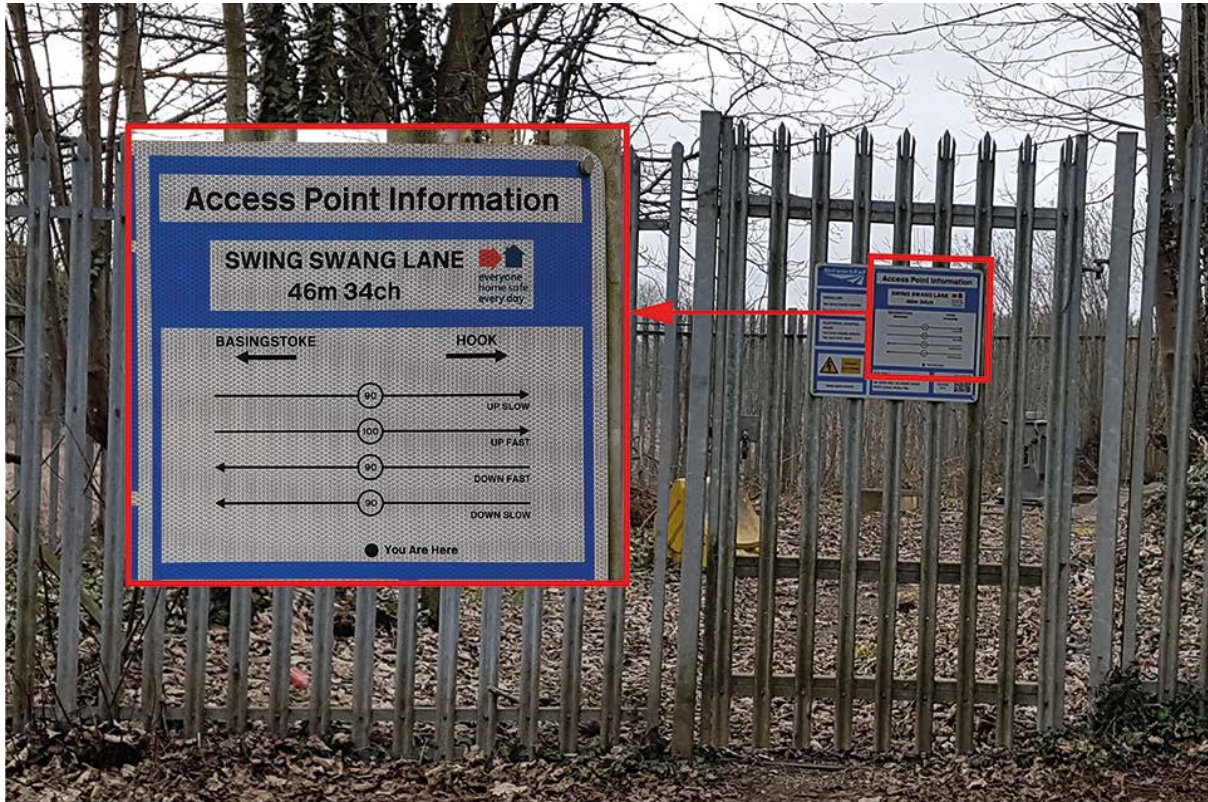
An example of access point information signage (as fitted near Basingstoke)

In December 2020, Network Rail revised its specification for facilities allowing safe access to the railway. It requires that such signage is provided at all new access points and at existing access gates where risk assessment has identified a need.
