# ***AAIB Bulletin***

***7/2021***

Published 8 July 2021

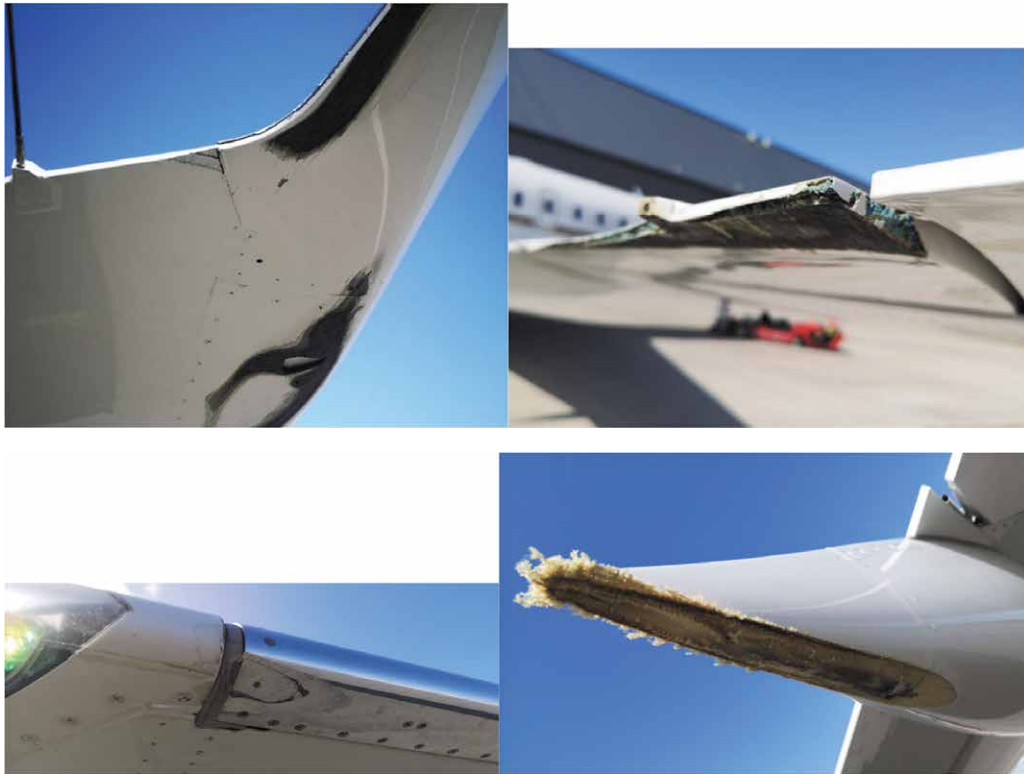
**Figure 6**

When the right wingtip contacted the runway, four areas of the structure were damaged as they briefly scraped along the runway. They were the underside of the winglet, the aileron, wing leading edge and both outer canoe fairings. The damage is shown below at Figure 6.

The damaged components which contacted the runway

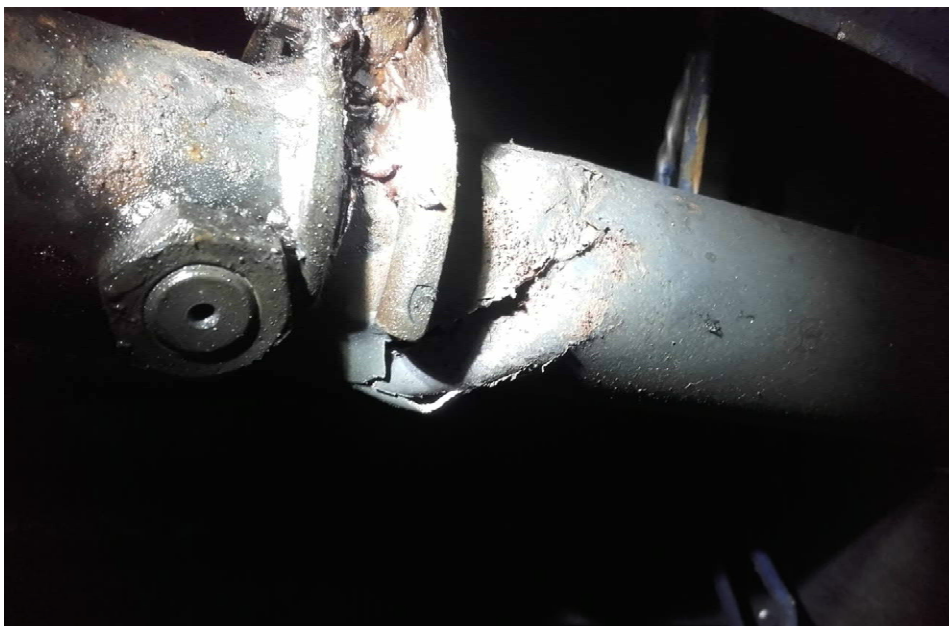
**Figure 1**

The AAIB did not attend, but the aircraft was later examined by a licenced engineer. It was identified that the right landing gear torque tube had failed in torsion (Figure 1). This torque tube should not have been carrying any load once the gear was locked down. Further examination revealed the landing gear had visible corrosion and an apparent lack of adequate lubrication of the pivot joints (Figure 2). An Annual / 100-hour inspection had been completed on 30 September 2020, 3½ months earlier, which included an inspection of the landing gear.

Right main landing gear torque tube showing condition and torsional failure

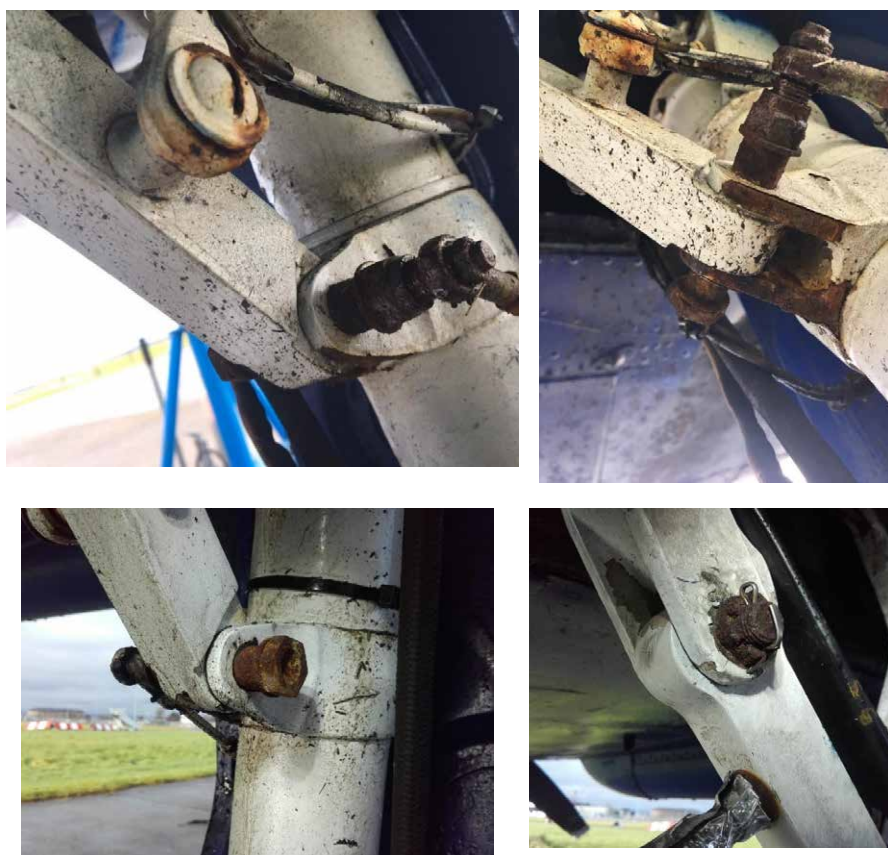
**Figure 2**

Images showing condition of right main landing gear mechanism pivot joints

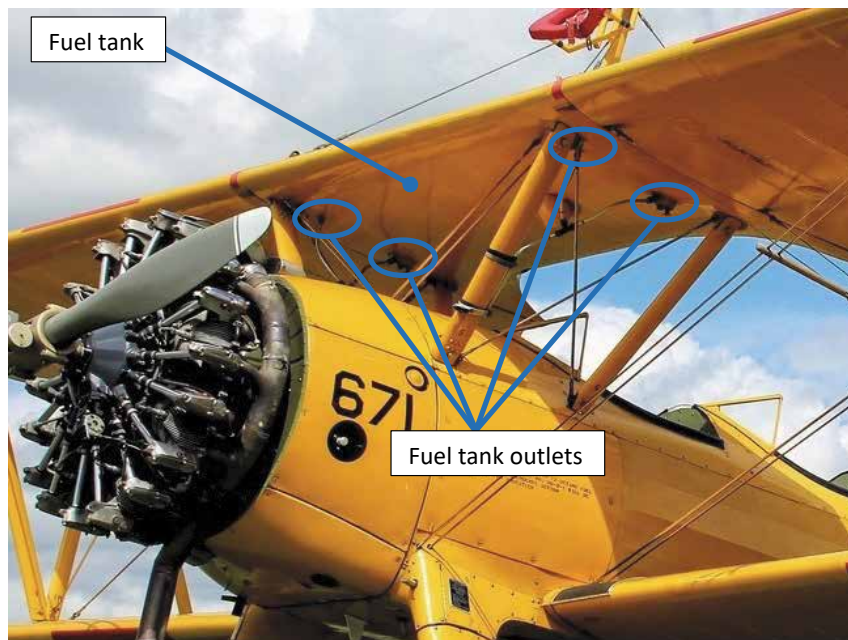
**Figure 2**

G-CGPY's CAMO thought the reason for the discrepancy between the two aircraft in what was considered 'usable' fuel was probably the addition of a safety margin by the other operator, in order to avoid conditions for starvation of the fuel feed sumps.

Fuel tank and fuel pipes from tank of G-CGPY (image used with permission)

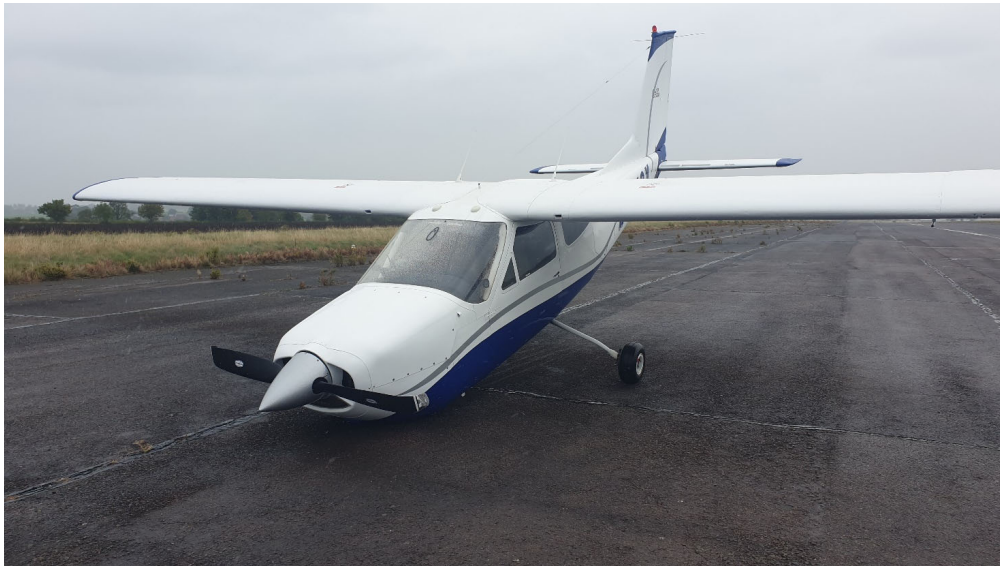
**Figure 1**

aircraft and suffered only minor injuries. The aircraft suffered damage to the nose landing gear and nose gear doors, propeller and engine. Figure 1 shows the aircraft on the runway.

G-AYSY on the runway at Leicester

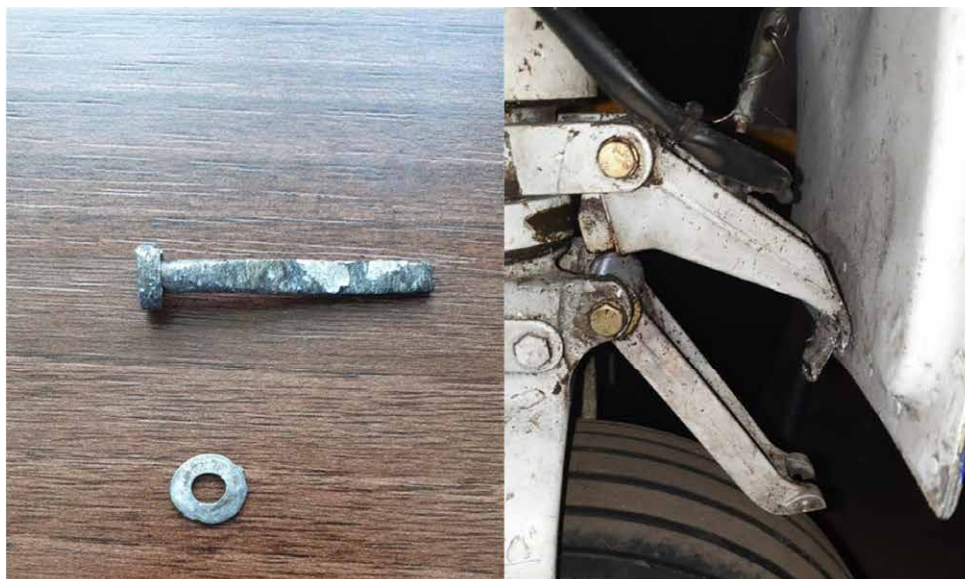
**Figure 2**

After the landing a bolt was recovered from the runway which was identified as the nose gear centre torque link bolt. This bolt had been in contact with the runway surface after the nose gear collapse and as a result suffered significant damage. The nut from the bolt was also missing. There was also corresponding runway contact damage to the nose gear torque link. These were the only two parts of the nose gear that were found to have sustained damage, and they are shown in Figure 2. Their positions in the nose gear assembly are shown in Figure 3.

Centre torque link bolt (left) and torque link (right)  
(used with permission)

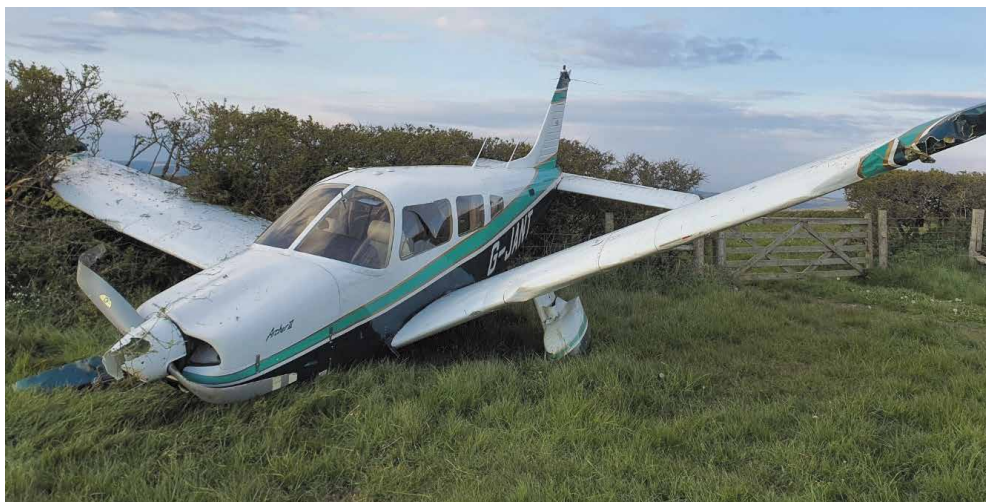
**Figure 1**

On the next approach, with full flap selected, the pilot slowed the aircraft from a 70 kt approach speed, flared and touched down about 50 m beyond the threshold. After bouncing once, the brakes were progressively applied to slow the aircraft on the damp grass. The pilot sensed that the aircraft was not slowing as anticipated so released and pumped the brakes, but without much apparent effect. Seeing the 4 ft high wire boundary fence about 150 m ahead, the pilot decided to go around. Two stages of flap were selected, and full power applied. The pilot allowed the aircraft to accelerate for "as long as possible" before pulling back on the stick. As the aircraft became airborne the pilot "possibly heard the stall warning and so pushed forward slightly to gather speed". However, the aircraft's landing gear contacted the fence and a second 4 ft high wire fence 2 m beyond, after which the nosewheel and right landing gear became detached. The aircraft came to a stop after sliding for about 300 m into a further field boundary fence (Figure 1).

Final resting position of G-JANT  
(used with permission)

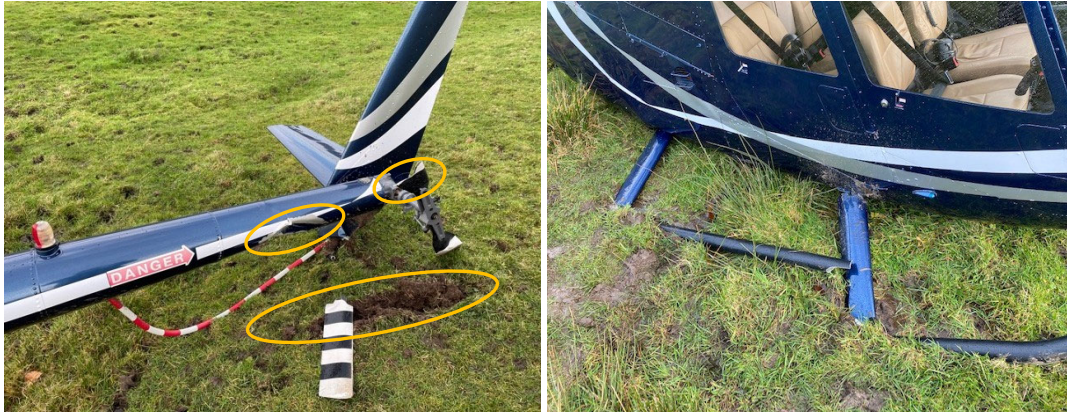
**Figure 2**

The vertical stabiliser, tail rotor guard and tail skid were damaged and disrupted. A large hole had been made in the left side of the tail boom where the tail rotor had punctured the skin and struck the tail rotor shaft, which had sheared. The landing skids were bent upwards and outwards and were partially disrupted (Figure 2). There was evidence of yielding of the cockpit seat structure and keel panels, and the lower belly of the aircraft was damaged.

Tail and tail rotor damage, ground impact marks and disrupted landing gear skids

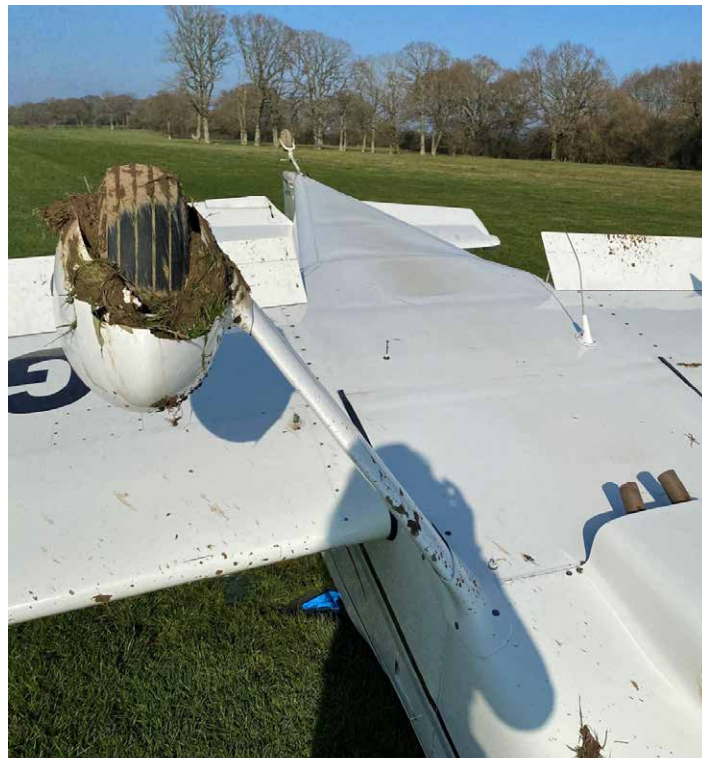
**Figure 2**  
Contamination and damage to one of the wheel spats  
(pictures courtesy of the pilot)

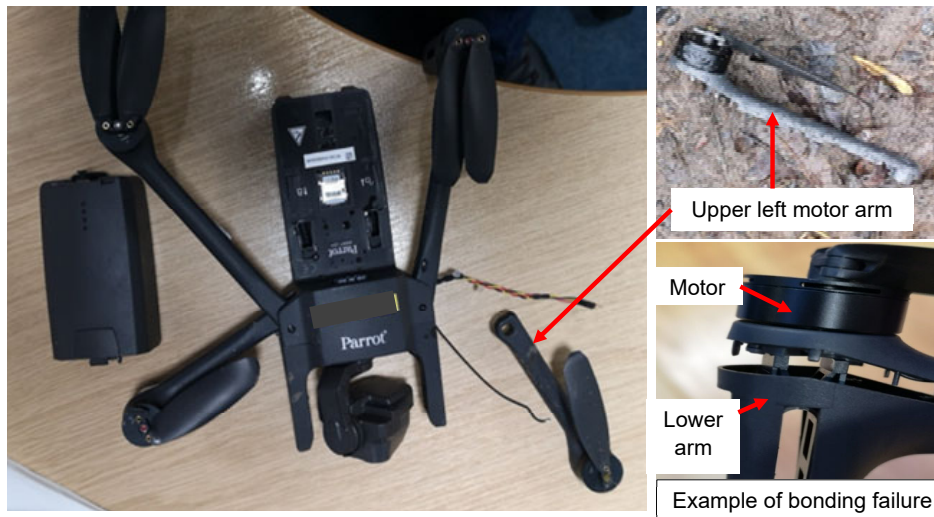
**Figure 2**

Examination of the remains of the front left propeller arm revealed the bonding between the upper and lower halves of the arm had failed allowing the two halves to separate (Figure 2).

Recovered aircraft, battery, and motor arm plus an example of bonding failure
