AAIB Bulletin S1/2021

SPECIAL

ACCIDENT

Aircraft Type and Registration:	Boeing 787-8, G-ZBJB	
No & Type of Engines:	2 Rolls-Royce Trent 1000-AE3 turbofan engines	
Year of Manufacture:	2013 (Serial no: 38610)	
Date & Time (UTC):	18 June 2021 at 0651 hrs	
Location:	London Heathrow Airport Stand 583	
Type of Flight:	Commercial Air Transport (Cargo)	
Persons on Board:	Crew - 2	Passengers - None
Injuries:	Crew - 1 (Minor)	Passengers - N/A Other - 1 (Minor)
Nature of Damage:	Damage to lower forward fuselage, engine cowlings and separation of passenger cabin door	
Commander's Licence:	Airline Transport Pilot's Licence	
Commander's Age:	47 years	
Commander's Flying Experience:	8,364 hours (of which 587 were on type) Last 90 days – 26 hours Last 28 days – 0 hours	
Information Source:	AAIB Field Investigation

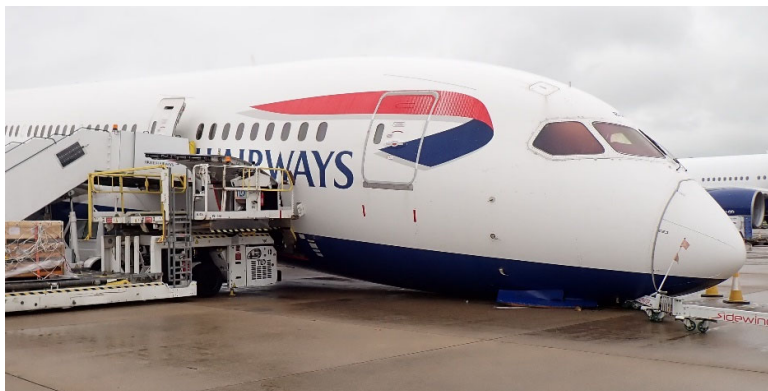
Figure 1

One of the ground loading team who was on the pallet loader and under the cargo door was slightly injured as the door moved down with the fuselage (Figure 1). The co-pilot, sat in the cockpit received a minor injury and the three personnel who were stood in the forward cabin and galley fell to the floor but were otherwise uninjured.

Pallet cargo loader positioned at the forward cargo door

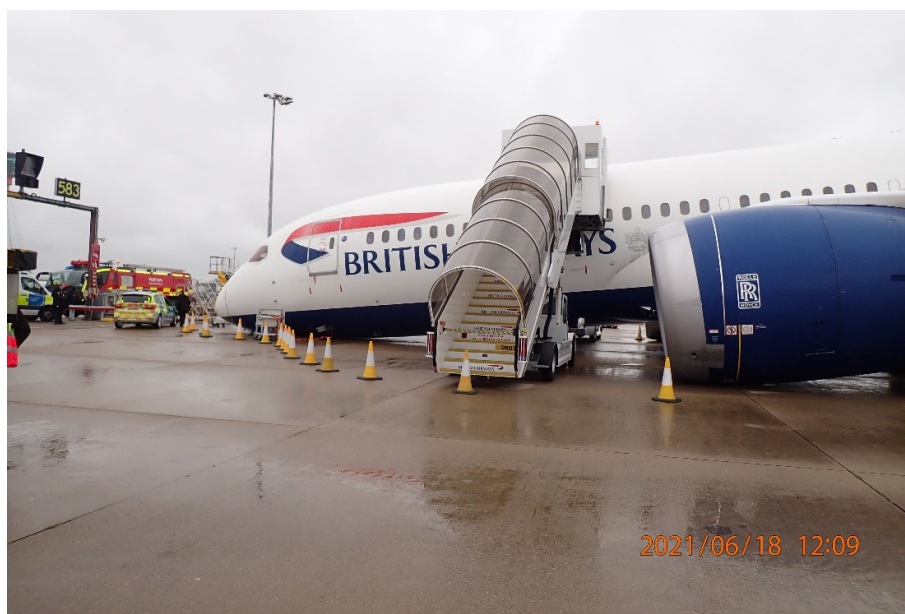
Figure 2

The aircraft's nose came to rest on the articulated arm of a ground power unit, crushing the cable arm. The aircraft sustained damage to the lower forward fuselage, NLG doors and both engine cowlings, which had also struck the ground. Door 2L had been severely damaged by contact with the stairs positioned at the door aperture as the aircraft sank onto its nose (Figure 2). The door hinges and actuating mechanism had failed and the door, which was resting on the top platform of the stairs, remained attached to the fuselage by the remains of its wiring loom.

G-ZBJB with stairs in position at Door 2L

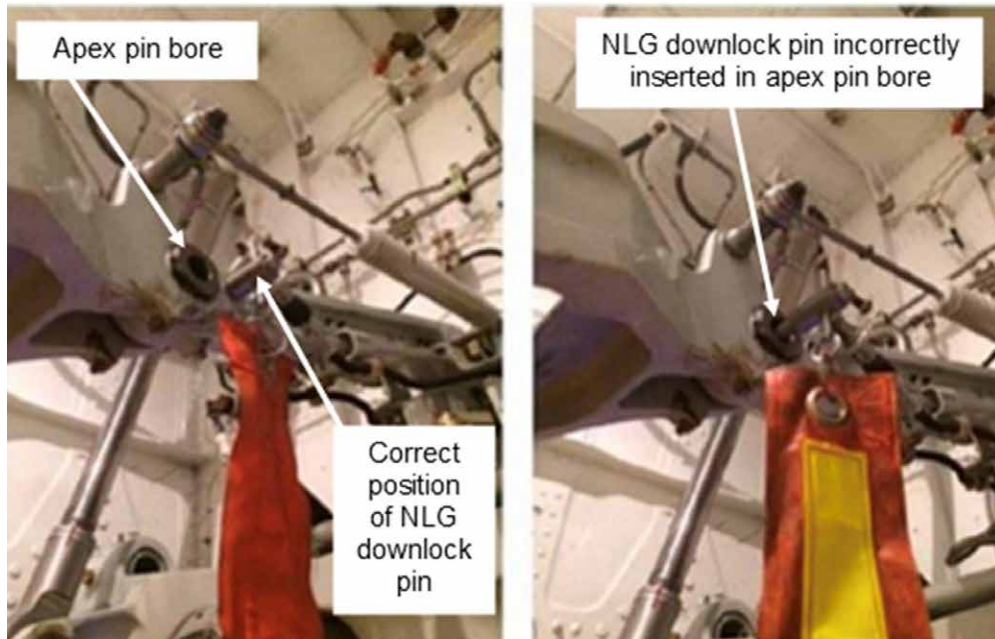
**Figure 3**

When the aircraft nose was lifted, during the recovery operation, the NLG was examined and the NLG downlock pin was found fitted in the NLG apex pin bore (Figure 3). With the downlock pin inserted in this position, when the LOCK OVRD is pressed and the landing gear lever selected to UP with hydraulic power applied, the NLG will retract.

In 2018, another Boeing 787 experienced a retraction of the NLG while the aircraft was on the ground which had been caused by the NLG downlock pin being accidentally installed in the apex pin inner bore, which is adjacent to the correct hole for the downlock pin in the NLG lock link assembly (Figure 3).

Illustrative image of the correct and incorrect installation of NLG downlock pin

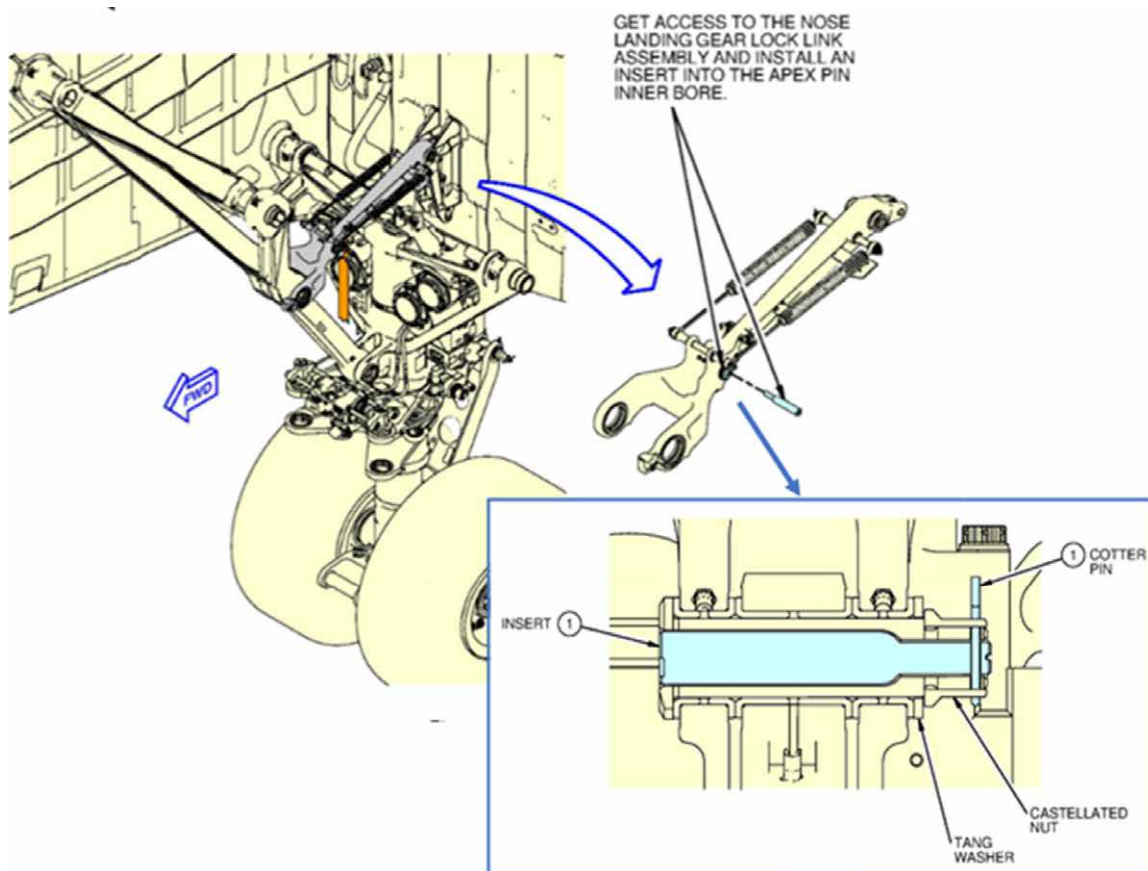
**Figure 4**

Installation diagram of NLG apex pin inner bore insert

As a result of this event the aircraft manufacturer published Issue 01 of Service Bulletin (SB) B787-81205-SB320040-00 on 12 March 2019. The SB provides instructions to install an insert into the NLG lock link apex pin inner bore (Figure 4). The insert prevents the NLG downlock pin from being inserted in the apex pin bore instead of the adjacent NLG downlock pin hole. Issue 02 of the SB was subsequently published on 23 October 2020.

Incorporation of SB B787-81205-SB320040-00 was subsequently mandated by FAA Airworthiness Directive (AD) 2019-23-07, published on 16 January 2020. The AD specified a compliance time of 36 months from the date of publication. This had not yet been implemented on G-ZBBB.
