AAIB Bulletin S1/2021

SPECIAL

ACCIDENT

Aircraft Type and Registration:	Boeing 787-8, G-ZBJB	
No & Type of Engines:	2 Rolls-Royce Trent 1000-AE3 turbofan engines	
Year of Manufacture:	2013 (Serial no: 38610)	
Date & Time (UTC):	18 June 2021 at 0651 hrs	
Location:	London Heathrow Airport Stand 583	
Type of Flight:	Commercial Air Transport (Cargo)	
Persons on Board:	Crew - 2	Passengers - None
Injuries:	Crew - 1 (Minor)	Passengers - N/A Other - 1 (Minor)
Nature of Damage:	Damage to lower forward fuselage, engine cowlings and separation of passenger cabin door	
Commander's Licence:	Airline Transport Pilot's Licence	
Commander's Age:	47 years	
Commander's Flying Experience:	8,364 hours (of which 587 were on type) Last 90 days – 26 hours Last 28 days – 0 hours	
Information Source:	AAIB Field Investigation

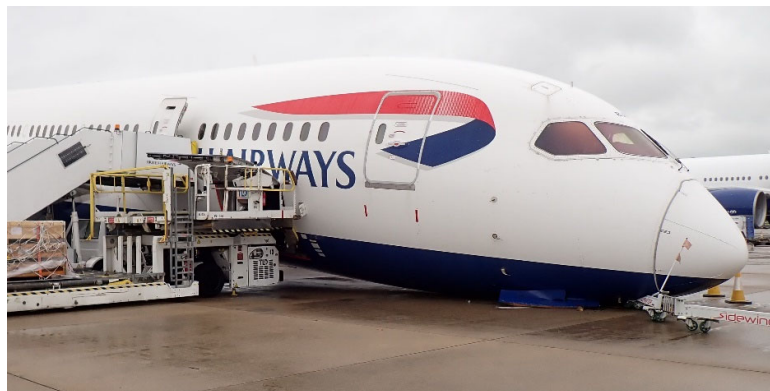
Figure 1

One of the ground loading team who was on the pallet loader and under the cargo door was slightly injured as the door moved down with the fuselage (Figure 1). The co-pilot, sat in the cockpit received a minor injury and the three personnel who were stood in the forward cabin and galley fell to the floor but were otherwise uninjured.

Pallet cargo loader positioned at the forward cargo door

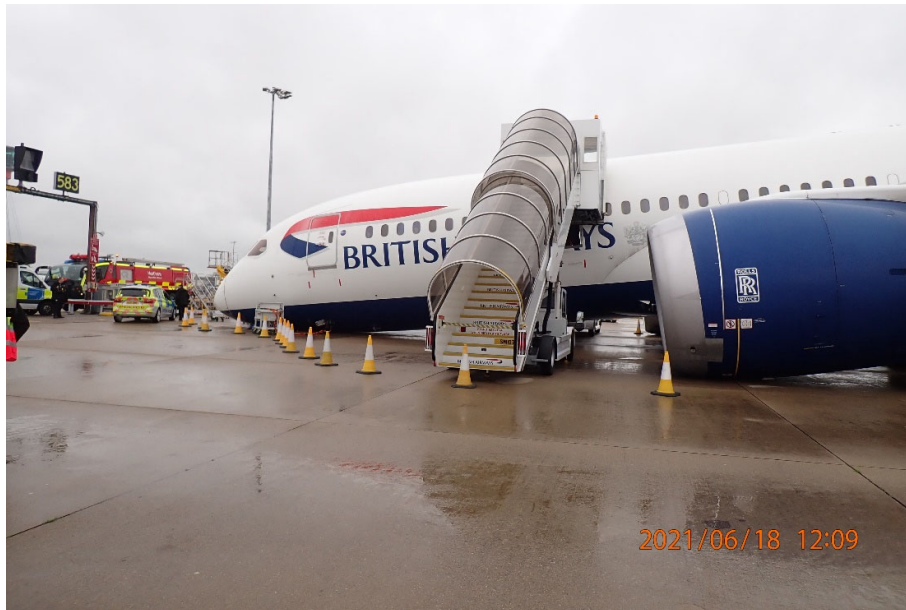
Figure 2

The aircraft's nose came to rest on the articulated arm of a ground power unit, crushing the cable arm. The aircraft sustained damage to the lower forward fuselage, NLG doors and both engine cowlings, which had also struck the ground. Door 2L had been severely damaged by contact with the stairs positioned at the door aperture as the aircraft sank onto its nose (Figure 2). The door hinges and actuating mechanism had failed and the door, which was resting on the top platform of the stairs, remained attached to the fuselage by the remains of its wiring loom.

G-ZBJB with stairs in position at Door 2L
