# ***AAIB Bulletin***

***8/2021***

| Sikorsky S-92A | G-LAWX | 14-Oct-19 | 3 |

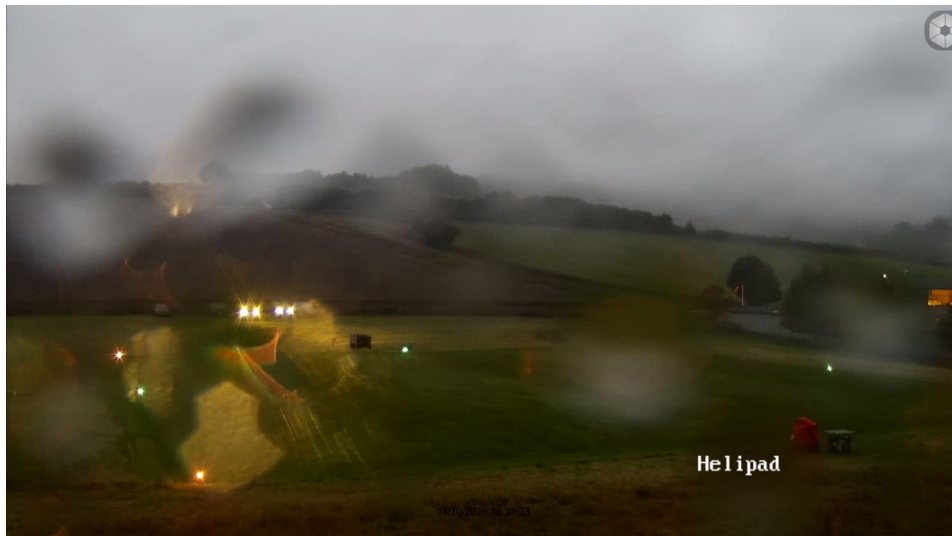
**Figure 6**

The LS had no weather reporting equipment and the estate manager had no formal meteorological observation qualifications. When the co-pilot spoke to him at around 1710 hrs, the estate manager reported that the weather was "closing in" and that the aerials to the north could not be seen, but that the poor weather was probably confined to that direction because the helipad camera indicated the LS was clearer. The conditions at the LS 10 minutes later are shown in CCTV picture (Figure 6.)

View of LS to the West at 1720 hrs, 10 minutes before departure from Birmingham (used with permission)

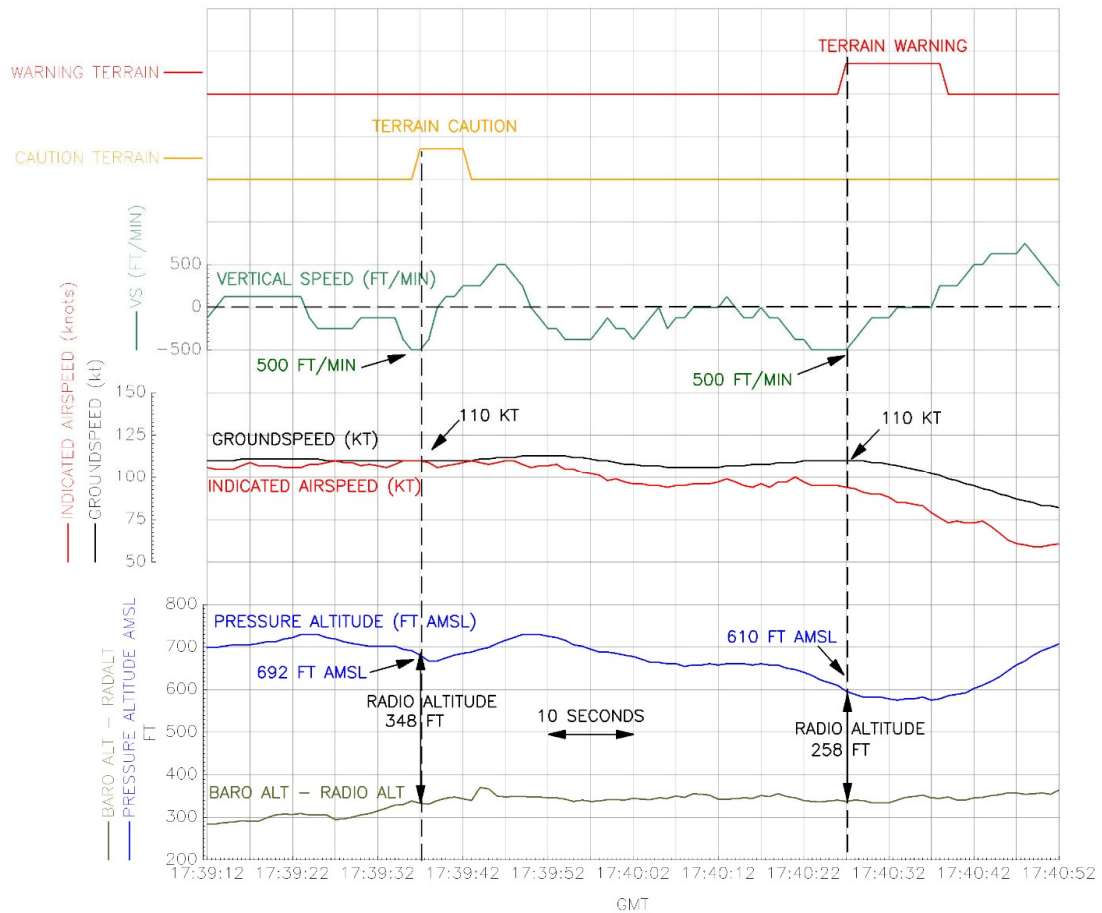
**Figure 10**

The helicopter then began descending again and fifty seconds after the first EGPWS alert, the CVR recorded an EGPWS, “WARNING TERRAIN, WARNING TERRAIN”. The helicopter had descended to an altitude of 610 ft (258 ft agl), at 110 kt groundspeed and with a rate of descent of 500 ft/min. The commander again acknowledged this with “ITS COPIED” and then “VISUAL”. The helicopter then climbed to an altitude of 720 ft (343 ft agl) over 30 seconds and reduced speed (Figure 10). There were no further EGPWS alerts for the remainder of the flight.

G-LAWX incident flight EGPWS parameters

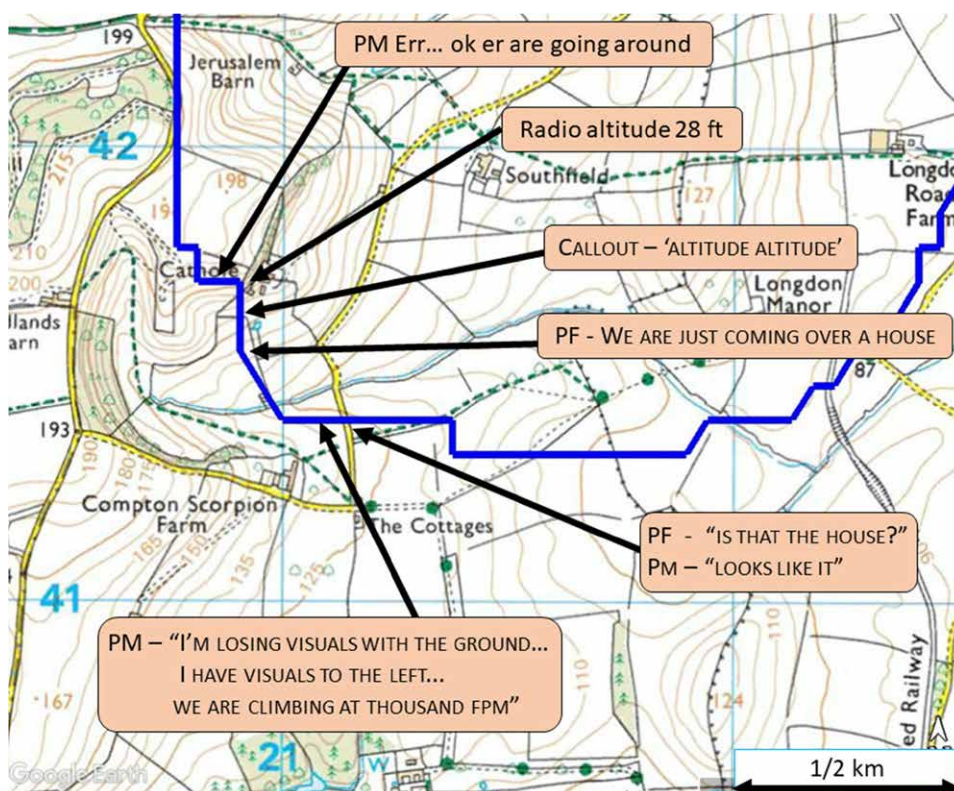
**Figure 13**

At the time of the “ALTITUDE, ALTITUDE” alert, although the helicopter maintained a level altitude of just over 700 ft, the radio altitude decreased through 78 ft agl, having passed through the ‘decision height’ of 150 ft agl approximately a second earlier. The rate of descent reduced and three seconds later, with a groundspeed of 30 kt and a pitch attitude of +18°, the helicopter probably passed over trees beside a house and on the edge of the field when the radio altitude decreased to 28 ft at its closest point to the ground below.

G-LAWX flight path and FDR data (terrain heights are in m)

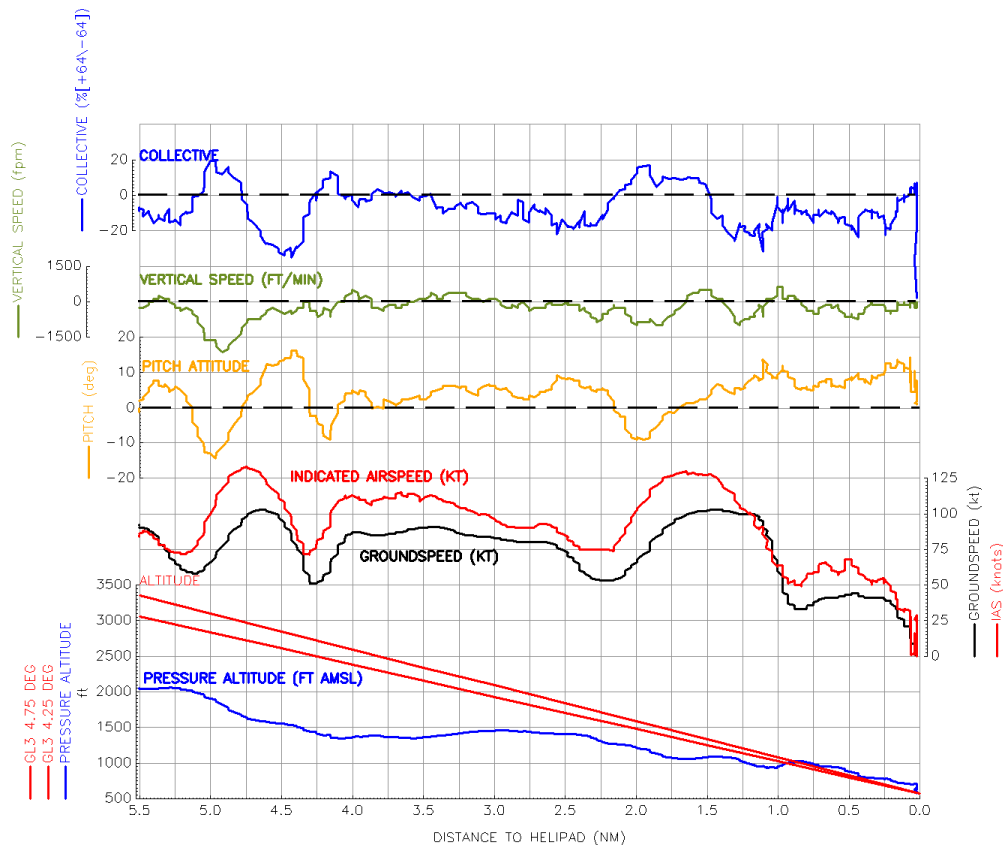
**Figure 14**

The helicopter flew towards the south-west for an approach using the GL3. It turned towards the LS passing the 5 nm point to the south at 1748 hrs and descended from an altitude of approximately 2,000 ft. During the next minute, the helicopter attitude pitched to  $-14^{\circ}$ , up to  $+16^{\circ}$  then back down to  $-10^{\circ}$  pitch before stabilising. This, along with modulation of the collective, caused fluctuations in airspeed from between 72 to 133 kt and a rate of descent up to 1,820 ft/min. During this time the co-pilot called out speed and height information and, when 4.25 nm from the LS, stated "so, ITS FIFTY KNOTS GROUND SPEED AT FIVE HUNDRED FT... I DON'T THINK WE ARE GOING TO GET IN ON THIS," to which the commander replied, "NO WE ARE NOT". The approach continued and the co-pilot continued to call out flight parameters. The flight path varied either side of the direct heading to the GL3 and consistently below the  $4.5^{\circ}$  glide path (Figure 14).

### G-LAWX flight data during GL3 approach

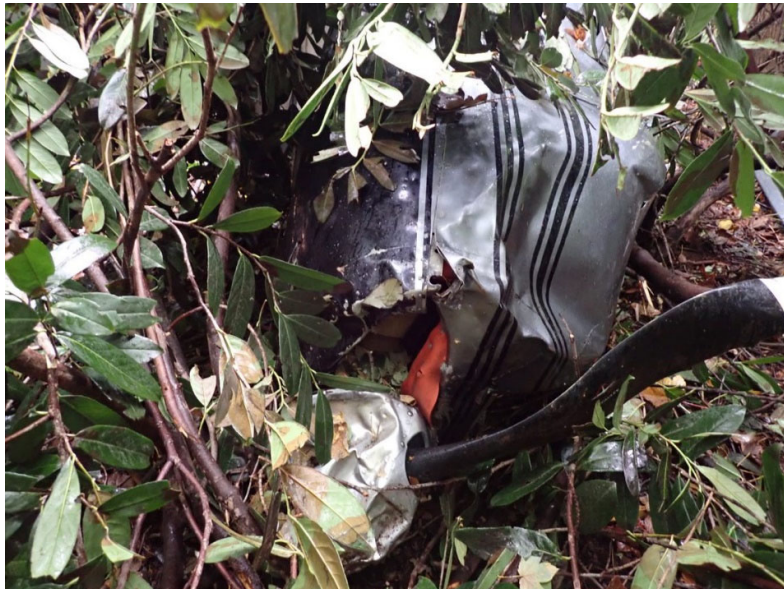
**Figure 2**

The nose section was dented and misshapen, but all the engine bay panels had remained in place. Both propeller blades were distorted in a manner indicative of rotation under power throughout the accident sequence. There were numerous dents over the entire surface of the spinner (Figure 2).

Nose section, propeller blade distortion and spinner

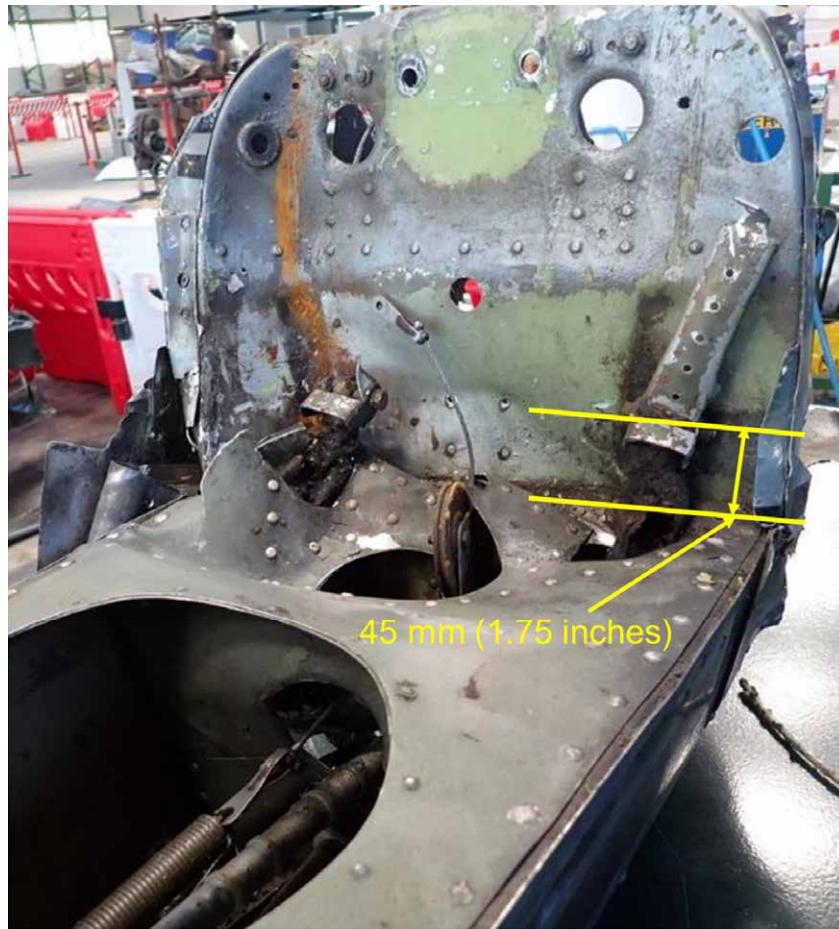
**Figure 8**

Tailplane trimmed position as found

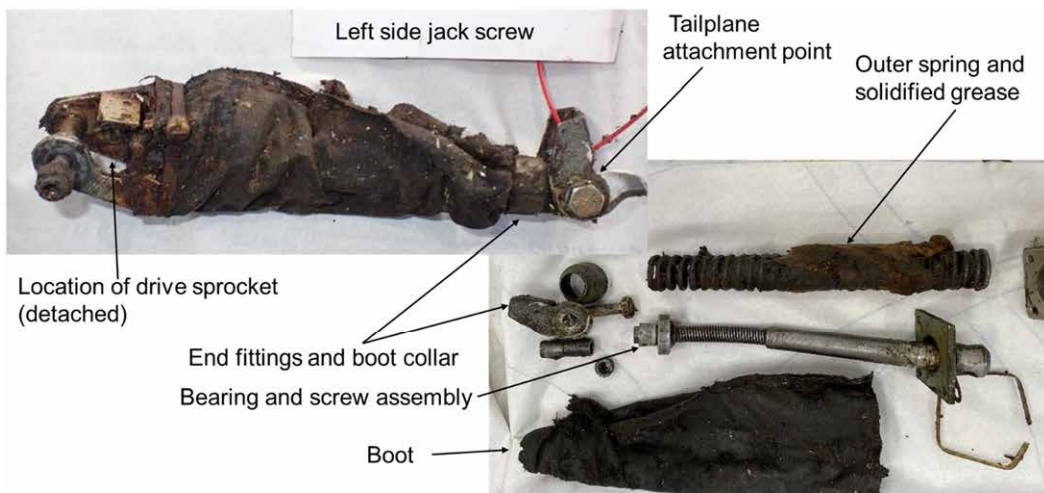
**Figure 9**

The jackscrews were correctly attached to the fuselage frame and to the tailplane leading frame brackets. However, the brackets were distorted and partially separated from the frame due to shearing of their attachment rivets. The rightward displacement of the tailplane had put a slight bend in both the jack screws. Disassembly of the two jack screws found them outwardly to be in very poor condition. Their boots were split and decayed and the grease covering the outer spring was aged and solidified. Despite this, both jack screw threads were free to rotate and extended and retracted correctly (Figure 9). The position on the screw shaft where the sprockets had been fitted showed that both had sheared in overload where the attachment pins passed through the shaft. An examination of the broken chain and the remaining sprocket supported this, with evidence of severe distortion to the sprocket teeth and chain links (Figure 10).

Disassembled left jack screw  
(Right jack screw found in the same condition)

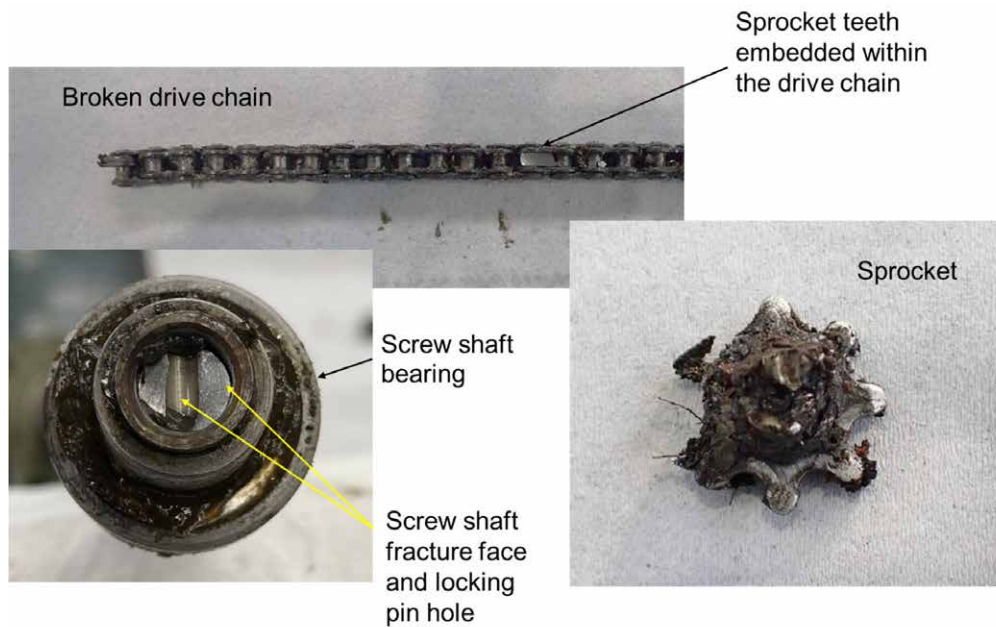
**Figure 10**

Left sprocket and chain

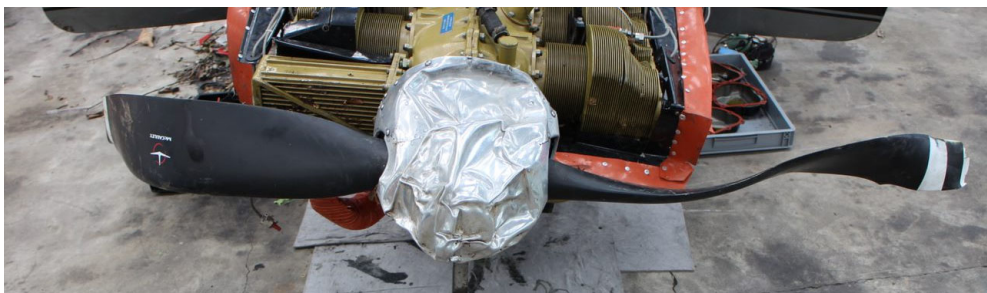
**Figure 11**

The upper and lower engine cowling had sustained multiple impact damage. The propeller spinner had multiple dents over its entire surface. Both propeller blades were loose in the propeller boss and the blade pitch change mechanism linkages had broken. One of the blades was twisted and bent rearwards and the other had pronounced multi-directional bending and twisting over its entire length. The tip of this blade had been fractured and was missing (Figure 11).

Condition of the propeller blades and spinner

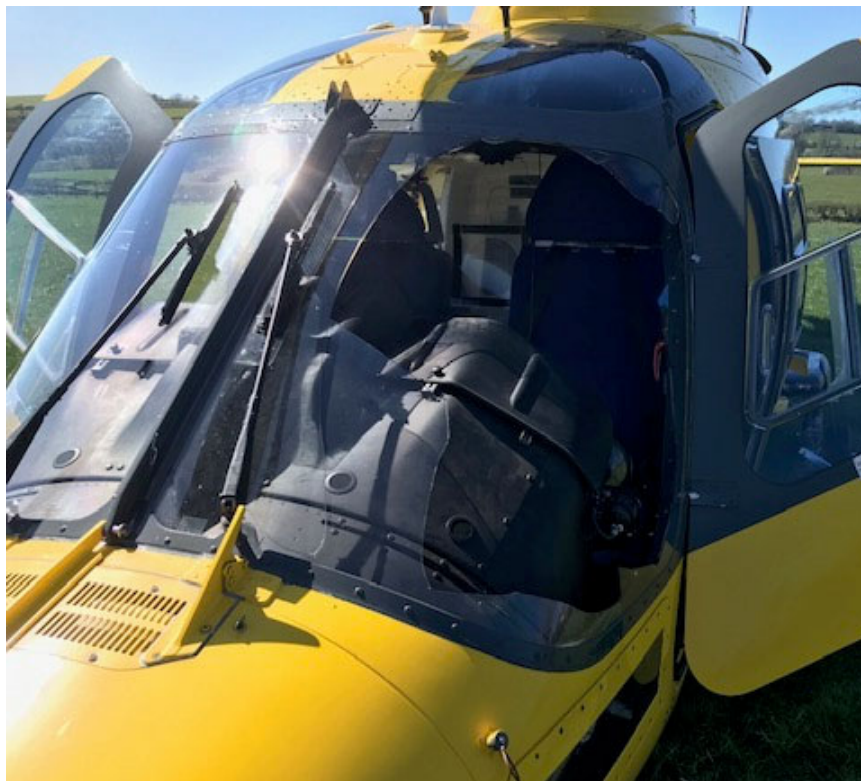
**Figure 1**

The left windshield, which was made of acrylic, had shattered into multiple pieces which were found throughout the cockpit and passenger area (Figure 1). Debris from the windshield also entered the main rotor disk, making a hole in the trailing edge of one of rotor blades (Figure 2).

Damage to the left windshield

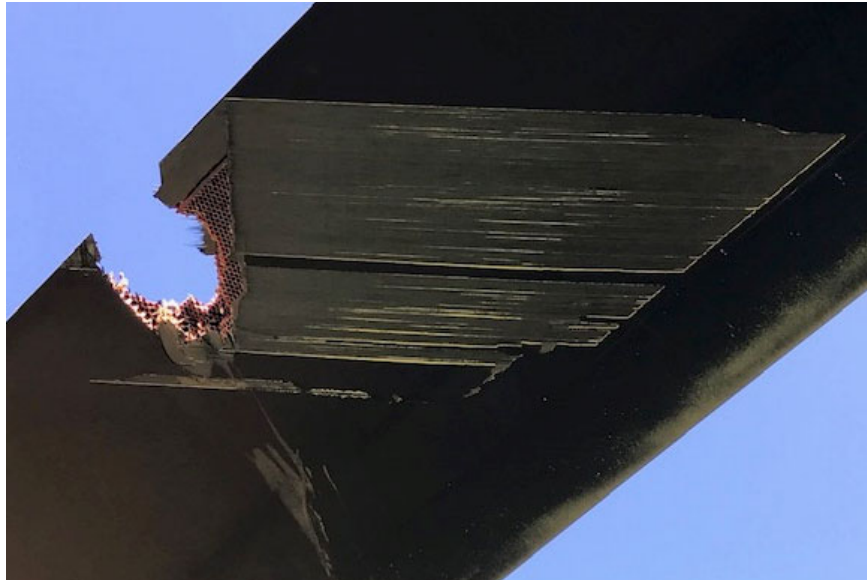
**Figure 2**

Main rotor blade trailing edge damage

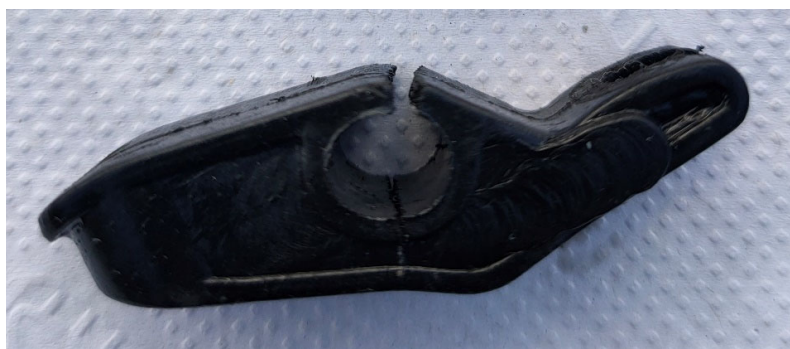
**Figure 1**

A post-accident engineering inspection revealed the plastic cam driven rocker arm in the mechanical fuel pump had cracked (Figure 1).

Plastic fuel pump rocker arm

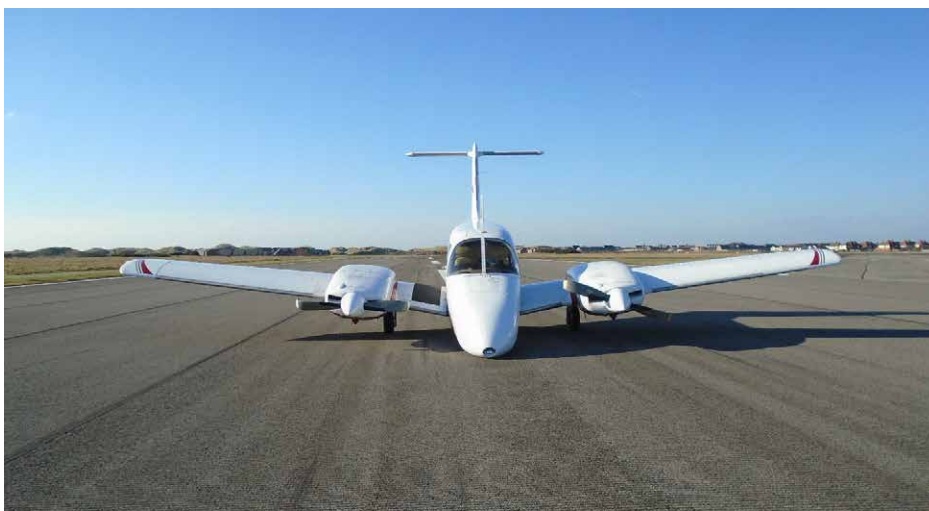
**Figure 2**

Aircraft after landing
