ACCIDENT

Aircraft Type and Registration:	Guimbal Cabri G2, G-PERH
No & Type of Engines:	1 Lycoming O-360-J2A piston engine
Year of Manufacture:	2016 (Serial no: 1164)
Date & Time (UTC):	8 June 2018 at 1433 hrs
Location:	Goodwood Aerodrome, Sussex
Type of Flight:	Training
Persons on Board:	Crew - 2 Passengers - None
Injuries:	Crew - 2 (Serious) Passengers - N/A
Nature of Damage:	Damaged beyond economic repair
Commander's Licence:	Commercial Pilots Licence
Commander's Age:	59 years
Commander's Flying Experience:	8,920 ¹ hours (of which 69 were on type) Last 90 days - 30 hours Last 28 days - 7 hours
Information Source:	AAIB Field Investigation

Note: Following a review, this report has been amended. This is the reissued report, published online on 5 August 2021. The original version of the report can also be found online and in the October 2019 AAIB Bulletin.'

Synopsis

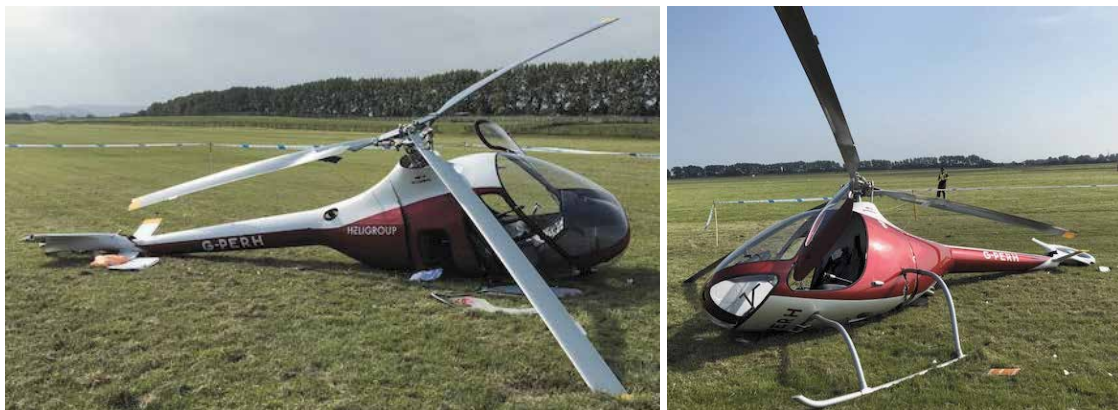
Figure 1

The accident site occurred in the Helicopter Training Area at Goodwood Aerodrome. The helicopter came to rest upright with the right side of the fuselage in contact with the ground and pointing in a north-east direction. The landing gear had penetrated the fuselage on the left side and the right passenger door had broken and become detached. The fenestron tail rotor had detached from the tail boom and there was evidence that two of the main rotor blades had struck the ground (Figure 1). Both landing skids had dug into the ground with no evidence of movement after contact.

G-PERH at the accident site

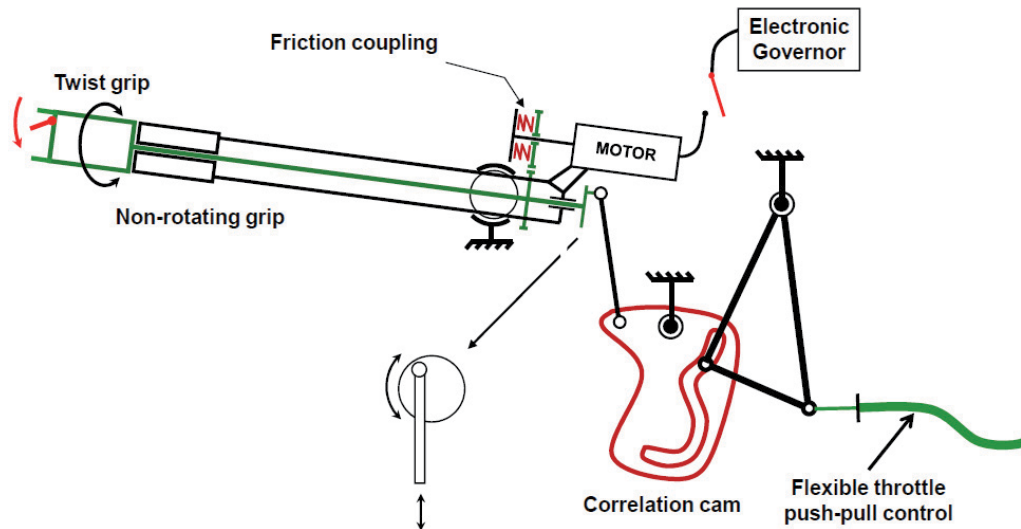
Figure 3

The accident manoeuvre was consistent with the application of left yaw pedal and raising the collective lever whilst the throttle was partially open. Lifting the collective before the throttle was fully closed would have resulted in the correlator cam increasing the engine speed until, at 2,000 rpm, the engine governor would have re-engaged. These actions would have caused an increase in engine speed resulting in the high rate of yaw and climb, which the student felt. Had the throttle been fully closed the correlator cam profile would have had no effect on the engine speed when the collective was raised.

SL 19001 - Throttle management during simulated engine failure.

This service letter provides an explanation of the engine governor / correlator system and the need to ensure the twist grip throttle is fully closed whilst practicing certain manoeuvres. It provides advice to flight instructors on how to position the hand on the throttle grip to enable the throttle to be closed in one movement and therefore ensuring the engine throttle does not open when the collective is raised.

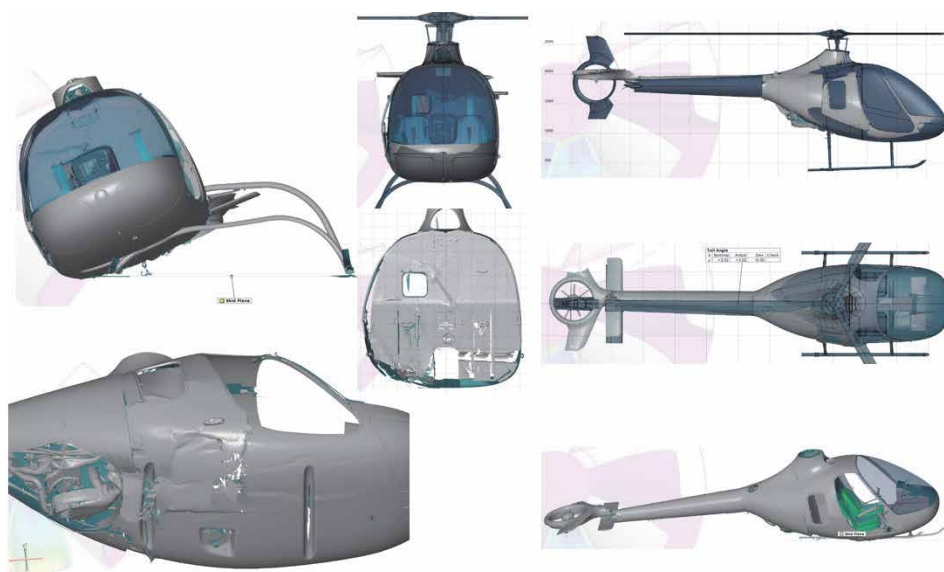
Figure 4

The results of the scanning showed that the tail boom of the helicopter was misaligned by approximately 3° to the left of nominal and bent slightly upwards. The cabin bulkhead showed evidence of multiple damage locations of crushing, cracking and delamination.

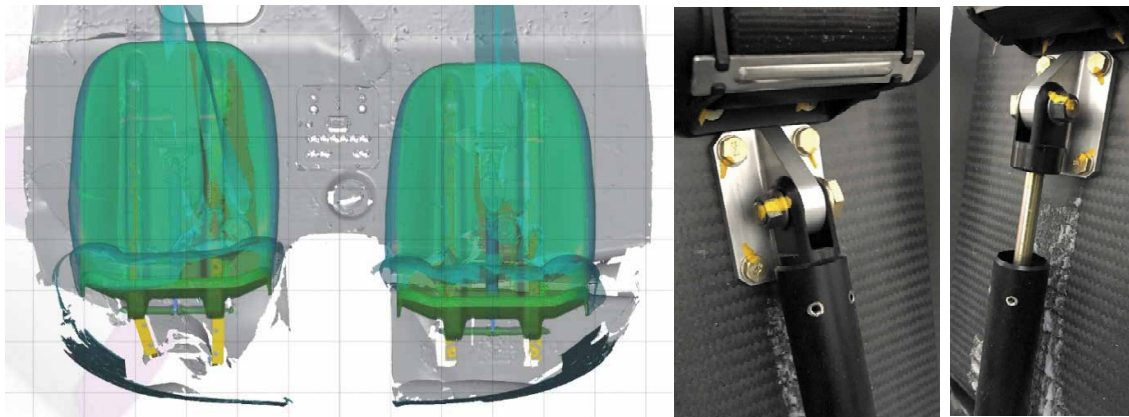
Figure 5

Strut	Nominal Length	Measured Length	Extension
Left	302 +/- 0.5 mm	351.6 mm	49.6 mm
Right		304.5 mm	2.5 mm

Seat position and energy absorbing strut extension

The right seat shell was examined, and several damage locations were identified. The left seat was undamaged.

The lower end of the right seat, outboard track was bent inwards and forwards by approximately 20° and the lower end of the inboard track showed minor deformation. The bend was located at the lower attachment to the seat and a witness mark was evident on the seat shell from the track. The deformation of the right seat tracks was coincident with the crushing deformation of the lower section of the monocoque and cabin bulkhead.

The energy absorbing struts in the seat system are designed to reduce the loads on the occupants in the event of a vertical impact. The manufacturer states that in certification testing the '*occupants would survive a 2000 ft/min impact, equivalent to a 5 m free fall*'. In this accident the left seat strut extended to 116% whereas the right seat strut extended to 101%. However, the injuries sustained by both occupants were similar and so it is judged that the impact energy was absorbed by a different mechanism for the right seat occupant.
