PART 1.4

Analysis and Findings

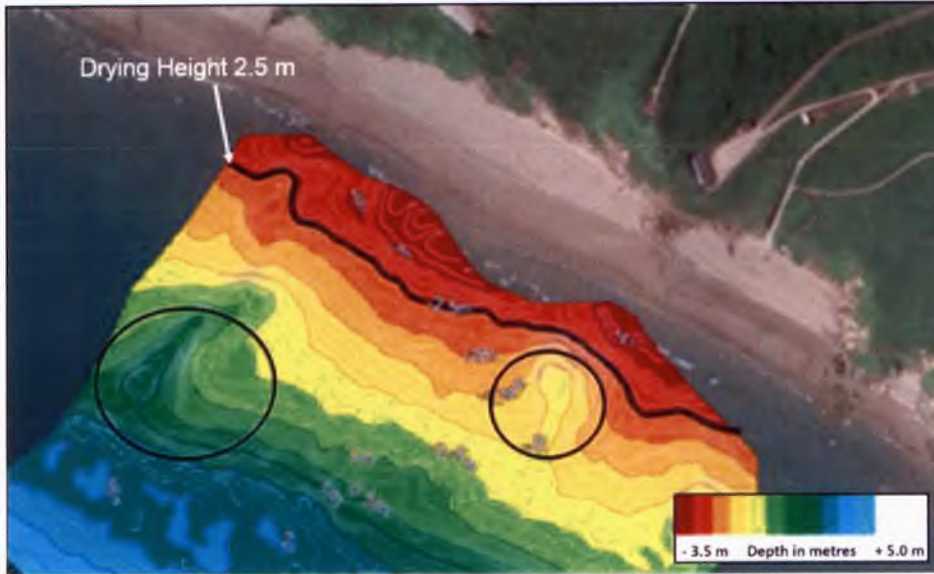
Figure 1.4.9 – Tregantle Beach Depth Contours as at 25 March 2020.

1.4.56. The Panel analysed three beach reconnaissance reports conducted by RM personnel and provided by the UKHO and observed that the gradient¹⁰ of the beach was measured between 1:45 to 1:50 on each report.

1.4.58. The Antony and Tregantle Training Area Standing Orders mentioned that the beach could experience some strong tidal currents, the Panel believe that this would have had negligible effect on troops disembarking from a LCVP into 0.77 m¹² of water.

1.4.61. Recommendation. The Commanding Officer 47 Commando (Raiding Group) Royal Marines should amend the Book of Reference (digital) 6600 to include a requirement for a beach survey to be conducted at a suitable interval prior to beach landings during amphibious training and exercises in order to enable accurate risk assessment of the beach conditions.

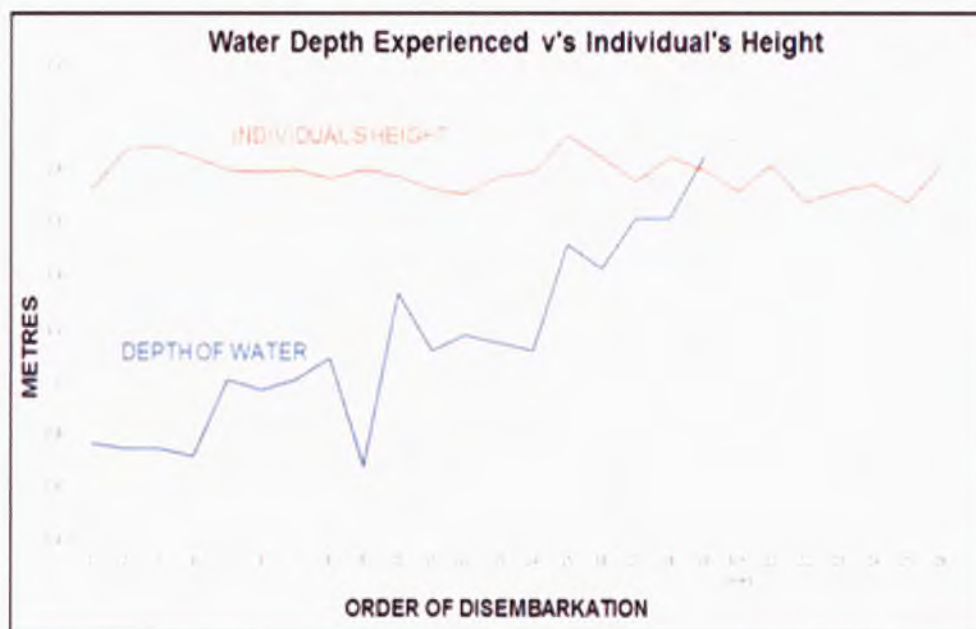
Figure 1.4.39 – Water Depth Experienced shown against the Height of Each Individual.

1.4.3. During the disembarkation the depth of water increased from approximately 0.77 m and the last 8 of the 26 individuals to leave the craft found themselves in water above their heads (>1.85 m). Three recruits were recovered from the water to the craft, including Recruit Ethan Jones, who was unconscious and unresponsive. First aid was given on the craft initially by the crew, some members of 282 Tp Training Team (Trg Team), a Royal Navy (RN) Medic and then the South West (SW) Ambulance Service paramedics. Recruit Jones was transferred to the beach and then transported by air to Derriford Hospital, Plymouth where he was subsequently pronounced dead on 24 January 2020.
