ACCIDENT

Aircraft Type and Registration:	Cessna 185A Skywagon, G-BLOS	
No & Type of Engines:	1 Continental Motors Corp IO-470-F piston engine	
Year of Manufacture:	1962 (Serial no: 185-0359)	
Date & Time (UTC):	7 October 2020 at 1620 hrs	
Location:	Pauncefoot Airstrip, Romsey	
Type of Flight:	Private	
Persons on Board:	Crew - 1	Passengers - None
Injuries:	Crew - 1 (Serious)	Passengers - N/A
Nature of Damage:	Wings separated and significant fuselage damage	
Commander's Licence:	Private Pilot's Licence	
Commander's Age:	63 years	
Commander's Flying Experience:	395 hours (of which 42 were on type) Last 90 days - 5 hours Last 28 days - 0 hours	
Information Source:	AAIB Field Investigation

Synopsis

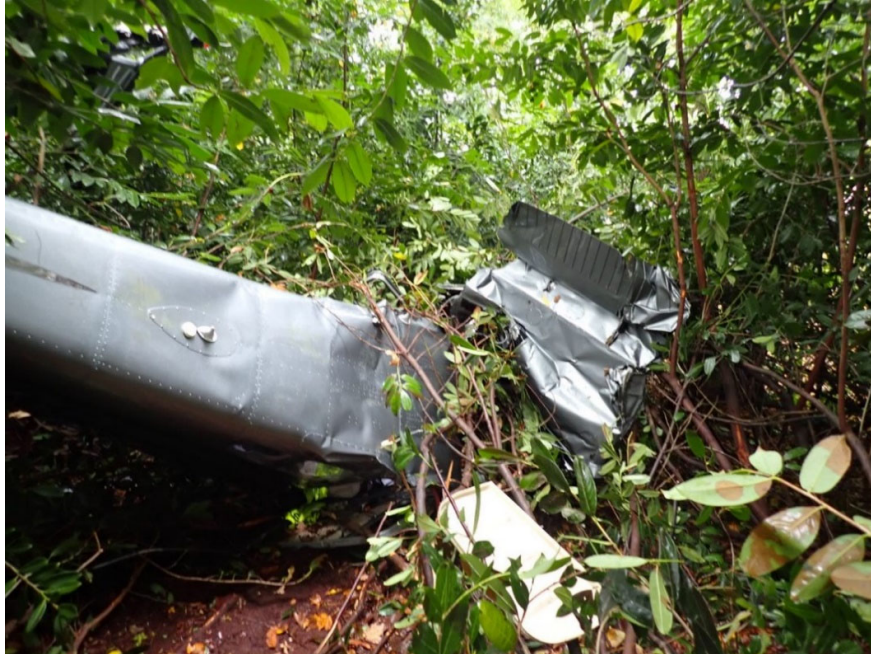
Figure 1

The aircraft hit the tops of the trees which were part of a small forest on private land. It had descended through the canopy during which the wings and parts of the landing gear had become detached. The wing fuel tanks had been split open and all the fuel had dispersed. The fuselage was brought to a stop right-side down in dense laurel bushes which were up to 2 m high and covered most of the forest floor (Figure 1). The rear fuselage was distorted and although still attached, the empennage and fin were displaced to the side. The cabin and cockpit had generally retained their shape and the windscreen was missing. Perspex fragments from the windscreen littered the accident site. The wings were found lying approximately 30 m behind the fuselage entangled within the trees and undergrowth.

Accident site showing the top of the fuselage and dense undergrowth

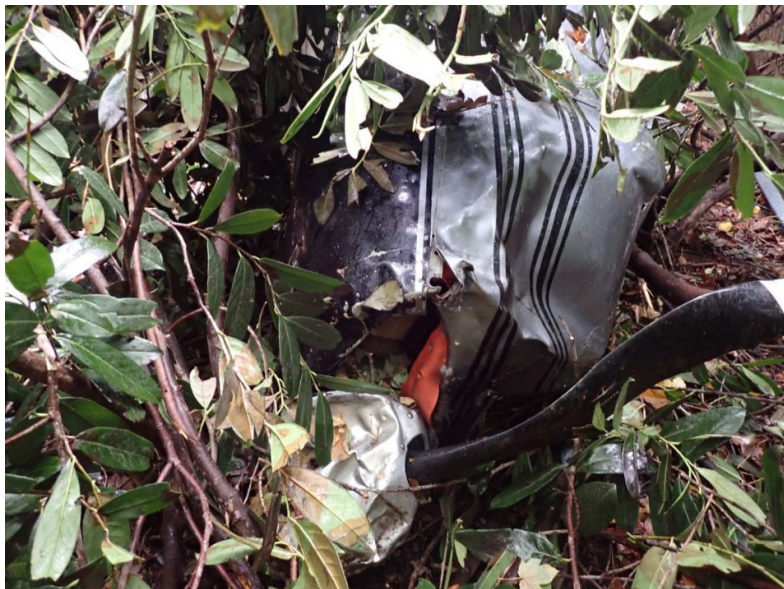
Figure 2

The nose section was dented and misshapen, but all the engine bay panels had remained in place. Both propeller blades were distorted in a manner indicative of rotation under power throughout the accident sequence. There were numerous dents over the entire surface of the spinner (Figure 2).

Nose section, propeller blade distortion and spinner

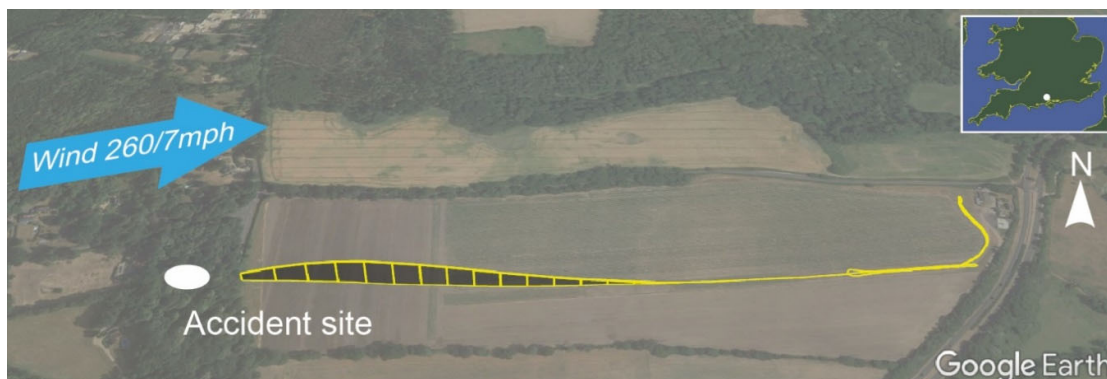
Figure 3

The accident flight log started at 1416 hrs (Figure 3). The aircraft taxied along the initial part of the runway and then backtracked to the east end of the runway. The takeoff started at 1433:08 hrs and the last recorded data point was 36 seconds later.

Oblique view of the accident flight

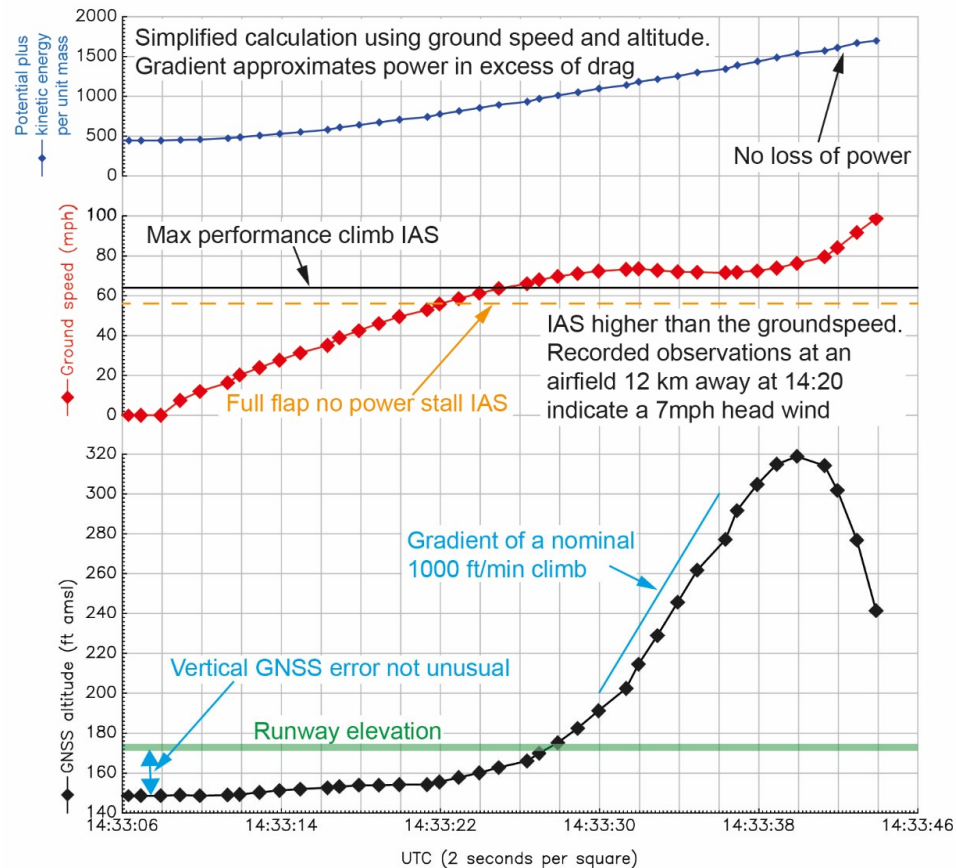
The data for the flight is shown in Figure 4. The aircraft initially climbed at approximately 1,000 ft/min with a ground speed of approximately 70 mph. Weather information, from Southampton Airport 12 km away, indicated a head wind of about 7 mph was present at the time. This indicates that the IAS was above that required for a maximum performance takeoff. The climb rate and speeds were as expected for the aircraft type and similar to previous takeoffs from that location recorded in the tablet.

The aircraft stopped climbing, peaked at approximately 150 ft agl and started descending. The aircraft accelerated in the descent. The energy of the altitude / speed profile in the descent indicates similar engine power was in use as that in the climb. The altitude / speed profiles of the previous takeoffs from the same runway indicated a similar amount of power being produced by the engine (Figure 5).

Figure 4
Accident flight data

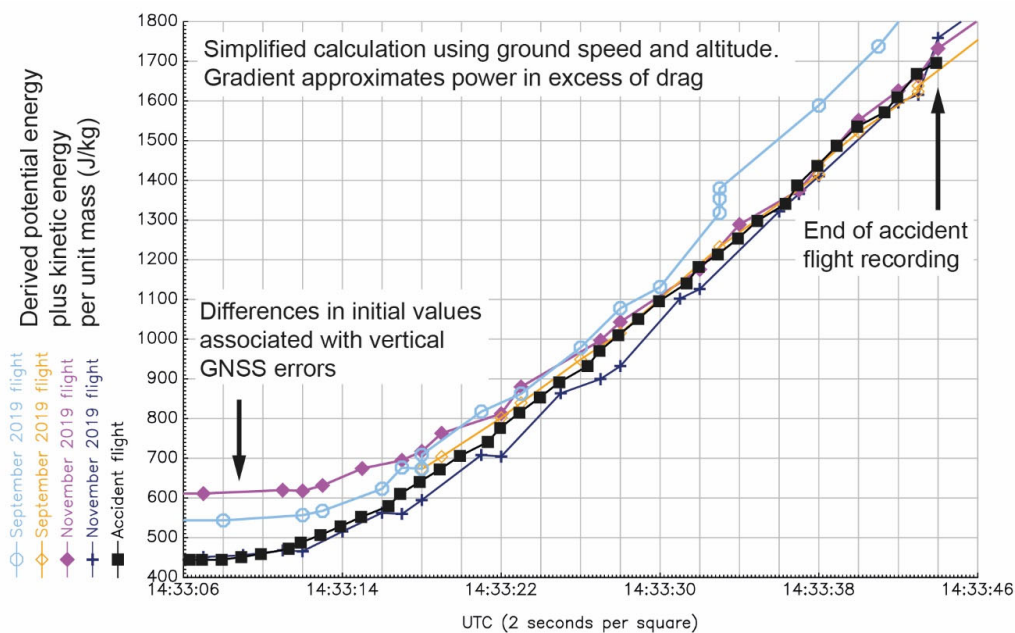
Figure 5
Comparison of the power used during the accident flight takeoff with that used during previous takeoffs from the same location.

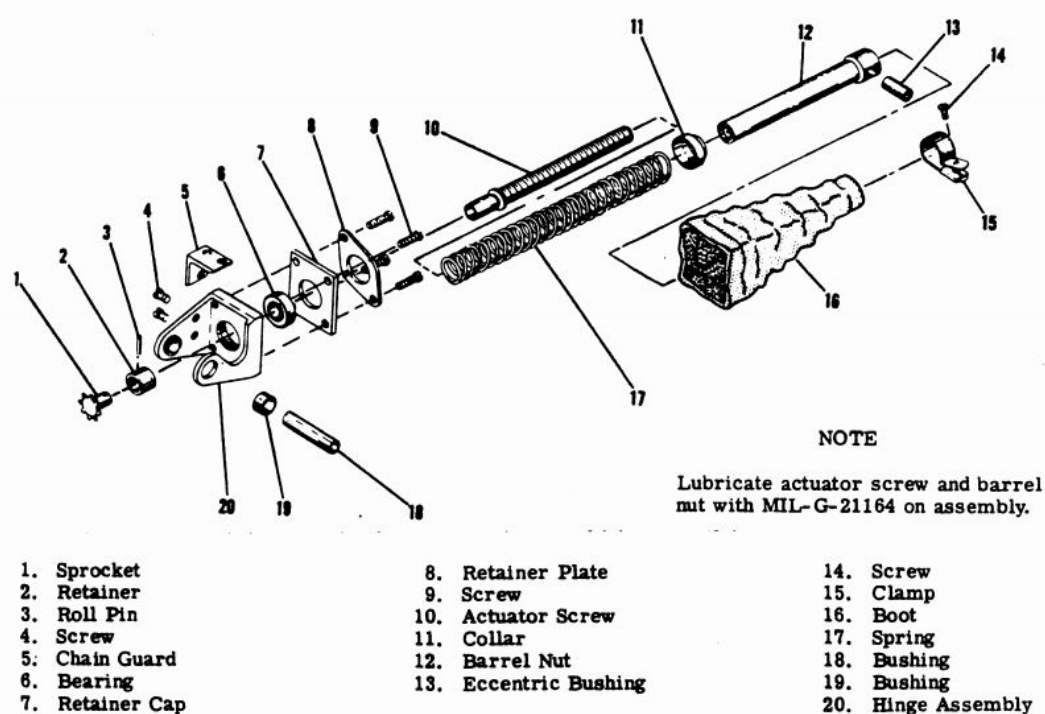
**Figure 7**

Jackscrew assembly
(Figures 6 & 7 courtesy of Textron)

Although the jack screw assemblies were found to work correctly in G-BLOS, their external condition was a cause for concern. The jacks screw assemblies originally had a 500 hour service and overhaul interval but in later revisions of the manuals for later models of the Cessna 180 and 185 series of aircraft this was changed to 3 years or 1,000 hours, whichever is sooner. This relies on accurate record keeping of when the overhaul was last carried out. In this case the tailplane jack screws on G-BLOS were working correctly and were smooth throughout their full range of operation. However, the evidence suggests that G-BLOS jack screws had been serviced in the past, indicated by the presence of a non-standard cable tie around the boot, but had not been removed for some time.

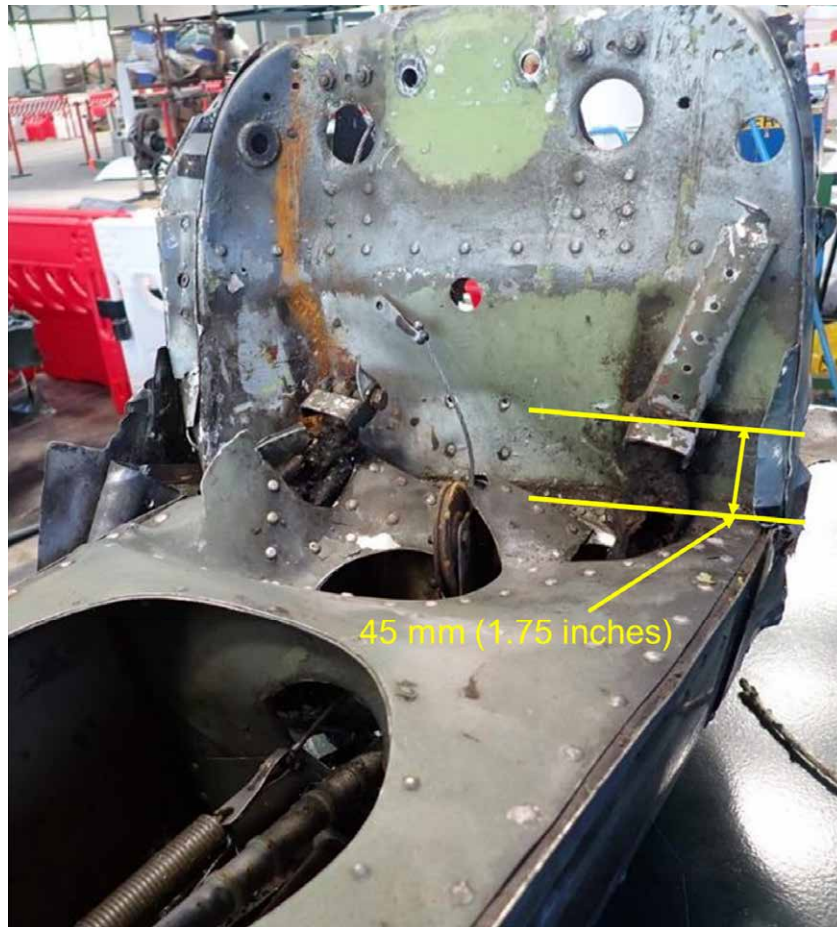
**Figure 8**

The distance between the leading edge of the tailplane and its hinge mounting plate was measured at the jack screw mounting bracket and found to be 45 mm (1.75 inches) and indicates the tailplane trimmed position as found (Figure 8).

Tailplane trimmed position as found

The owner was also asked to set the pitch trim to what, in his experience, would be normal for a standard rate of climb after takeoff. A measurement was then taken between the tailplane hinge plate and the tailplane leading frame and found to be 45 mm (1.75 inches) which was the same as found in G-BLOS (Figure 8).

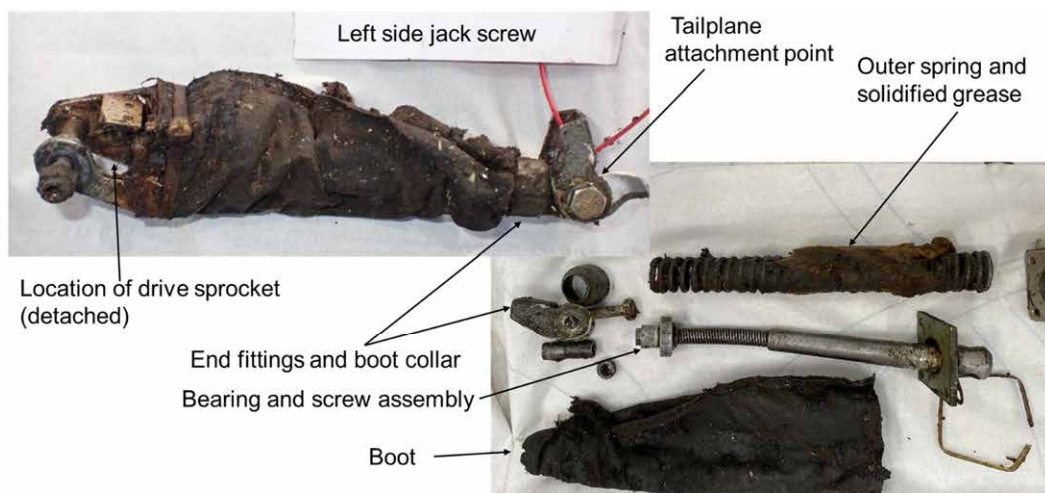
**Figure 9**

The jackscrews were correctly attached to the fuselage frame and to the tailplane leading frame brackets. However, the brackets were distorted and partially separated from the frame due to shearing of their attachment rivets. The rightward displacement of the tailplane had put a slight bend in both the jack screws. Disassembly of the two jack screws found them outwardly to be in very poor condition. Their boots were split and decayed and the grease covering the outer spring was aged and solidified. Despite this, both jack screw threads were free to rotate and extended and retracted correctly (Figure 9). The position on the screw shaft where the sprockets had been fitted showed that both had sheared in overload where the attachment pins passed through the shaft. An examination of the broken chain and the remaining sprocket supported this, with evidence of severe distortion to the sprocket teeth and chain links (Figure 10).

Disassembled left jack screw
(Right jack screw found in the same condition)

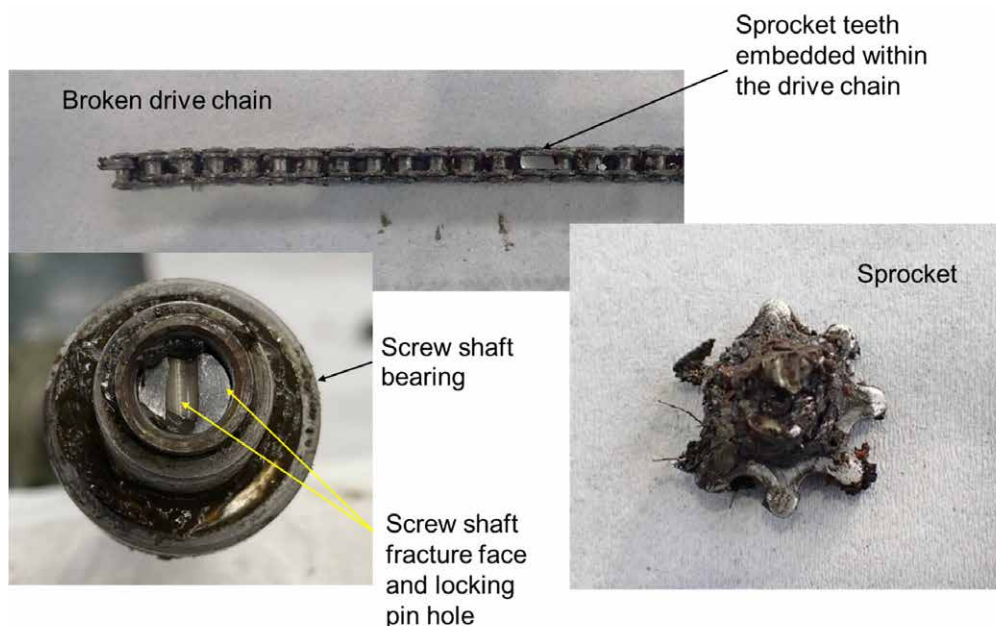
**Figure 10**

Left sprocket and chain

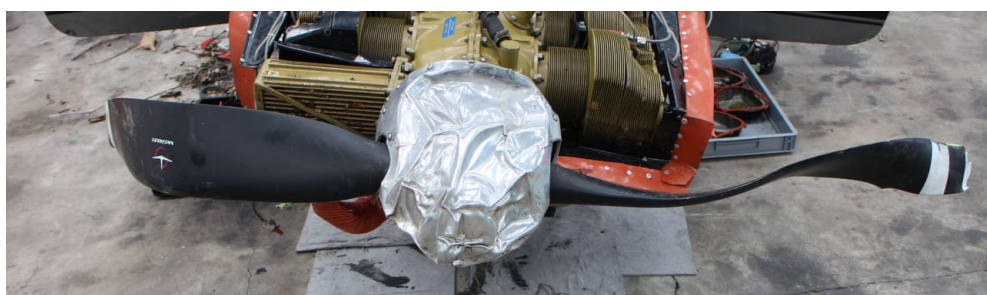
**Figure 11**

The upper and lower engine cowling had sustained multiple impact damage. The propeller spinner had multiple dents over its entire surface. Both propeller blades were loose in the propeller boss and the blade pitch change mechanism linkages had broken. One of the blades was twisted and bent rearwards and the other had pronounced multi-directional bending and twisting over its entire length. The tip of this blade had been fractured and was missing (Figure 11).

Condition of the propeller blades and spinner

The dents apparent over the entire propeller spinner surface suggest it was rotating as it descended in the trees. The nose section and cockpit remained relatively intact during the impact sequence.
