ACCIDENT

Aircraft Type and Registration:	Druine D.31 Turbulent, G-ARNZ	
No & Type of Engines:	1 Volkswagen 1600 piston engine	
Year of Manufacture:	1961 (Serial no: PFA 579)	
Date & Time (UTC):	18 October 2020 at 1510 hrs	
Location:	Damyns Hall Aerodrome, Upminster	
Type of Flight:	Private	
Persons on Board:	Crew - 1	Passengers - None
Injuries:	Crew - 1 (Minor)	Passengers - N/A
Nature of Damage:	Extensive damage	
Commander's Licence:	Commercial Pilot's Licence	
Commander's Age:	26 years	
Commander's Flying Experience:	391 hours (of which 21 were on type) Last 90 days - 32 hours Last 28 days - 9 hours	
Information Source:	Aircraft Accident Report Form submitted by the pilot

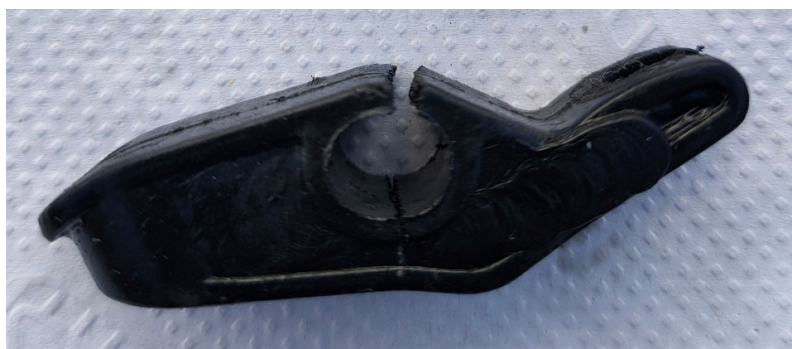
Figure 1

A post-accident engineering inspection revealed the plastic cam driven rocker arm in the mechanical fuel pump had cracked (Figure 1).

Plastic fuel pump rocker arm

The plastic rocker arm in the fuel pump cracked, causing the pump to fail. No other fuel pump was fitted, so this resulted in a loss of engine power and the pilot performed a forced landing.

'mechanical fuel pumps using a plastic rocker arm must not be used on VW derivative engines operating under an LAA administered Permit to Fly'

'it must be established beyond doubt whether or not the mechanical fuel pump fitted to the engine uses a plastic rocker arm'
