ACCIDENT

Aircraft Type and Registration:	Piper PA-44-180, G-BGCO	
No & Type of Engines:	2 Lycoming O-360-E1A6D piston engines	
Year of Manufacture:	1978 (Serial no: 44-7995128)	
Date & Time (UTC):	12 February 2021 at 1310 hrs	
Location:	Blackpool Airport, Lancashire	
Type of Flight:	Private	
Persons on Board:	Crew - 1	Passengers - None
Injuries:	Crew - None	Passengers - N/A
Nature of Damage:	Damaged beyond economic repair.	
Commander's Licence:	Commercial Pilot's Licence	
Commander's Age:	70 years	
Commander's Flying Experience:	16,500 hours (of which 1,000 were on type) Last 90 days - 45 hours Last 28 days - 17 hours	
Information Source:	Aircraft Accident Report Form submitted by the pilot

Synopsis

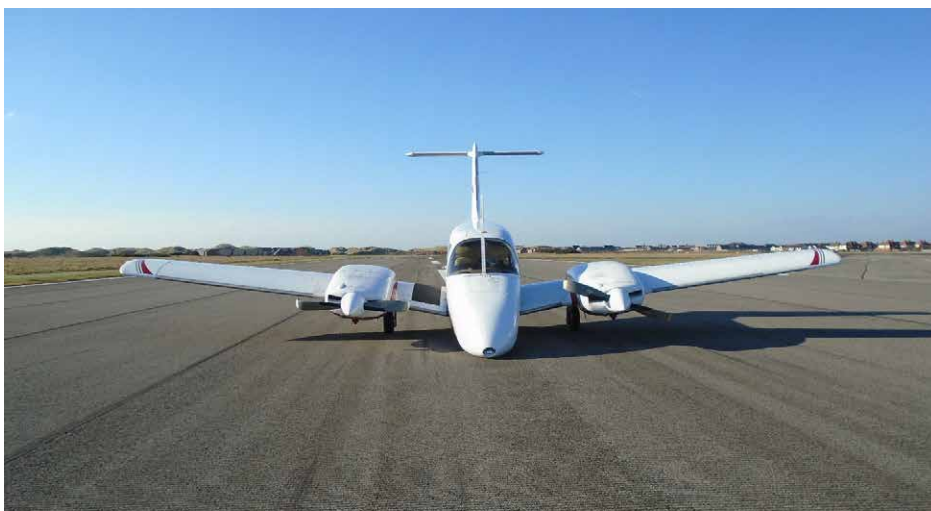
Figure 2

After consultation over RTF with the factory test pilot at Warton, it was decided to fly the aircraft to Blackpool Airport where suitable engineering facilities were available. The aircraft landed on Runway 10 at Blackpool, the nose landing gear collapsed on touchdown and the aircraft came to rest with its nose on the ground (Figure 2). Damage was sustained to both engines, both propellers and the nose landing gear. The pilot was able to vacate the aircraft via the cockpit door and was uninjured.

Aircraft after landing

The pilot had anticipated the possibility of the nose landing gear collapsing on touchdown and diverted the aircraft to Blackpool so that suitable engineering facilities would be available after landing to support the recovery of the aircraft. The collapse of the nose landing gear precipitated the damage to the engines, propellers and nose landing gear but the aircraft was brought to a safe halt on the runway.
