ACCIDENT

Aircraft Type and Registration:	Europa XS, G-FIZY	
No & Type of Engines:	1 Rotax 912-UL piston engine	
Year of Manufacture:	2007 (Serial no: PFA 247-13291)	
Date & Time (UTC):	30 June 2014 at 1445 hrs	
Location:	Tangley, Hampshire	
Type of Flight:	Private	
Persons on Board:	Crew - 2	Passengers - None
Injuries:	Crew - None	Passengers - N/A
Nature of Damage:	Left door detached, damaging the left tailplane	
Commander's Licence:	Airline Transport Pilot's Licence	
Commander's Age:	72 years	
Commander's Flying Experience:	17,670 hours (of which 5 were on type) Last 90 days - 79 hours Last 28 days - 34 hours	
Information Source:	Aircraft Accident Report Form submitted by the pilot and LAA information

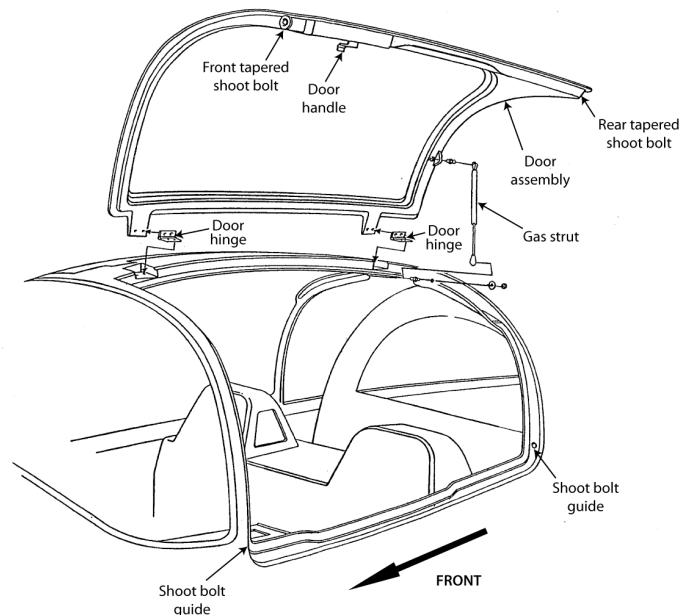
Figure 1

The doors are of a gull wing arrangement. Each door is hinged in two places along its top edge, (Figure 1). A gas strut is fitted to the rear of the door to support it in the open position.

The door is held closed by two tapered shoot bolts which extend out longitudinally, from the lower corners of the front and rear sides of the door, into guides in the door frame. If the door is not fully closed at the rear, it is possible to move the door locking lever to the closed position with only the front shoot bolt engaged in its guide. This gives the false impression that the door is closed and fully locked. There have been a number of previous incidents on the Europa fleet where a door has detached due to the rear shoot bolt not engaging in its guide when the door was closed.

The LAA are working with Europa Aircraft Ltd to design a safety modification intended to prevent a recurrence.
