# **CRAMBER TOR TRAINING AREA**

## **Monument Condition Survey**

**February 2012**

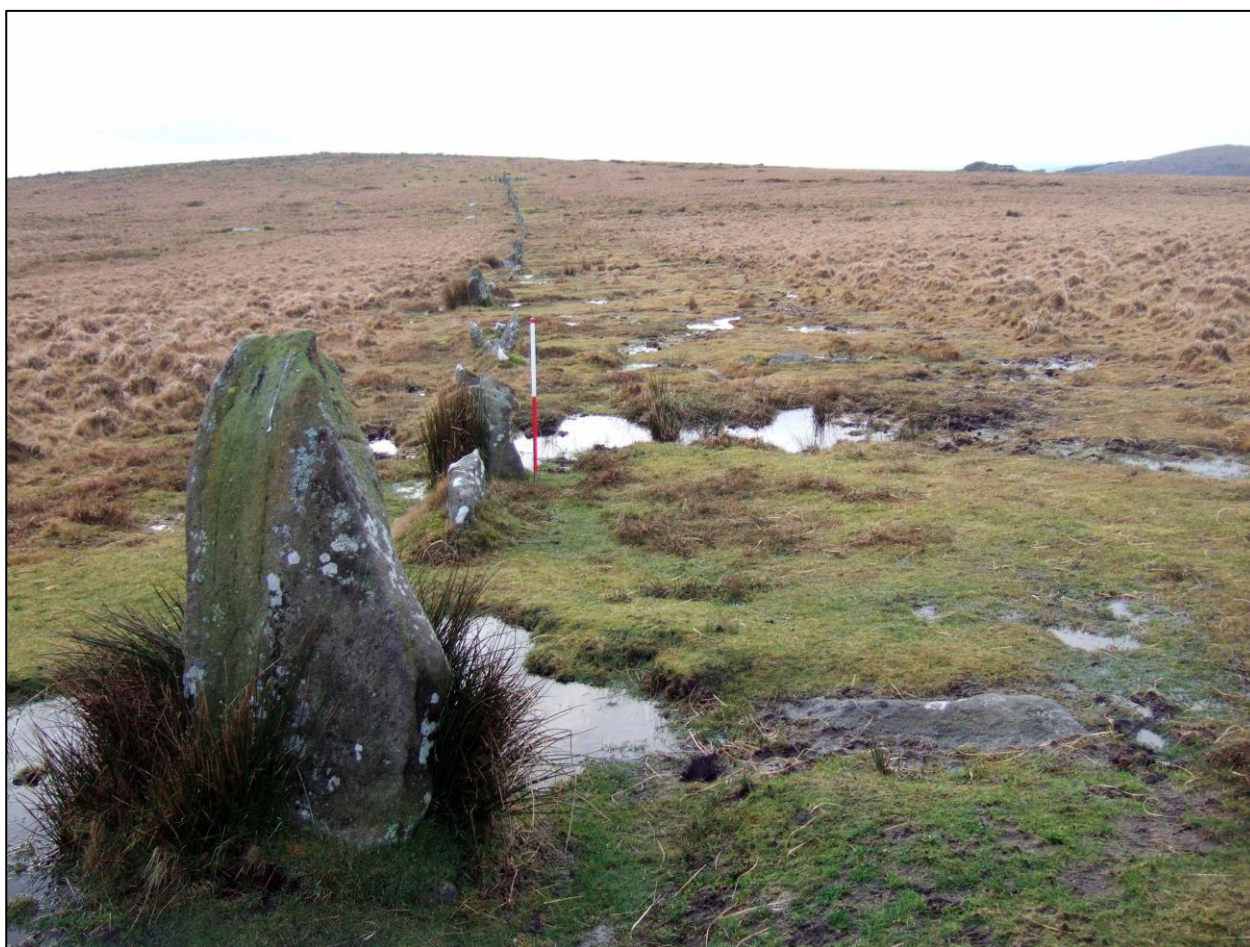
- 3.3. The only site which seems potentially vulnerable due to visitor pressure is the scheduled prehistoric stone row at Down Tor (438583 – see cover image) due to several wet and eroded areas along the length of the row on its north side, which people

naturally walk along (see photographs). This was highlighted in Probert (2008, p.4) with a recommendation that 'military activity should be excluded from the immediate area'. Military personnel were observed on one occasion walking along the row during current fieldwork.

*Cover photo:* Stone row near Down Tor (438583) from east end, showing waterlogged areas (Scale: 1m).
