## **A Condition Survey of the Archaeological Sites of the Cramber Tor Training Area**

County:	Devon
District:	West Devon
Parish:	Sheepstor, Walkhampton
NGR (Centre):	SX 593699
Surveyed:	Nov – Dec 2013
Contractor:	S Probert
Client:	Landmarc/Defence Infrastructure Organisation

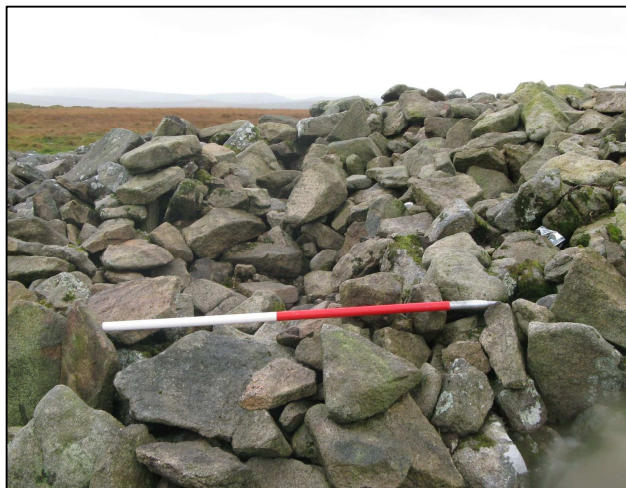
The stony matrix of the southernmost of the Eylesbarrow cairns, 438743, has been rearranged to create a small scooped shelter in the eastern side of the mound. Similar disturbance was recorded by the 2007 baseline survey and the damage rectified by DNPA/EH as part of the follow up works (Probert, 2008). However, the cairn is vulnerable to this kind of disturbance and has suffered again in the intervening years. Such action is in contravention of the Ancient Monuments and Archaeological Areas Act of 1979. It is not thought that this is a result of the military use of the area.

**Fig 3** *Detail of recently constructed shelter on prehistoric monument 438743 at Eylesbarrow*

While the reinstatement of the disturbance at the Eylesbarrow cairn 438743 will restore the monument in the short term it remains vulnerable to similar activity. As with the reave 1450575 the process of monitoring at regular intervals should be continued. The continuance of the 'bracken stamp' programme at the small tin processing site 1446212 will eventually lead to its removal from the Gradual Decline category.

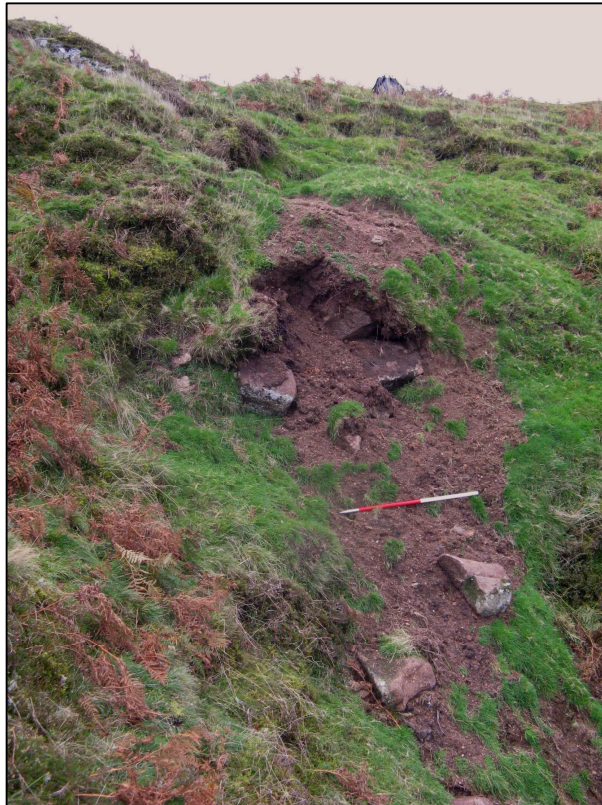
The wheelpit 1300628, formerly supplying power to the pumping mechanisms at Eylesbarrow Mine has been damaged by burrowing animals. A large burrow has been created above the masonry at the eastern end of the pit dislodging several stones. Fresh earth at the mouth would indicate current occupation and the lack of bedding material normally associated with badgers would suggest the presence of a fox.

**Fig 4** *Probable fox damage to wheelpit 1300628 at Eylesbarrow Mine*

The practicality and even the efficacy of removing the burrowing animals from the wheelpit 1300628 at Eylesbarrow Mine are doubtful. It is hoped that in the medium term the damage will stabilise.

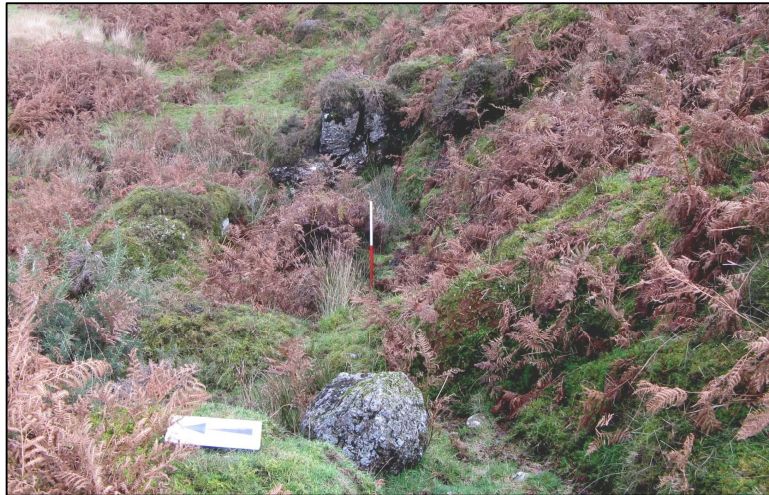
Bracken is concentrated in one corner of the training area and affects parts of several monuments. Of particular note is the small tin processing works, 1446212, on the left bank of Newlycombe Lake. Despite remedial work by DNPA/EH described in the 2008 follow up works programme (Probert 2008) the ruined structure is still occupied by bracken. This has the potential to severely disrupt any sub-surface remains. The proximity of the site to the watercourse makes the use of chemical sprays impractical. The continuation of the bracken stamping strategy is to be encouraged.

**Fig 5**  
*Bracken  
occupying  
interior of tin  
processing  
works  
1446212*

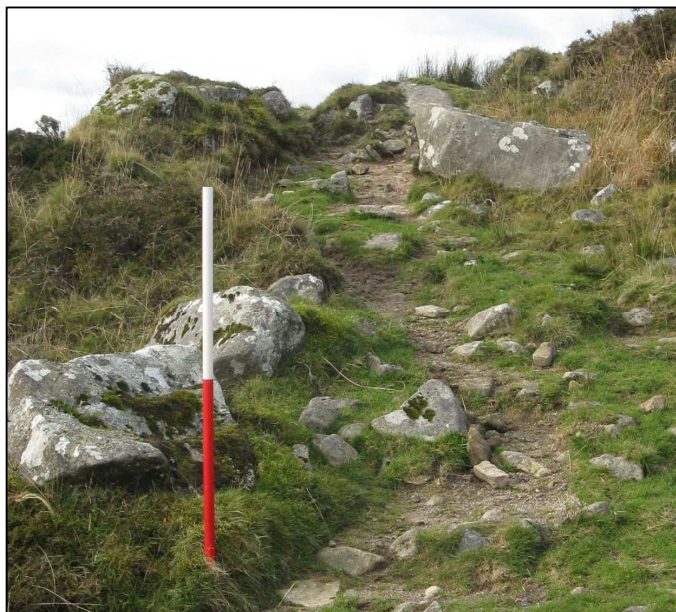
Several of the sites at the Cramber Tor Training Area are affected by footpath erosion. In the majority of cases the damage is limited to footpaths crossing long linear features where remedial action in the form of diversions would only lead to the transfer of the problem to a different stretch of the same feature. In these cases the very localised disturbance is to be tolerated. A particular example of this is the footpath that crosses the streamworks, 1448375, on the upper reaches of the Narrator Brook. First raised as an issue by the 2007 Baseline Survey this feature was subject to monitoring in the 2008 follow up programme. Examination of the ground photography from 2008 and 2013 indicates that there has been no appreciable deterioration in the state of the monument at this point in the intervening years.

**Fig 6** *Footpath scar  
ascending the north  
side of streamwork  
1448375*

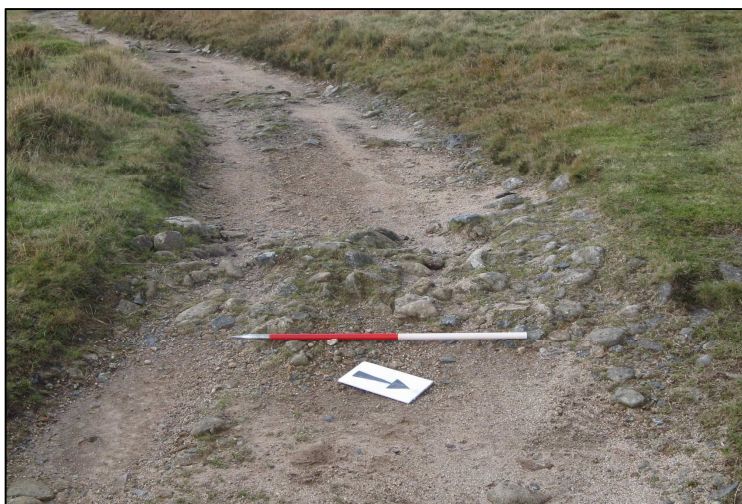
In contrast to the above example is the short length of reave, 1450575, that is visible as it crosses the Nosworthy Bridge to Peat Cot track. While it appears to be a remarkably robust feature it is slowly being reduced by foot and cycle traffic. As this is the only point at which this feature can be traced it must be regarded as in decline. Once one or more of the larger stones are displaced its disintegration will probably follow quite rapidly. The diversion of the track at this point is not only impractical but would also expose further elements of this feature.

**Fig 7 1450575.**  
*Reave at threat  
from foot and  
cycle damage*

The condition of this reave should continue to be monitored and, in the event of major deterioration a small excavation should be considered.

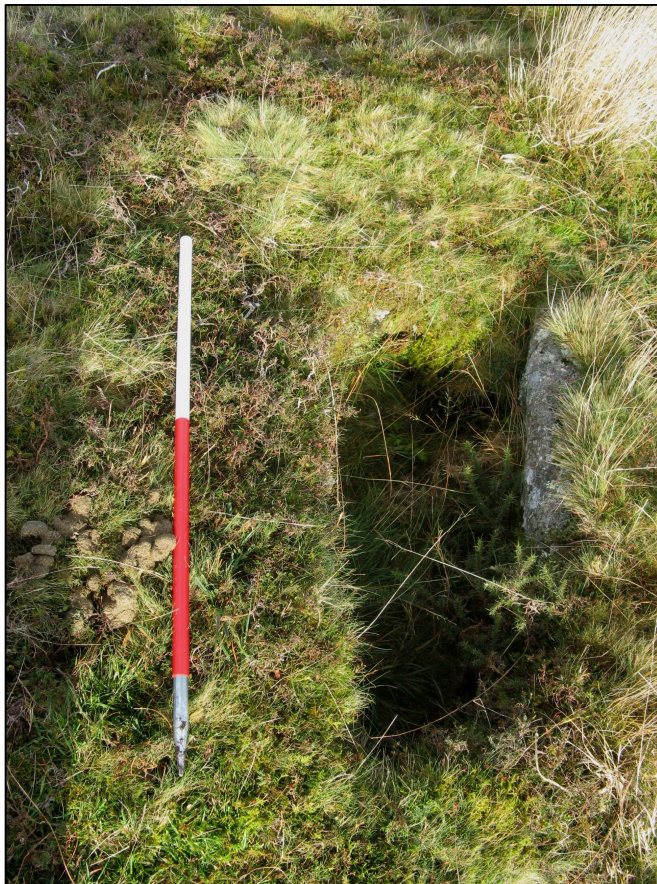
The reduced stocking levels have resulted in a significant increase in the areas covered by shrubs such as gorse and heather and purple moor grass. The issue of undergrazing and the subsequent spread of gorse in particular has already been raised by the 2007 baseline survey. A result of this was the scrub clearance carried out in the 2008 follow up programme (Probert 2008). Amongst the features cleared of gorse were three small cists, 438861, to the northeast of Down Tor. The most recent condition survey has noted the presence of small gorse shoots within these features. It is anticipated that by the time of the next assessment the plants will be sufficiently large to threaten these features once more.

**Fig 8** *Gorse regrowth in cist 438861*

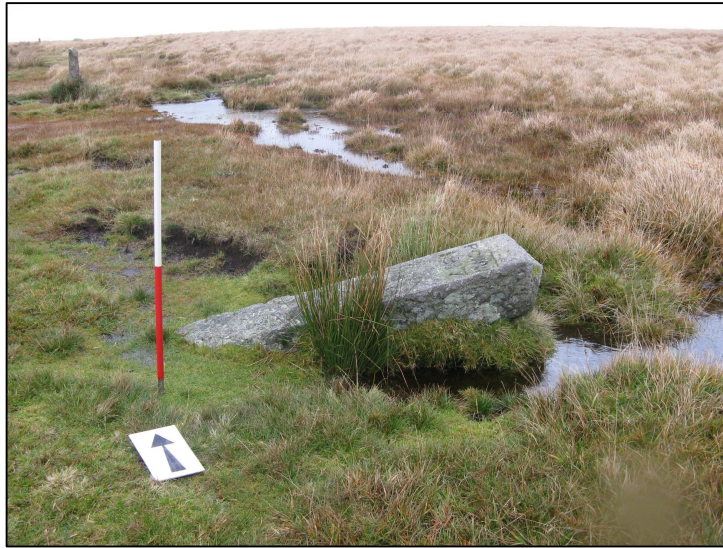
Despite the reductions in stocking levels in recent years livestock still has a direct impact on the archaeological resource. Many of the 20<sup>th</sup> century boundary stones marking the reservoir watershed possess erosion hollows at their bases. These stones are being used by livestock, cattle in particular, as rubbing posts. In extreme circumstances the stones may become unstable and topple. Examples are boundary stones 1063660 (Fig 9) and 1063810.

**Fig 9** *Recumbent  
boundary stone  
1063660*

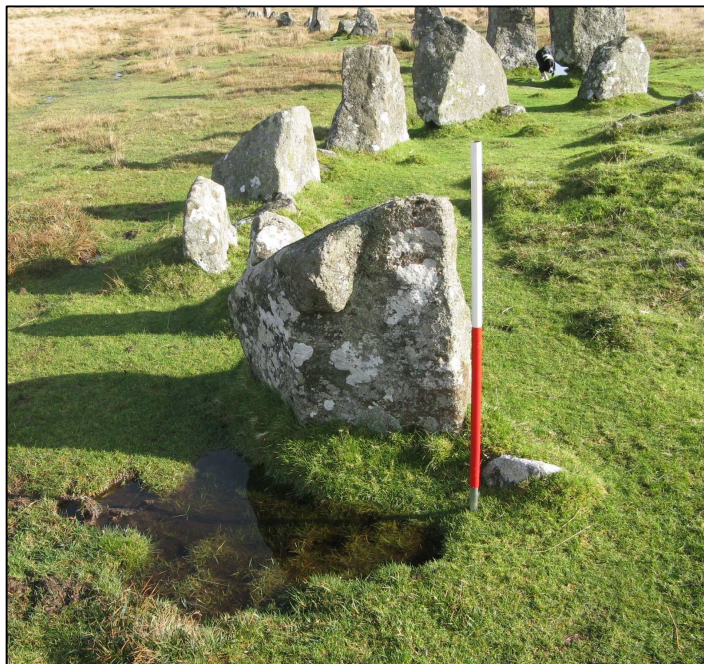
Several water-filled hollows and bare peaty patches have, since the 2007 baseline survey, caused concern at the Down Tor stone row, 438583 (Fig 10). These also appear to be largely the result of livestock activity as the main footpath in the area does not intrude directly upon the row. None of the stones with basal hollows appear to be unstable in their sockets.

**Fig 10** *Water-  
filled erosion  
hollow at Down  
Tor stone row  
438583*
