**A Condition Survey of the Archaeological Sites of the Cramber
Tor Training Area, 2017**

County:	Devon
District:	West Devon
Parish:	Sheepstor, Walkhampton
NGR (Centre):	SX 593699
Surveyed:	April – May 2017
Contractor:	S Probert
Client:	Landmarc/Defence Infrastructure Organisation

A CONDITION SURVEY OF THE ARCHAEOLOGICAL SITES OF THE CRAMBER TOR TRAINING AREA, DEVON, 2017

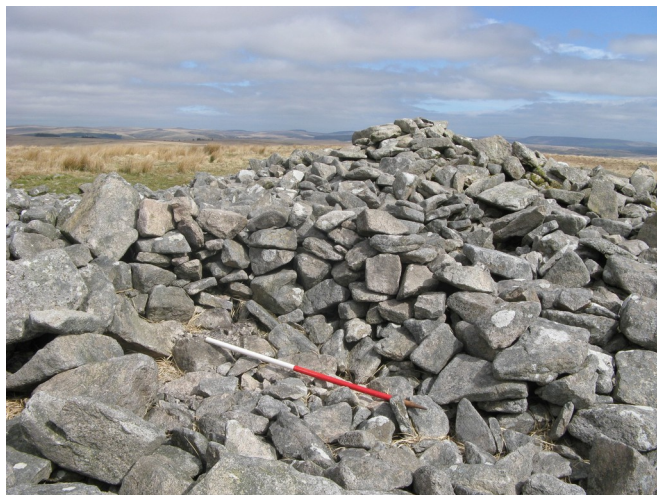
The stony matrix of the Eylesbarrow cairns, 438743, has been rearranged to create small shelters. Similar disturbance was recorded by the 2007 baseline survey and the damage rectified by DNPA/EH as part of the follow up works (Probert, 2008). The problem had reoccurred in 2013 and was again dealt with. These features are vulnerable to this kind of disturbance. A small cairn has also been constructed from loose stone on the prehistoric feature 438589, west of the Down Tor stone row. Such action is in contravention of the Ancient Monuments and Archaeological Areas Act of 1979. It is not thought that these disturbances are a result of the military use of the area.

Fig 3 *Detail of recently constructed shelter on prehistoric monument 438743 at Eylesbarrow.*

While the deconstruction of the disturbance at Eylesbarrow, 438743, the cairn east of the stone row, 438589, and the small building 441725 will restore these features in the short term they remain vulnerable to similar activity. As with the reave 1450575 the process of monitoring at regular intervals should be continued. The continuance of the 'bracken stamp' programme at the small tin processing site 1446212 will eventually lead to its removal from the Gradual Decline category.

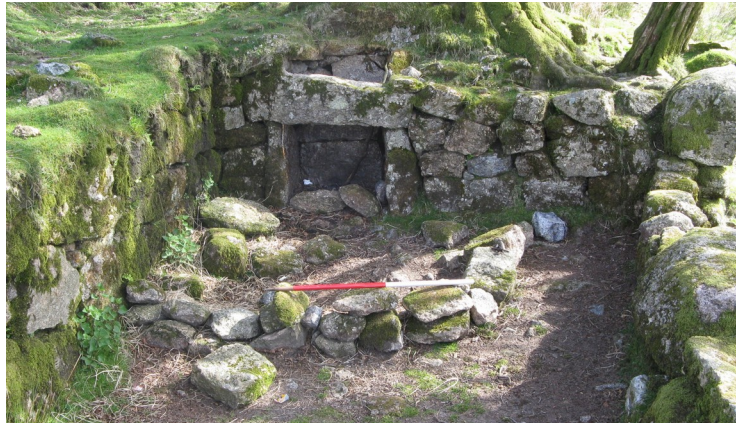
Stones lying within the ruined rectangular building 441725 near the Devonport Leat portal have also been rearranged to form a small shelter. It is possible and probably likely that should it be allowed to remain this recent construction will be further enhanced by the addition of stones removed from the building's walls

Fig 4 *Detail of recently constructed shelter in the ruined building 441725.*

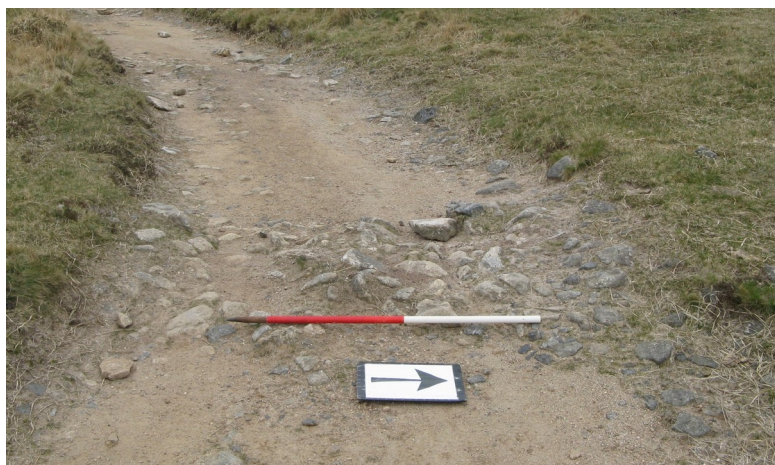
The short length of reave, 1450575, that is visible as it crosses the Nosworthy Bridge to Peat Cot track is the only monument deemed in decline by virtue of footpath erosion. While it appears to be a remarkably robust feature it is being reduced slowly by foot and cycle traffic. There has been some minor deterioration in this feature since 2013 but not sufficient to trigger any further action. Once one or more of the larger stones become displaced its disintegration will probably follow quite rapidly. The diversion of the track at this point is not only impractical but would also expose further elements of this feature. In the event of major deterioration a small excavation should be considered.

Fig 5 *1450575. Reave at threat from foot and cycle damage*

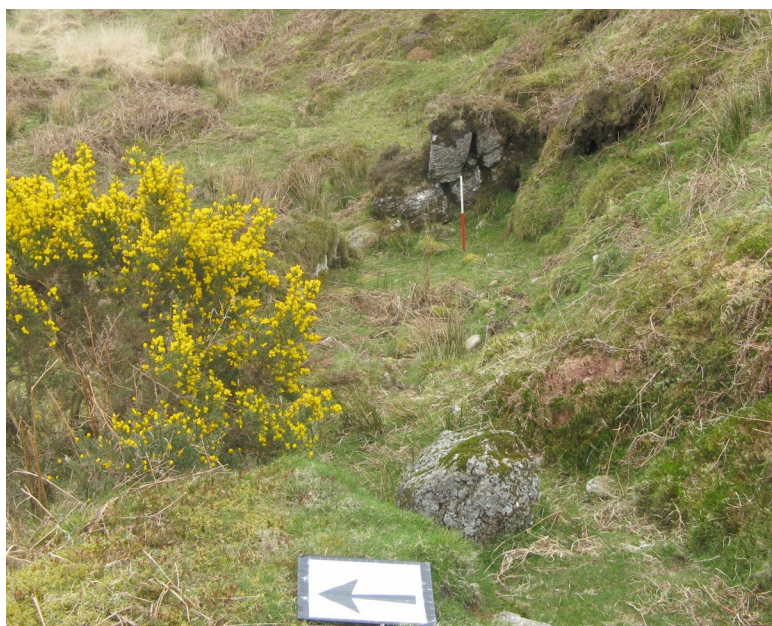
Bracken is concentrated in one corner of the training area and affects parts of several monuments. Of particular note is the small tin processing works, 1446212, on the left bank of Newlycombe Lake. Despite remedial work by DNPA/EH described in the 2008 follow up works programme (Probert 2008) the ruined structure is still occupied by bracken. This has the potential to severely disrupt any sub-surface remains. The proximity of the site to the watercourse makes the use of chemical sprays impractical. The continuation of the bracken stamping strategy is to be encouraged.

Fig 6 *Bracken occupying interior of tin processing works 1446212*

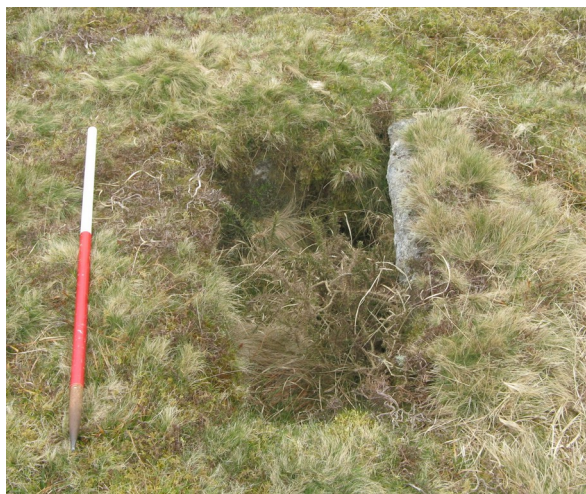
The reduced stocking levels have resulted in a significant increase in the areas covered by shrubs such as gorse and heather. The issue of undergrazing and the subsequent spread of gorse in particular has already been raised by the 2007 baseline survey. A result of this was the scrub clearance carried out in the 2008 follow up programme (Probert 2008). Amongst the features cleared of gorse were three small cists, 438861, to the northeast of Down Tor. The 2013 Condition Survey noted the presence of small gorse shoots within these features though during the 2017 survey it was noticed that these had not matured and the plants appear to be dying back naturally.

Fig 7 Gorse regrowth in cist 438861

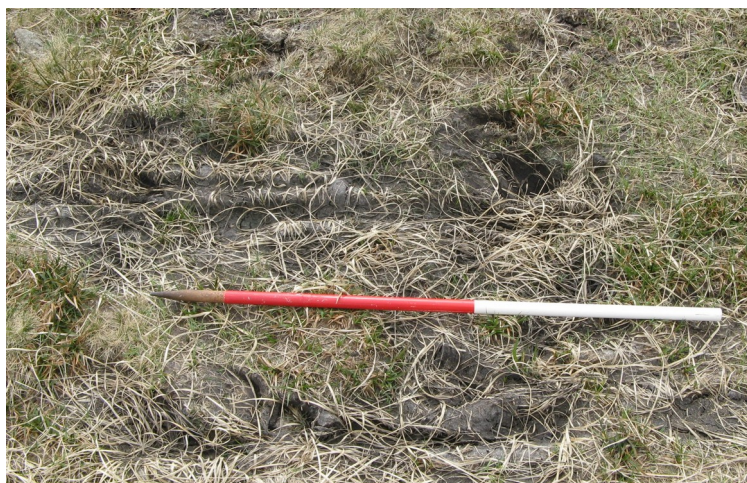
The impact of livestock on the archaeological resource has been significant though, since what appears to have been a dramatic decrease in stocking levels and recent mitigation works (3.4), it is now limited mostly to poaching marks either side of the Down Tor stone row and erosion hollows around the bases of some stones. The former have been further enhanced by cycle and pedestrian traffic (Fig 8). The erosion hollows are caused by the use of the stones as rubbing posts by cattle and ponies. Fortunately no stones appear to be loose and in danger of collapse.

Fig 8 Hoofprints, footprints and bicycle tracks adjacent to the Down Tor stone row, 438583

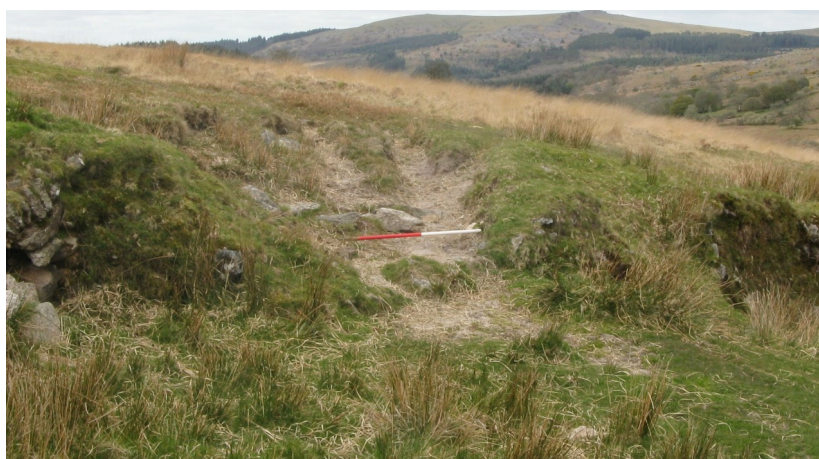
An example of this lies the eastern side the enclosure 1451219, associated with the medieval settlement at Outcombe (Fig 9). Similarly the footpath crossing the streamworks 1448375 on the upper reaches of the Narrator Brook was first raised as an issue by the 2007 Baseline Survey. Examination of the ground photography from 2008, 2013 and 2017 indicates that there has been no appreciable deterioration in the state of the monument during this period.

Fig 9
Footpath cutting through the Outcombe enclosures. 1451219

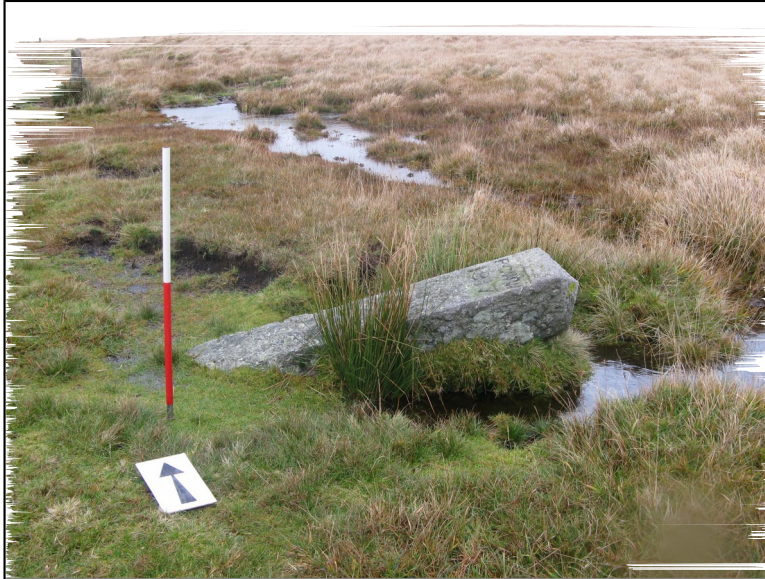
Previous assessments of the stones marking the boundaries of the catchment area for Burrator reservoir and the former Royal Forest of Dartmoor have noted the erosion hollows around many of these features. Indeed some of the stones situated in the wetter areas were recumbent. (Fig 10). These features were first recorded in detail as archaeological monuments in 1995 (RCHME 1995). These earlier records show that erosion hollows were present and several stones lay fallen. While their condition was regarded as stable in subsequent assessments there existed the potential for further stones to fall and those

Fig 10 *Recumbent boundary stone 106366, 2013*

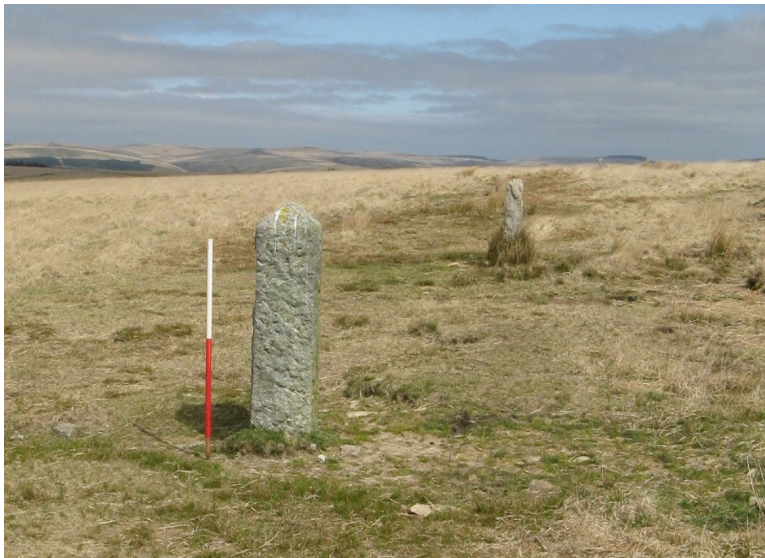
Fig 11 *Boundary stone 106366, 2017, after restoration*

already recumbent to disappear beneath the peat. In a programme of work undertaken since 2014, several concerned parties coordinated by the Dartmoor Society have filled the erosion hollows and re-erected the fallen stones (Fig 11).

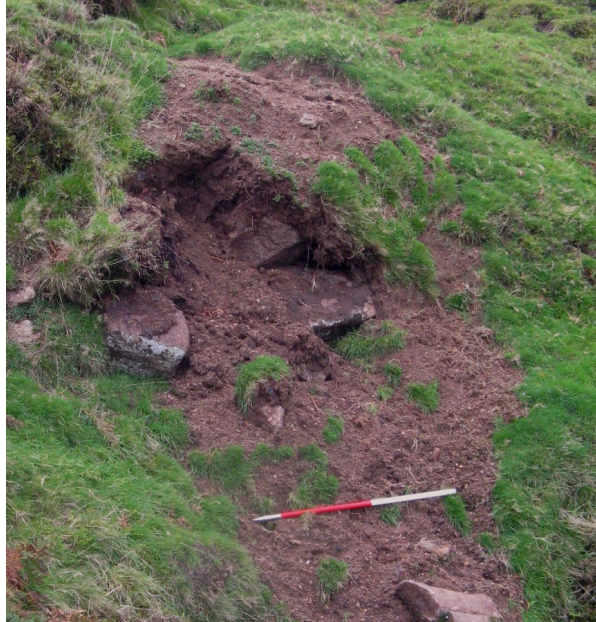
The 2013 assessment highlighted burrowing animal damage (Fig 12) to a major feature of the former Eylesbarrow Mine, 1300628. Conservation work has discouraged further burrowing and this shaft has been returned to a stable condition (Fig 13).

Fig 12 1300628, 2013. *Burrowing animal damage at Eylesbarrow Mine*

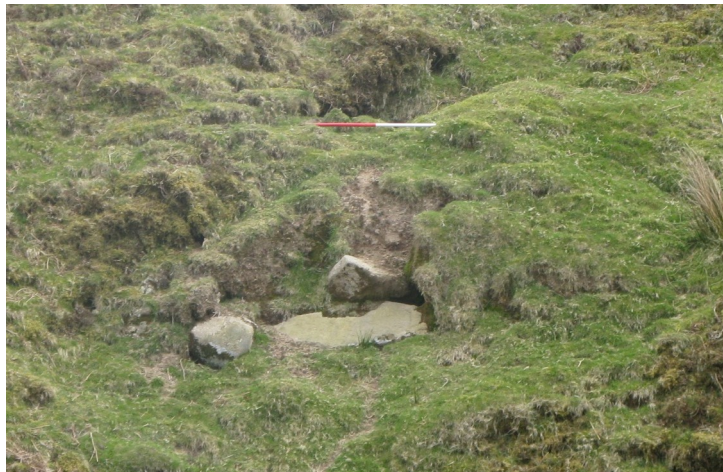
Fig 13 1300628, 2017. *Area restored*
