Archaeological Sites within Merrivale Training Area, Dartmoor National Park, Devon: A condition survey on behalf of Defence Infrastructure Organisation

March 2018

Southwest Landscape Investigations

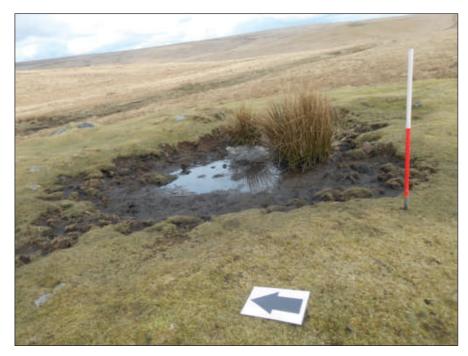
Fig 5. 439600 White Barrow. The center of this important monument continues to be affected by livestock erosion and waterlogging, causing a hollow on the top of the mound.

439600 (SM No: 1007896) White Barrow. The center of this important monument continues to be affected by livestock erosion and waterlogging, causing a hollow on the top of the mound. Repair with compacted stone and a turf covering could remedy this problem without affecting the integrity of the monument.

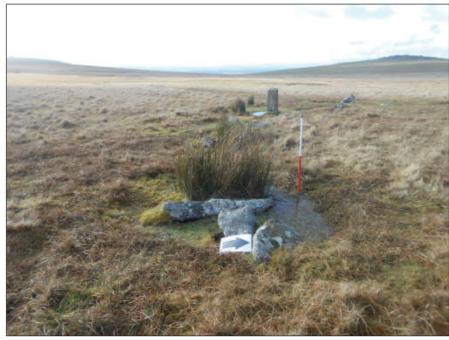
439606 (SM No: 1007550) Langstone Moor stone circle. Conservation work carried out in 2003, to fill erosion hollows around the bases of the upright stones, is beginning to fail, and watery hollows are again present around several of the stones. Remedial action may not be necessary just yet, but continued monitoring will be necessary to assess further decline in this situation.

Fig 6. 439606 Langstone Moor stone circle. Conservation work carried out in 2003, to fill erosion hollows around the bases of the upright stones and some recumbent, is beginning to fail,

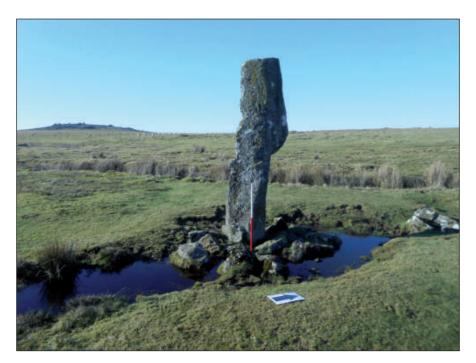
Fig 8. 439621 Langstone Moor stone row. The terminal standing stone (Longstone) is within a water-worn erosion hollow, where supporting stones around the base have become further exposed since the 2010 assessment.

439621 (SM No: 1007897) Langstone Moor stone row continues to be bisected by former vehicle tracks, now used by walkers and livestock (as reported in 2005 and 2010). The terminal standing stone is within a water-worn erosion hollow, where supporting stones around the base have become further exposed since the 2010 assessment and the hollow appears much deeper. The risk of the stone toppling needs to be properly assessed and remedial action taken if felt necessary. One useful action may be to divert the water away from the hollow in which the stone stands, with the option of filling the channel with stone and turf.

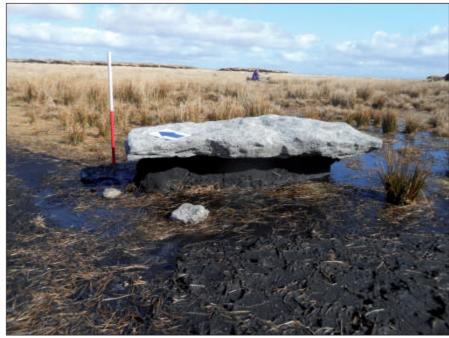
1406369 Cut Hill stone row. The western most recumbent stone is supported by a plinth of peat. It appears that the height of this plinth is greater than in 2010, suggesting that the ground level is eroding quite rapidly. The monument remains stable at present.

Fig 9. 1406369 Cut Hill stone row. The western most recumbent stone is supported by a plinth of peat. It appears that the height of this plinth is greater than in 2010, suggesting that the ground level is eroding quite rapidly. The monument remains stable at present.

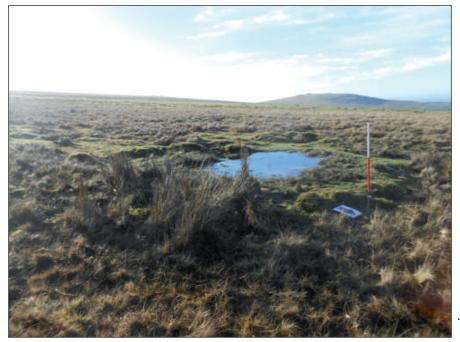
1388126 A cluster of four military mortar pits are permanently filled with boggy material, and losing their definition, although these very recent features are of no great significance archaeologically.

Fig 10. 1388126 A cluster of four military mortar pits are permanently filled with boggy material, and losing their definition, although these very recent features are of no great significance archaeologically.
