**SERIOUS INCIDENT**

<b>Aircraft Type and Registration:</b>	BN2T-4S Islander, G-CGTC	
<b>No &amp; Type of Engines:</b>	2 Rolls Royce M250-B17F/1 turboprop engines	
<b>Year of Manufacture:</b>	2013 (Serial no: 4019)	
<b>Date &amp; Time (UTC):</b>	12 November 2020 at 2055 hrs	
<b>Location:</b>	City of Derry Airport, Eglinton, Londonderry	
<b>Type of Flight:</b>	Emergency services operations	
<b>Persons on Board:</b>	Crew - 1	Passengers - 2
<b>Injuries:</b>	Crew - None	Passengers - None
<b>Nature of Damage:</b>	Undamaged	
<b>Commander's Licence:</b>	Commercial Pilots Licence/Instrument Rating	
<b>Commander's Age:</b>	59 years	
<b>Commander's Flying Experience:</b>	8,325 hours (of which 3,153 were on type) Last 90 days - 31 hours Last 28 days - 10 hours	
<b>Information Source:</b>	AAIB Field Investigation

**Synopsis**

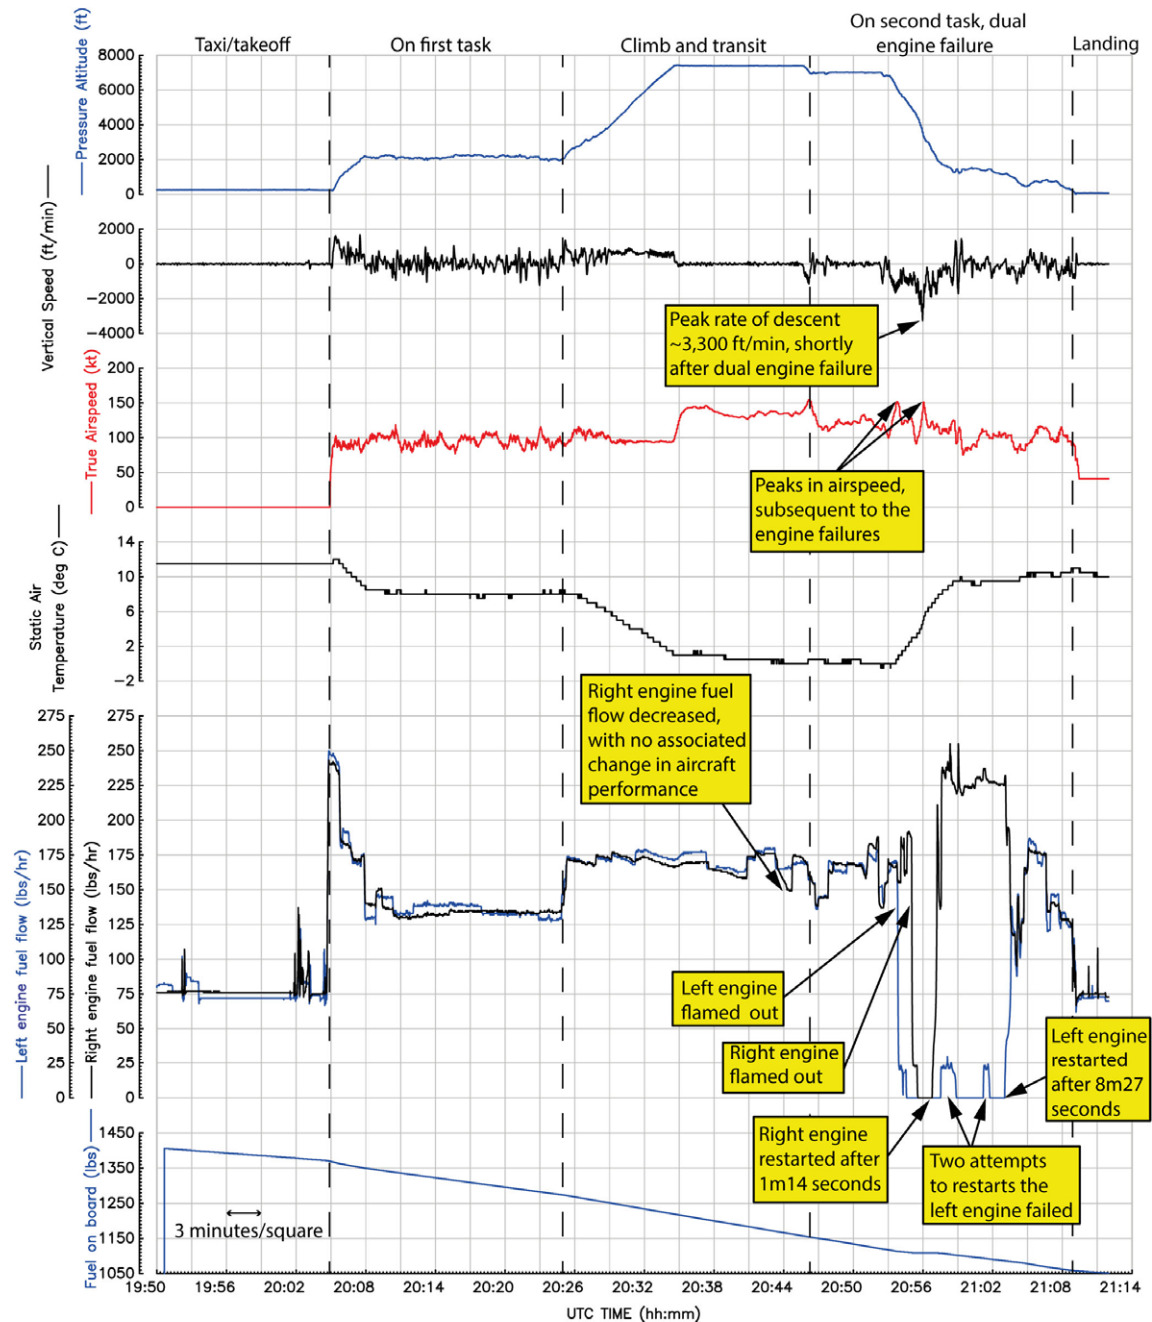
The data showed that, after the first tasking was completed at approximately 2025 hrs, the aircraft climbed to a pressure altitude of 7,400 ft (equivalent to 7,000 ft amsl), reaching this altitude at 2035 hrs, and tracked from the general vicinity of Aldergrove towards the west. As G-CGTC climbed, the SAT decreased from 8°C to 1°C. Eight minutes after levelling off, at 2043 hrs, while maintaining a westward track the SAT reduced further to 0°C and a marked decrease in the right engine's fuel flow was seen on the data, without a notable change in G-CGTC's flightpath or performance. Ten minutes later, at 2053 hrs, after a descent to a pressure altitude of 7,000ft (equivalent to 6,600 ft amsl) and while G-CGTC performed the flight's second tasking, the left engine's fuel flow reduced to zero as the engine flamed out.

G-CGTC entered a descent, at up to 1,500 ft/min, and its true airspeed increased to 150 kt. A minute later, at 2054 hrs, the right engine's fuel flow reduced to zero as this engine also flamed out. (The data showed that the engines did not fail in the order recalled by the pilot). G-CGTC then entered a steeper descent, during which the true airspeed (which after the first engine flameout had reduced to 120 kt) again reached 150 kt, the SAT rose rapidly and a peak rate of descent of approximately 3,300 ft/min was recorded.

The right engine was successfully restarted 74 seconds after it flamed out and at a pressure altitude of 2,500 ft (2,100 ft amsl), at which point G-CGTC's flight path began to stabilise with a reduction in both the rate of descent and true airspeed recorded. The data then showed two unsuccessful attempts were made to restart the left engine, while the aircraft was in a shallow descent towards Eglinton, before it was successfully restarted at a pressure altitude of 1,200 ft (800 ft amsl) 8 minutes 27 seconds after it had failed. G-CGTC landed at 2109 hrs, with both engines operational, after one circuit flown at approximately 500 ft agl. An annotated copy of this data is shown in Figure 2 below.

FMC data for the incident flight

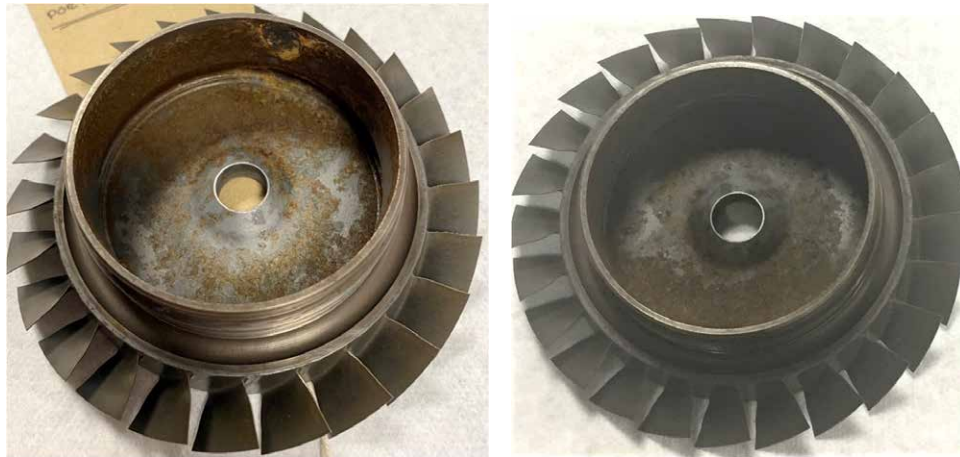
**Figure 4**

Some of the corrosion found on the left engine axial compressor wheel hubs

Further detailed examination of the left engine's rotor wheels showed there was heavy corrosion present on their hubs (Figure 4). Despite these issues, there was no damage that could be attributed to ice ingress, a potential overspeed or overheat event during the roll-back and shutdown of the engines.
