Report on the investigation of  
the immobilisation and flooding of the dredger  
***Shearwater***  
after repeated collisions with the unmanned barge  
***Agem One***  
near Kinlochbervie, Scotland  
on 9 April 2020

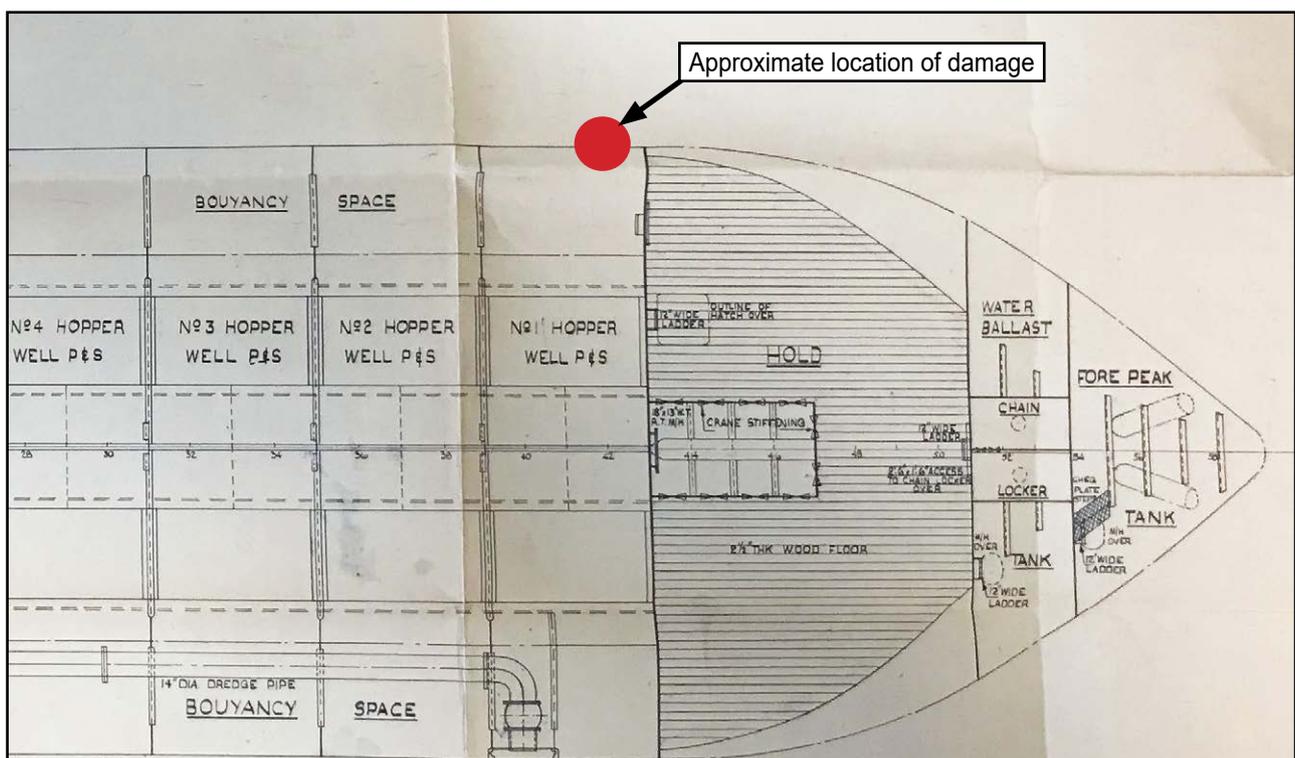
When the crew checked *Shearwater* for damage, water was found entering the port side buoyancy space through damage holes in the shell plating (**Figure 3**).

**Figure 3:** Extract from *Shearwater's* general arrangement showing the approximate location of damage

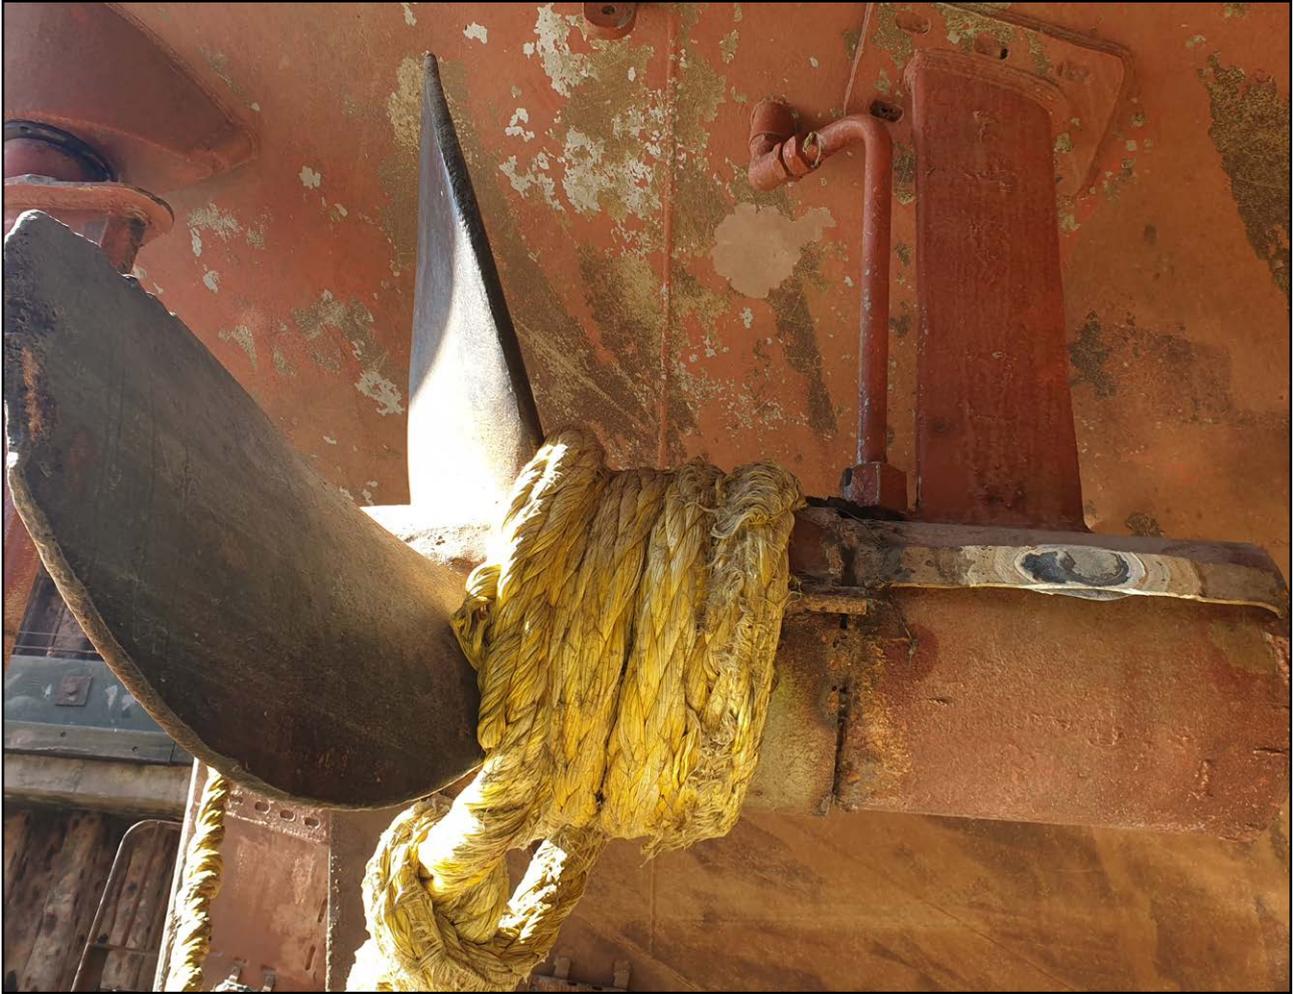
The excavator driver then went to the engine room to assess the situation and found that the port shaft was dislodged from the gearbox and the gearbox's casing was damaged. He went to the bridge and briefed the master and the owner about the damaged propulsion. By this time, the owner and master had seen from the aft deck that the shafts were fouled by the towline.

**Figure 6:** *Shearwater* in dry dock showing the towline around the starboard propeller

Once both shafts were fouled by an extremely strong rope, there was no prospect of restoring propulsion and this became clear after the excavator driver had witnessed the engine room damage. Thereafter, the only safe course of action was to anchor *Shearwater*. This action may have stabilised the situation for the dredger, but it resulted in the collision and flooding when the heavy, sharp-edged barge was out of control. There was little prospect of the crew regaining control of the barge at this point, and further damaging collisions occurred before the barge drifted away and the towline, which was fouling the propellers, parted. With *Shearwater* anchored

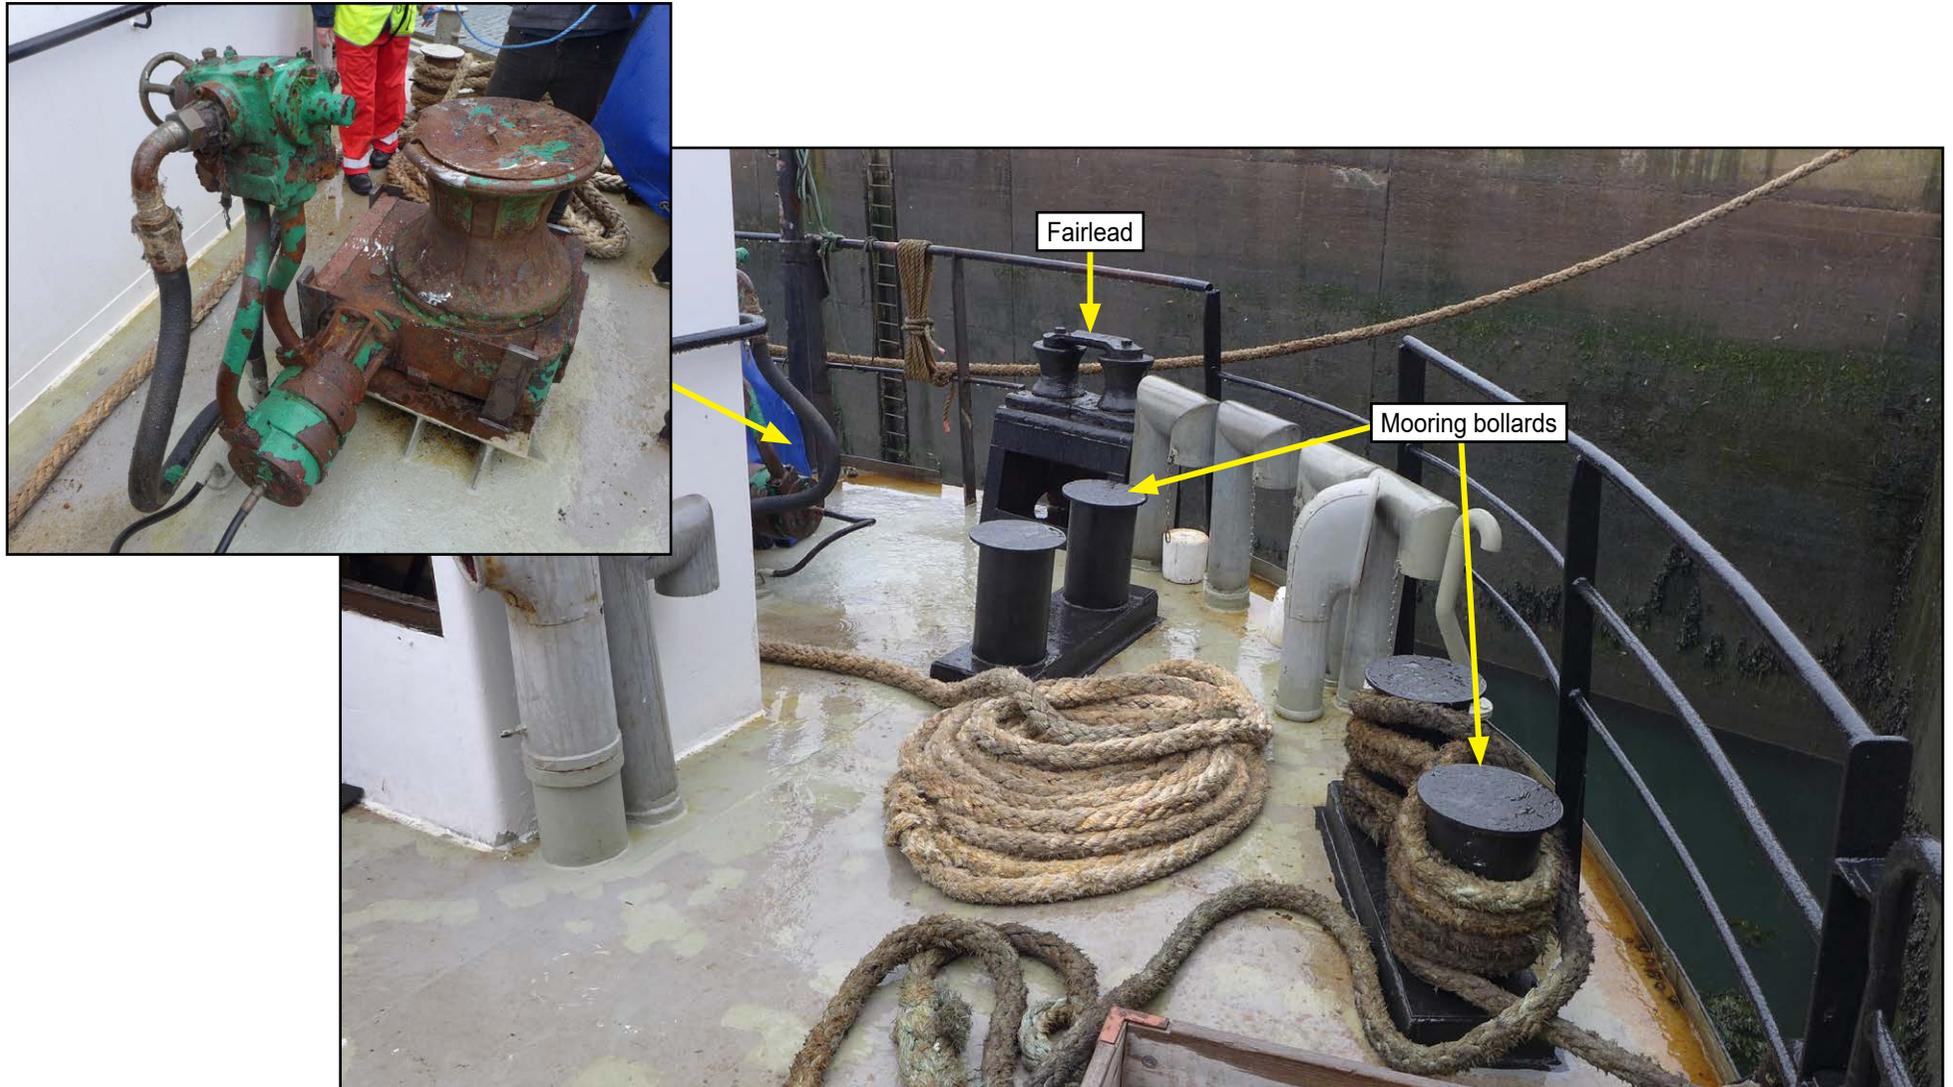
**Figure 7:** *Shearwater's* port side aft deck (looking aft) showing mooring equipment used for towing, with capstan inset

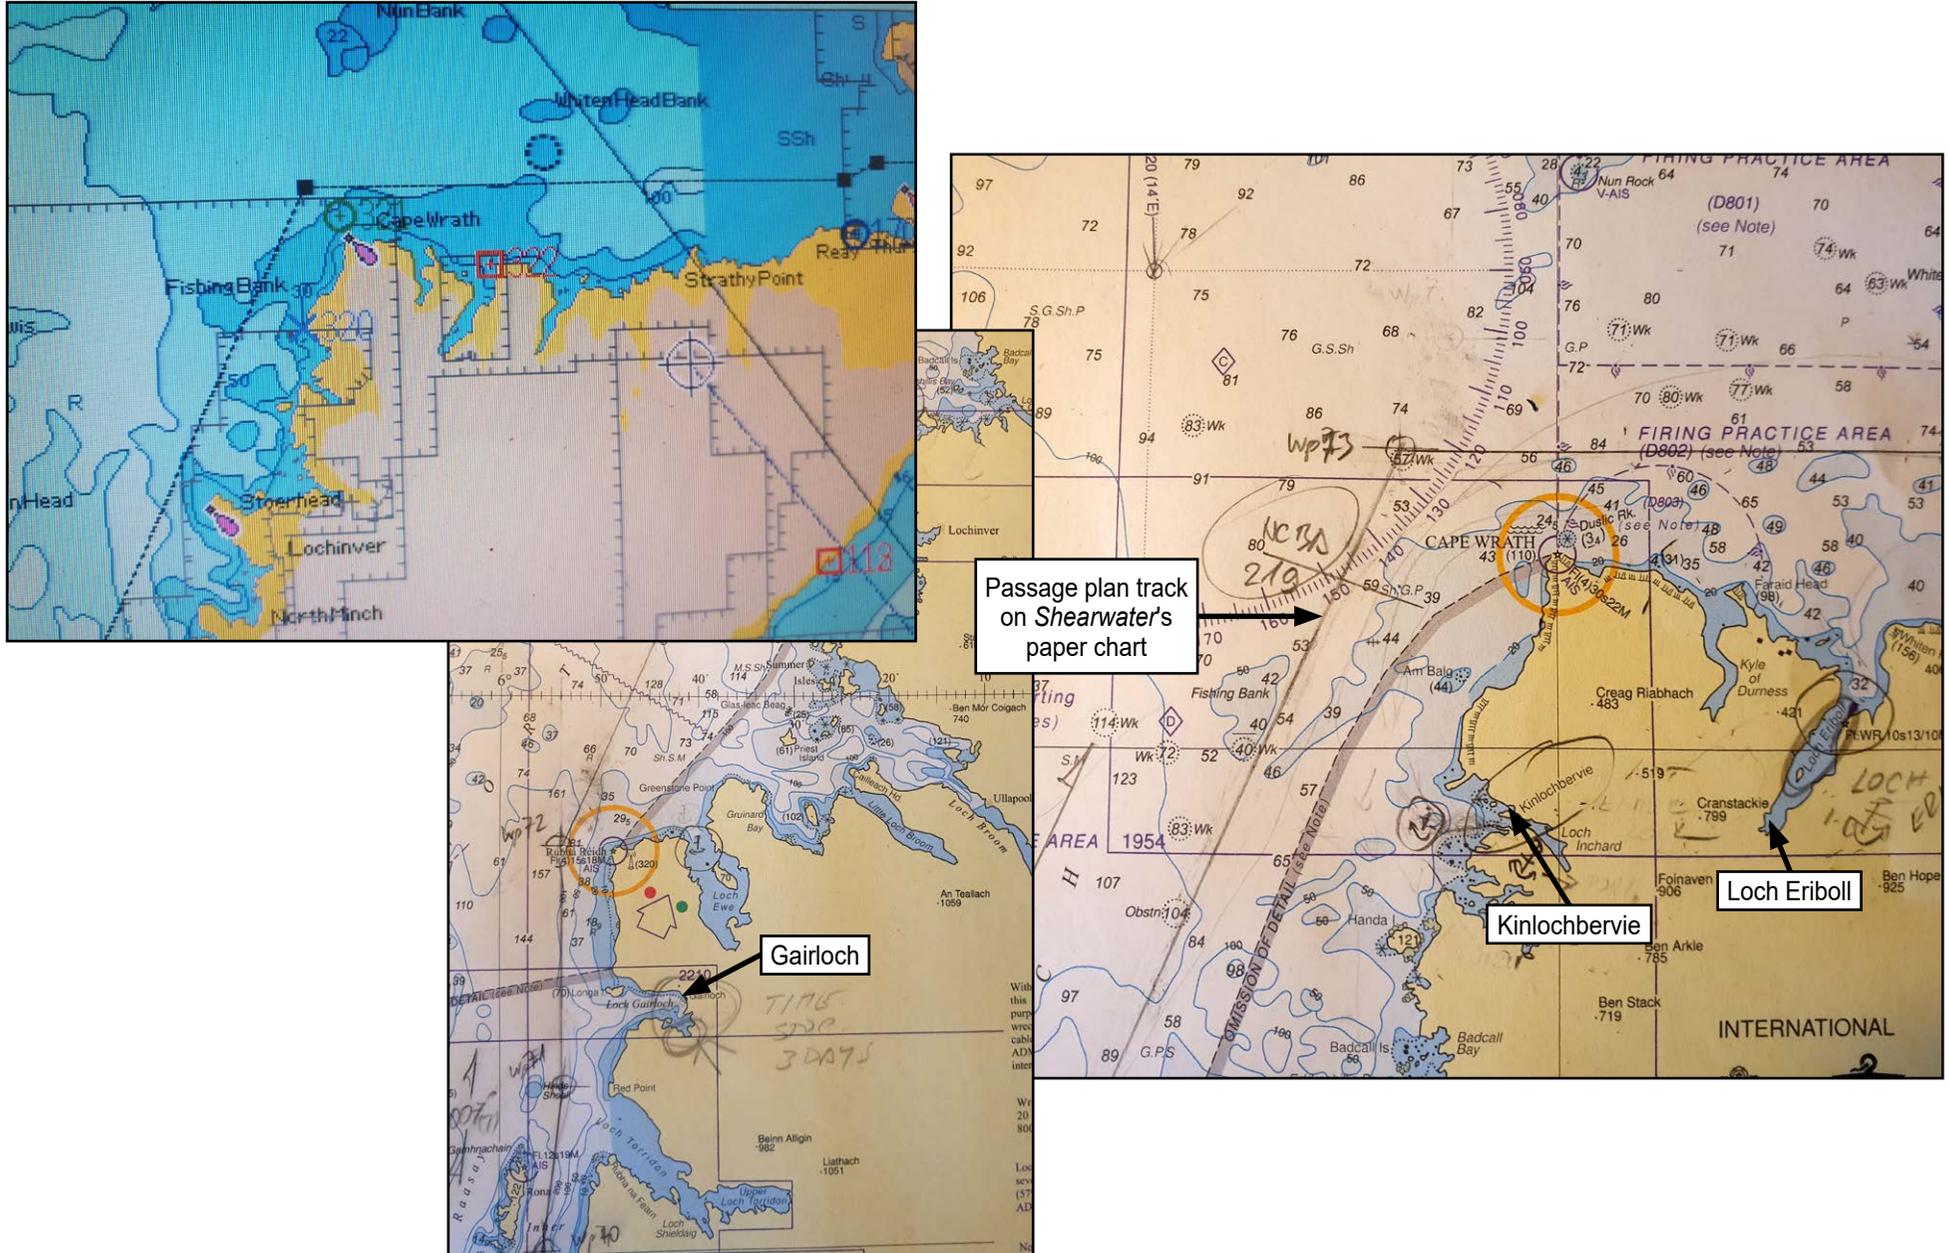
*Shearwater's* primary means of navigation was paper charts. The passage plan on board *Shearwater* consisted of a list of hand written positions with the courses and distances inbetween. There was no information on anticipated navigational hazards, speeds, predicted tidal streams or aids to navigation. The intended route was plotted on a paper chart and replicated on the vessel's electronic charting system (ECS) (**Figure 9**). The master used 4kts as the planning speed for passages towing a barge. Evidence from automatic identification system (AIS) data (**Figures 1 and 2**) indicated that *Shearwater's* passage speeds were between 3kts and 5.2kts.

Figure 9: Images of paper and ECS charts in use and on board Shearwater showing the intended track from the passage plan
