Rail Accident Investigation Branch

Rail Accident Report

**Fatal accident at Waterloo Underground station,
London
26 May 2020**

Report 05/2021
September 2021

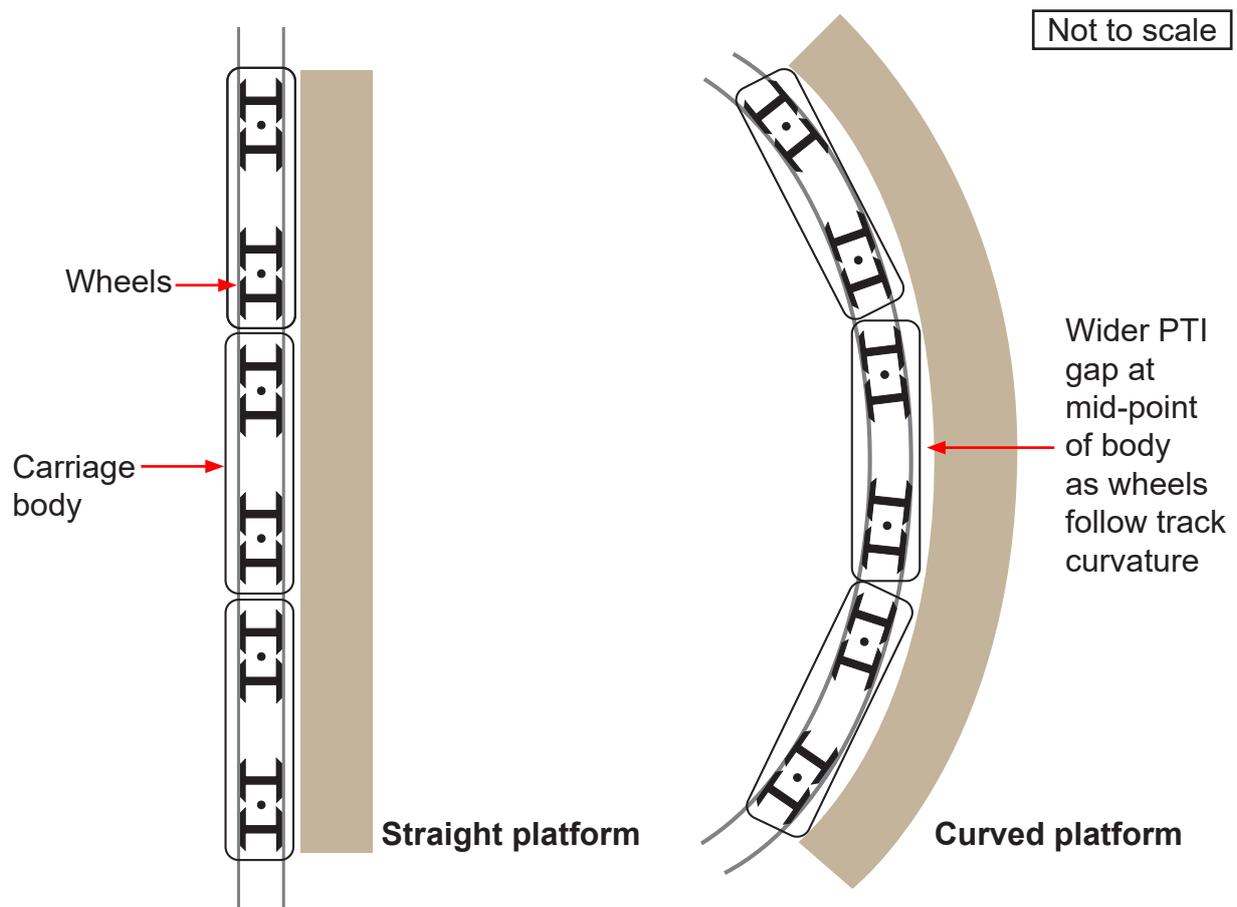
Figure 2: Diagram showing increased gap between the train and platform as a consequence of track curvature

- 6 The railway is tightly curved to the left (in the direction of travel of trains) through the platform, and this results in larger gaps between the platform and the train in some parts of the platform than would be found at a straight platform (figures 2 and 3). A lineside signal on the approach to the station controlled the movement of trains into the platform area and another signal, about 10 metres beyond the departure end of the platform, controlled movements out of the platform towards the next station.

- 36 When the Bakerloo line was constructed at the start of the 20th century, the northbound track alignment through Waterloo station incorporated a tight curve with a radius of between 133 metres and 156 metres. This curve creates a large PTI gap close to the middle of the carriages (figure 6). With a train of this type stationary in the platform, RAIB found the gap to be approximately 264 mm when measured diagonally between the lower corner of the train body and the edge of the platform at the mid-point of the fourth carriage, the area in which the passenger fell (figure 7).

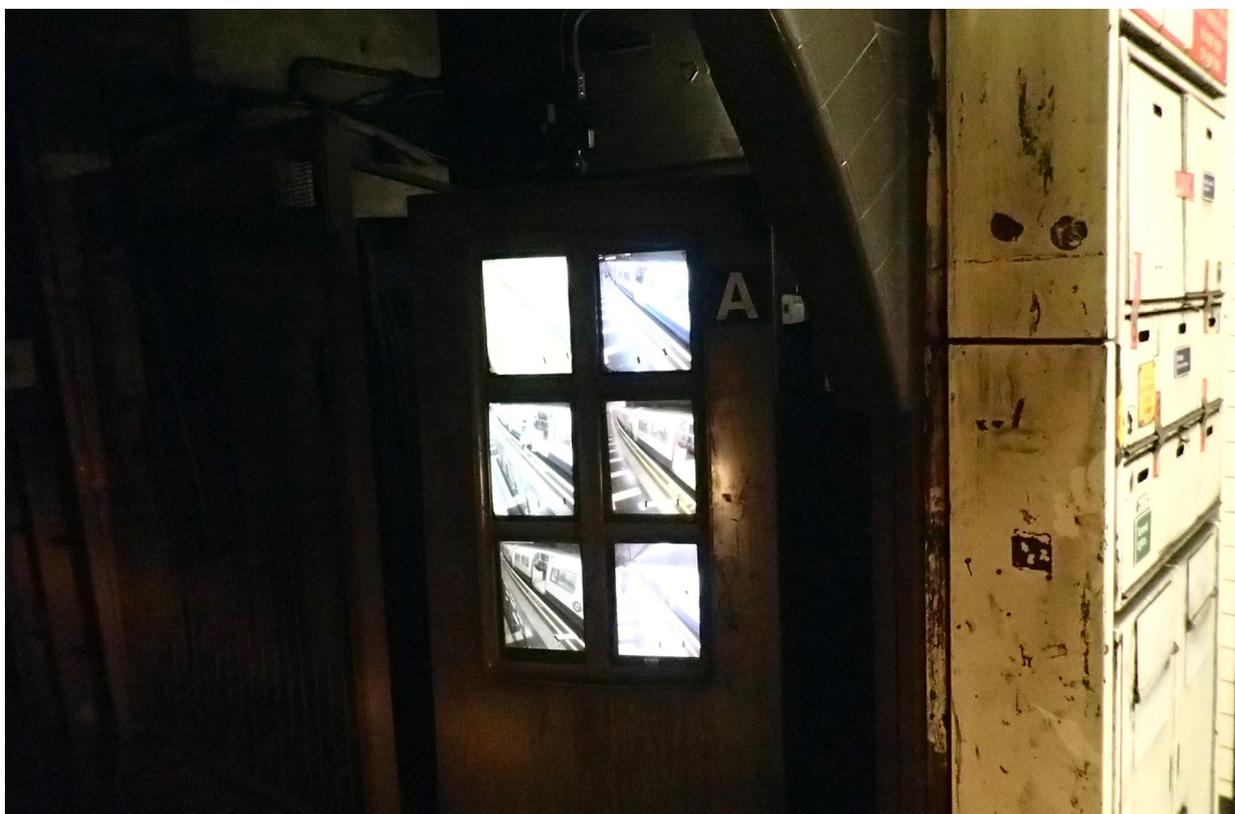
Figure 5: OPO monitors provided inside the tunnel at Waterloo Bakerloo line platform 3

- 47 At Waterloo Bakerloo line platform 3, the six OPO monitors that allow train operators to view the full length of the PTI (paragraph 12) were positioned behind a glass screen approximately 3.2 metres from the train operator's driving position (station CCTV images show that train 210 had stopped in the correct position at the time of the accident). The monitors are inspected each morning to confirm that the cameras are correctly aligned and the images are displayed distinctly. The monitors were checked at 04:55 hrs on the day of the accident and no defects were recorded.

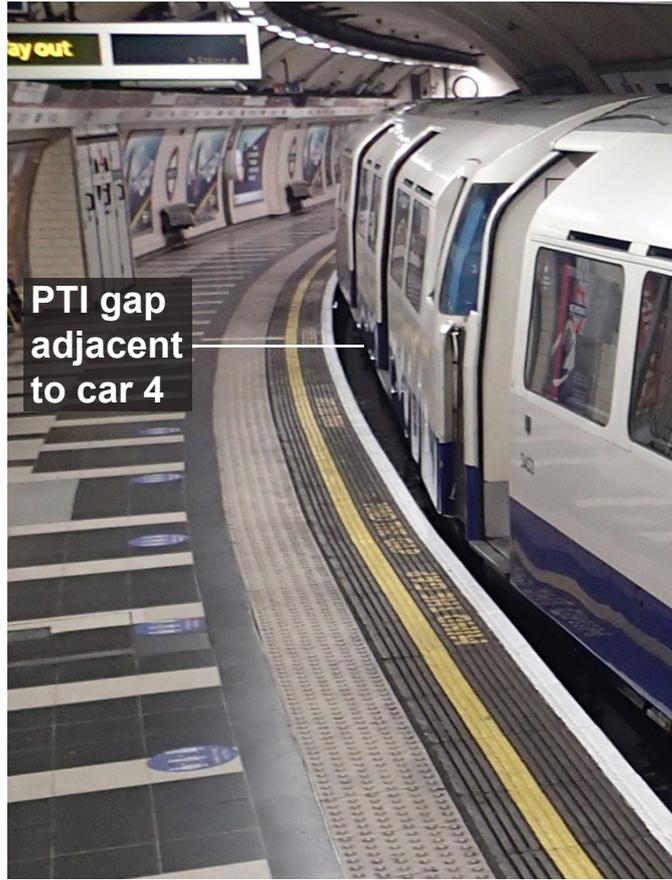
Figure 6: Platform-train interface gap adjacent to carriage 4 at Waterloo Bakerloo line platform 3

- 38 Once in the PTI gap, the passenger was unable to get out. This was probably at least in part because there was limited space between the platform, the train and the track (figure 8). The task could have been made more challenging by pre-existing mobility limitations which were described (by the passenger's family) as being due to previous leg injuries, any injuries sustained in the fall, or a combination of both.

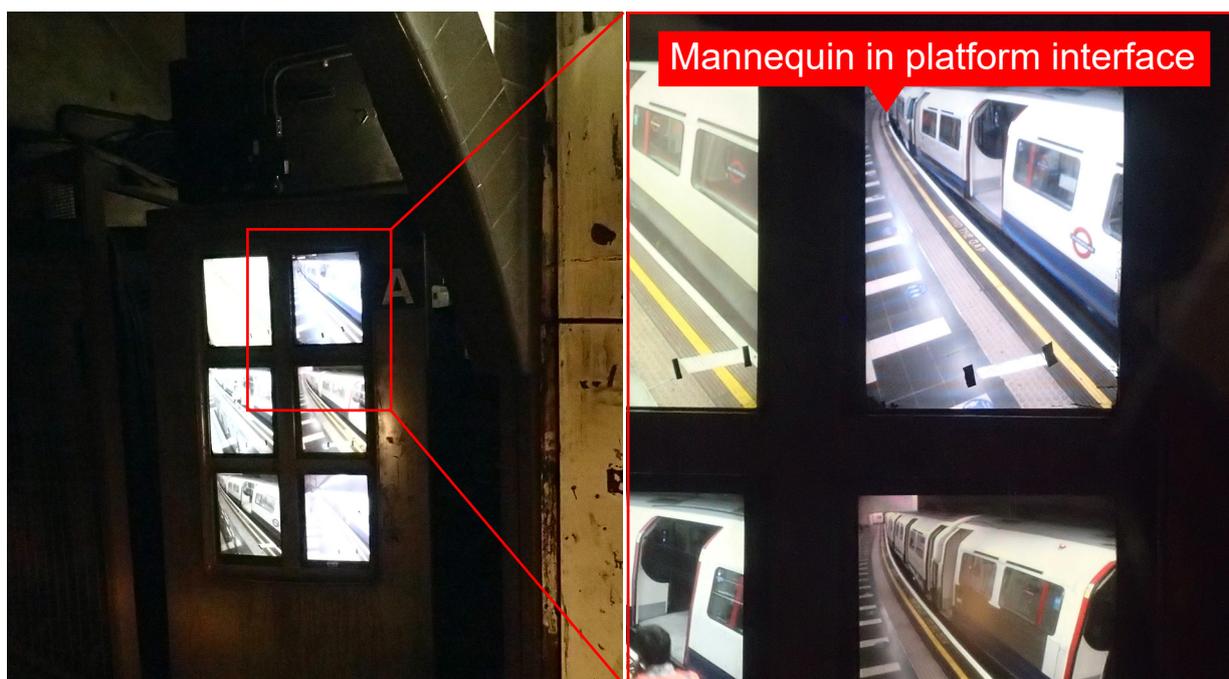
Figure 9: Layout of OPO monitors and position of passenger during despatch adopted by mannequin as would have been presented to operator of train 210 (inset)

- 49 At the time of despatch, the image of the passenger would have been in the top left-hand corner of the top right OPO monitor. The passenger was wearing dark clothes and only his head and arms were above platform level. One of his arms was out across the platform and this arm would have been the only part of his body visible on the OPO monitor. Given these factors, the simulation showed that it would have been very difficult for the train operator to detect the passenger. RAIB photo-edited an OPO monitor image to show there would be little difference in image with and without the passenger's arm and head above the platform (figure 10).

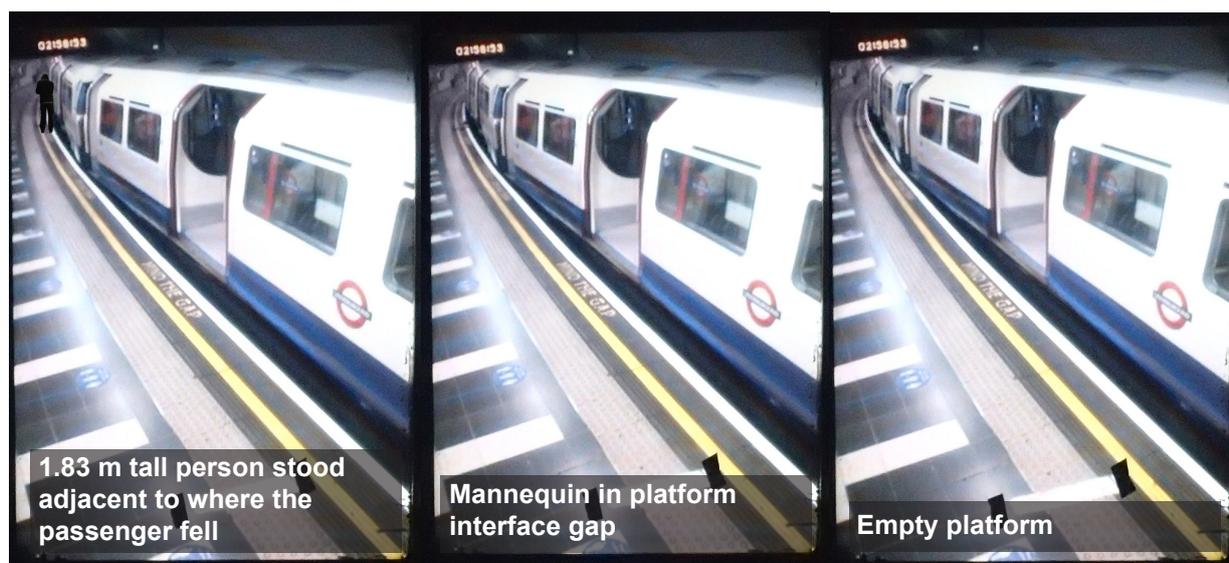
Figure 10: OPO monitor images

- 50 To compare the image seen with only a passenger's arm above the platform, and the image seen when a person is standing on the platform at the same location, RAIB photo-edited an OPO monitor image to show how a 1.83 metres tall person would appear on the OPO monitor. The standing person is considerably more apparent (figure 10). LUL's formal investigation into this fatal accident also found that the OPO monitors, although fit for identifying incidents above platform level, were not suitable for detecting unsafe events in the PTI gap such as those which occurred in this accident.

- 52 RAIB measured the height of the monitor image at Waterloo and found that a 1.83 metres person, at the furthest point from the camera, would appear about 28 mm high and a 1.6 metres person would be about 7.2% of the overall monitor size. LUL has stated that, in accordance with its processes,⁸ new standards are not applied retrospectively unless a safety shortcoming is identified.

- 53 A replacement OPO platform CCTV system, compliant with the 1997 standard (or the 2003 revision), combined with more modern cameras and monitors, would have provided a larger and higher quality image. Although this would have improved the conspicuity of the passenger's arms across the platform white line, it is likely that the passenger's dark-skinned head would have remained difficult to distinguish against the dark background. Given that the image of the passenger's arm(s) would still occupy only a very small fraction of a monitor screen that was located 3.2 metres from the driving position, it is uncertain, but considered unlikely by RAIB, that the train operator would have noticed the presence of the passenger had more modern cameras and monitors been installed in the same positions as the current equipment.

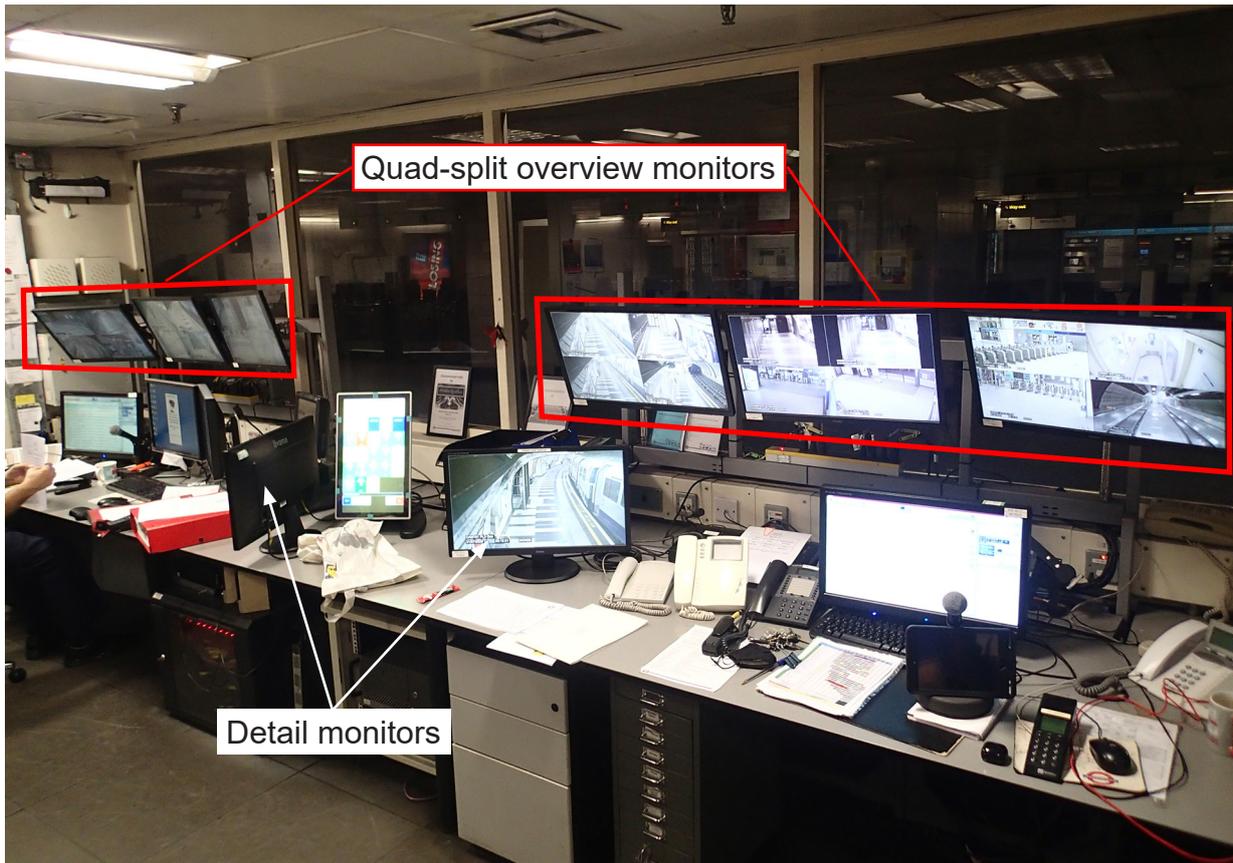
Figure 11: CCTV workstations at Waterloo station control room

- 62 There are two CCTV workstations in the station supervisor's office, each comprising three 'quad-split' overview screens, so each workstation can show twelve images (figure 11). The system is configured such that the image captured by each camera will appear for approximately five seconds in sequence. This automatic refresh sequence can be interrupted by many triggers such as an alarm or fire door being opened, which LUL states is a frequent occurrence. There is also an additional detail monitor at each workstation which can show any one of the camera images at the request of the system operator.

- 63 Camera 181 of the station CCTV system is on Bakerloo line platform 3 and captured the whole accident sequence, including the period between the departure of train 210 and the arrival of train 214. It is probable, but not certain, that part of this sequence was shown on the system monitors, but if so, it is not known if this would have been in time to stop train 210 from departing or to stop train 214 from entering the station area.

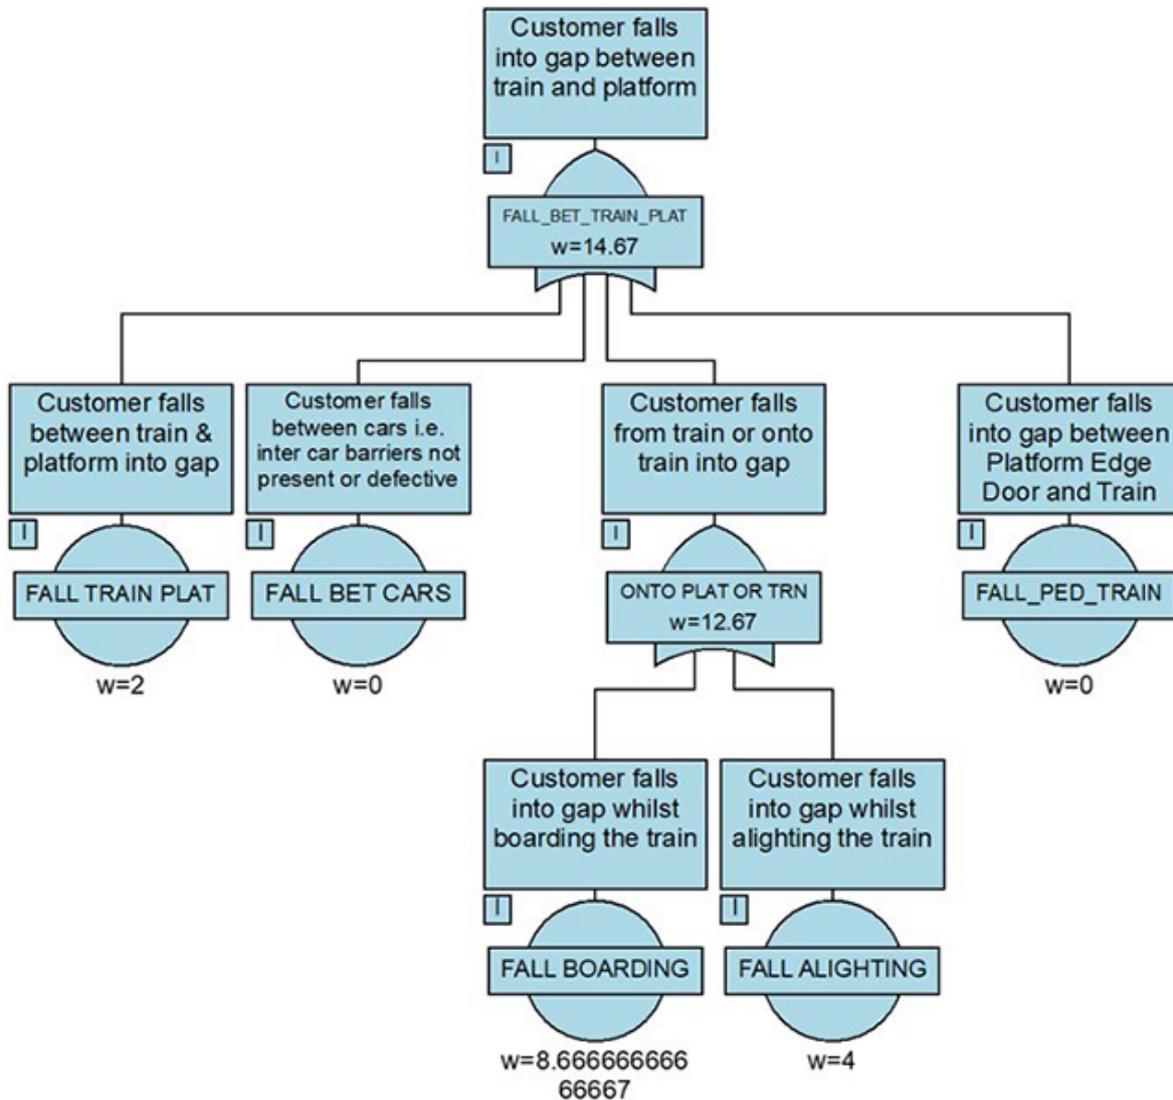
Figure 12: LUQRA fault tree analysis used to calculate likelihood of a fall into the PTI gap on the Bakerloo line

68 Some parts of LUL risk management processes did not take into account the differing levels of risk at different stations when considering the risk of a passenger falling into the PTI gap. Platform markings, lighting within the gap and ‘mind the gap’ announcements are evidence that the particularly large gap caused by platform curvature had been recognised as a risk. However, LUL’s formal risk assessment processes did not identify the gap at curved platforms as a greater risk than at stations with straight platforms and, as a result, these processes would not trigger full consideration of possible mitigation measures.⁹

¹⁰ The type of event which occurred on 26 May 2020 would be described in the fault tree analysis as: ‘customer falls between train and platform into gap while not stepping on or off the train, or where there is insufficient data to determine if the passenger involved was boarding or alighting’.
