**ACCIDENT**

<b>Aircraft Type and Registration:</b>	Head AX8-88B hot air balloon, G-TIMX	
<b>No &amp; Type of Engines:</b>	N/A	
<b>Year of Manufacture:</b>	2008 (Serial no: 384)	
<b>Date &amp; Time (UTC):</b>	20 April 2021 at 0905 hrs	
<b>Location:</b>	Welton, Daventry, Northamptonshire	
<b>Type of Flight:</b>	Private	
<b>Persons on Board:</b>	Crew - 1	Passengers - 2
<b>Injuries:</b>	Crew - None	Passengers - 1 (Serious) 1 (None)
<b>Nature of Damage:</b>	None	
<b>Commander's Licence:</b>	Private Pilot's Licence	
<b>Commander's Age:</b>	32 years	
<b>Commander's Flying Experience:</b>	407 hours (of which 70 were on type) Last 90 days - 4 hours Last 28 days - 4 hours	
<b>Information Source:</b>	Aircraft Accident Report Form submitted by the pilot

**Synopsis**

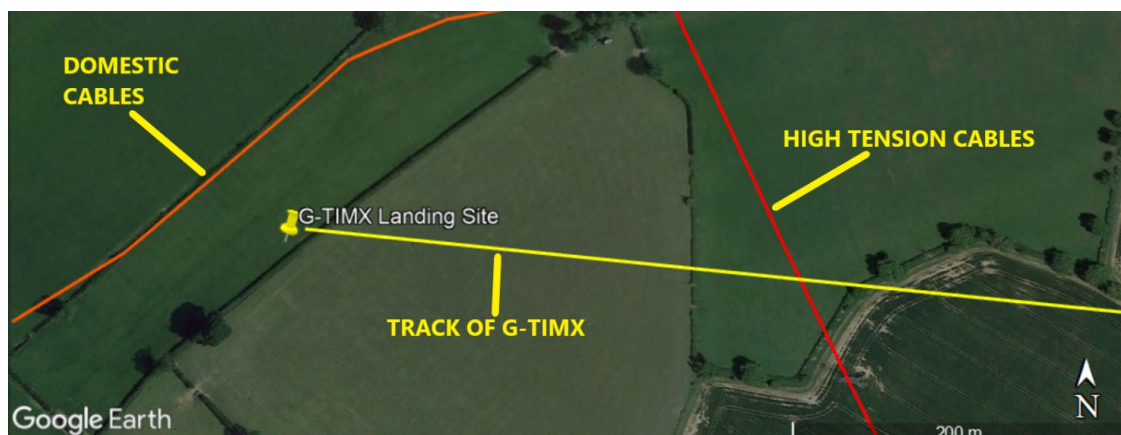
**Figure 2**

Landing site

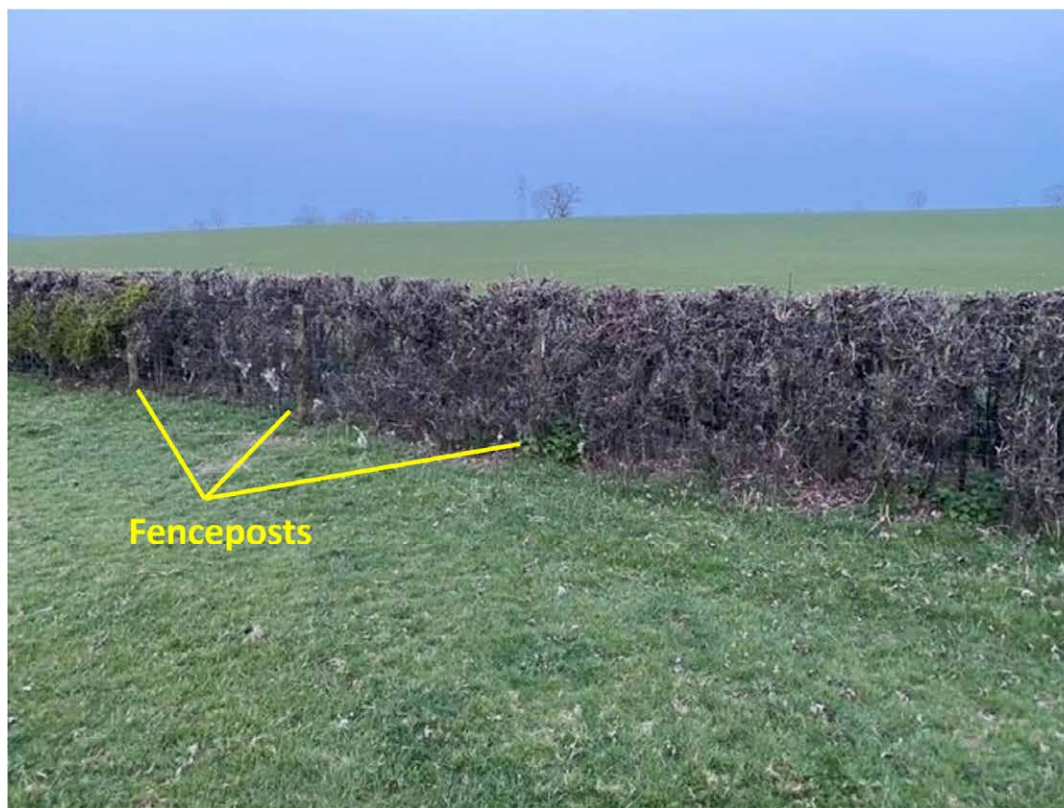
**Figure 3**

After crossing the high-tension cables, the pilot descended to approximately 80 ft agl. His handheld GPS indicated a groundspeed of 8 to 9 kt, which was below the limit for landing. As the balloon approached the chosen landing field the pilot instructed the passengers to adopt the brace position. The eastern side of the landing field is bounded by a hedgerow and the pilot decided to allow the balloon basket to make contact with this to reduce the groundspeed for touchdown. The hedge and landing area are shown in Figure 3, which shows a view looking upwind. There were fence posts embedded in the hedge which were not visible to the pilot.

He reduced the height of the balloon to bring the basket level with the top of the hedge and made contact as he intended. One passenger described the impact with the hedge as “hard” and believed it dislodged her from the brace position. As a result, the passenger did not believe she was in the planned brace position when the basket struck the ground. The wind then carried the balloon past the hedge pulling the basket clear and it dropped approximately one metre into the field. The pilot described the touchdown as a “small bump on the landing which is normal and expected with the wind conditions”. During touchdown the basket fell onto its side and the balloon then deflated normally.

Hedge and fenceposts bordering landing site

It is difficult to assess the hazard posed by the possibility of solid obstructions within a hedge line and so CAA FSO considered that the fast landing technique as described in the BBAC Pilot Training Manual would have been preferable.
