## ACCIDENT

<b>Aircraft Type and Registration:</b>	Rans S6-ES Coyote, G-CCJN	
<b>No &amp; Type of Engines:</b>	1 Rotax 582-48 piston engine	
<b>Year of Manufacture:</b>	2005 (Serial no: PFA 204-13575)	
<b>Date &amp; Time (UTC):</b>	18 October 2020 at 1215 hrs	
<b>Location:</b>	500 m east of Insch airfield, Aberdeenshire	
<b>Type of Flight:</b>	Private	
<b>Persons on Board:</b>	Crew - 1	Passengers - 1
<b>Injuries:</b>	Crew - None	Passengers - None
<b>Nature of Damage:</b>	Collapsed nose landing gear, damaged right landing gear leg and dented engine cowling	
<b>Commander's Licence:</b>	Light Aircraft Pilot's Licence	
<b>Commander's Age:</b>	67 years	
<b>Commander's Flying Experience:</b>	702 hours (of which 1 was on type) Last 90 days - 40 hours Last 28 days - 15 hours	
<b>Information Source:</b>	Aircraft Accident Report Form submitted by the pilot

## Synopsis

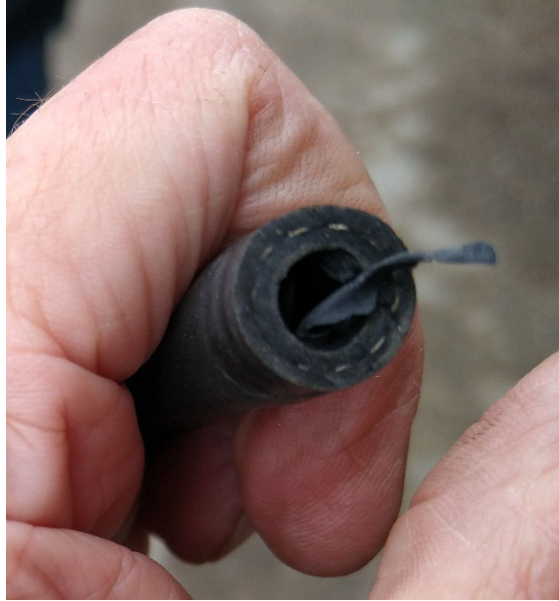
**Figure 2**

To facilitate the recovery of the aircraft from the field the fuel tanks were drained. The combined outlet of the left tank was disconnected but it was found that no fuel would flow from the pipe when the aircraft was in a nose high attitude, even though fuel was visible in the tank. When the aircraft was placed in a level attitude fuel was able to flow from the tank.

Examination of the fuel lines by the owner found a sliver of material within one of the pipes that ran from the combined left tank outlet to the fuel selector valve (Figure 2). It is likely that this obstruction caused the engine to stop in flight.

Sliver of material found in the fuel pipe between the left tank and engine  
(photograph reproduced with permission)

Although an extended engine ground run and power check was completed on the aircraft prior to the flight, carrying out an aircraft fuel flow assessment, such as that detailed in LAA Technical Leaflet TL 2.20– LAA<sup>2</sup> might have identified the restriction. TL 2.20 '*Carrying out a fuel flow check to a pumped fuel system*' provides guidance on ensuring that there is at least 125% of the maximum engine fuel flow through each tank outlet.
