SERIOUS INCIDENT

Aircraft Type and Registration:	Spitfire Mk 26, G-CLKN	
No & Type of Engines:	1 Isuzu 6VE1 piston engine	
Year of Manufacture:	2019 (Serial no: PFA 324-14634)	
Date & Time (UTC):	22 April 2021 at 1455 hrs	
Location:	Brighton Airfield, Brighton, Selby	
Type of Flight:	Private	
Persons on Board:	Crew - 1	Passengers - None
Injuries:	Crew - None	Passengers - N/A
Nature of Damage:	Propeller broken and damage to left wing	
Commander's Licence:	Airline Transport Pilot's Licence	
Commander's Age:	65 years	
Commander's Flying Experience:	22,000 hours (of which 6 were on type) Last 90 days - 24 hours Last 28 days - 15 hours	
Information Source:	Aircraft Accident Report Form submitted by the pilot and further enquiries by the AAIB

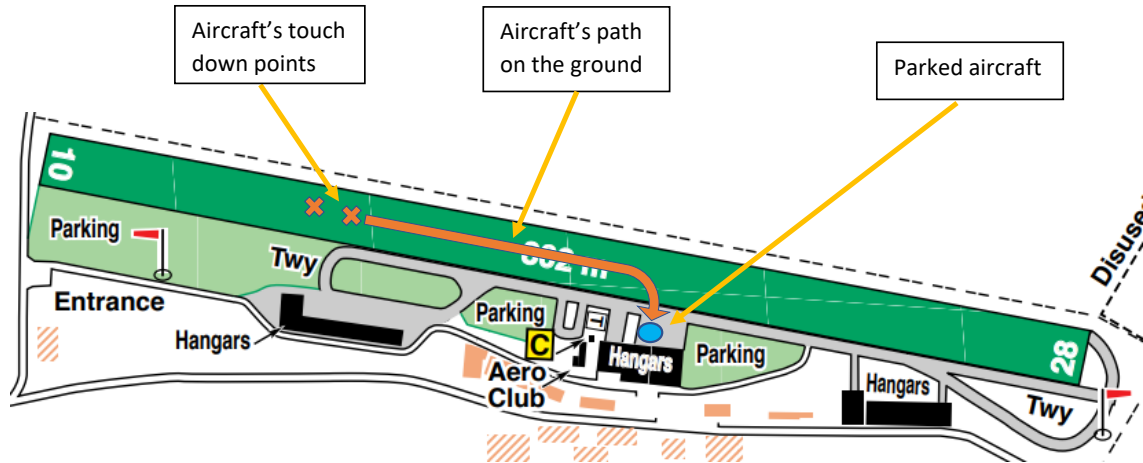
Figure 1

G-CLKN was performing its eleventh test flight since being built, with the purpose of achieving its Permit to Fly¹. The wind was variable at 5 kt. The pilot reported flying an approach to Brighton Airfield's grass Runway 10 at an airspeed of 80 mph, with full flap selected, for a three-point² landing. The aircraft bounced slightly as it touched down on the runway, then settled on all three wheels, initially straight ahead. Around 100 m into its landing roll, it veered right. The pilot applied opposite rudder and brake, and thereafter a "burst of power" (with the intention of increasing the rudder's effectiveness). However, the aircraft left the runway and struck a parked aircraft (Figure 1).

Pilot's description of the incident

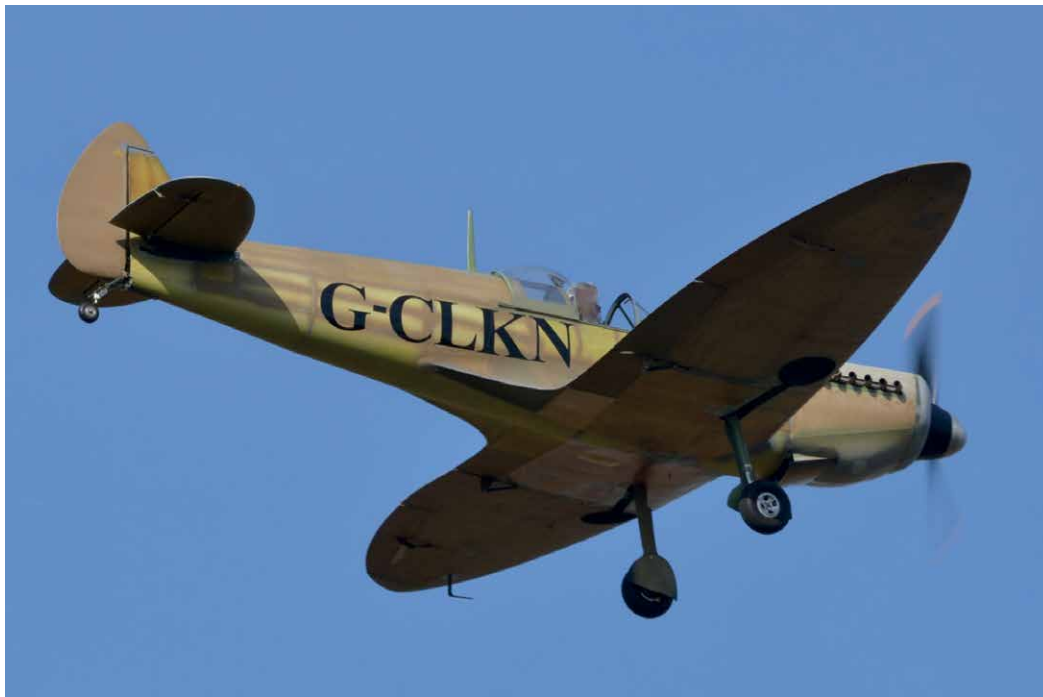
Figure 2

G-CLKN (image used with permission)
