**SERIOUS INCIDENT**

<b>Aircraft Type and Registration:</b>	Airbus A321-251NX, G-UZMI	
<b>No &amp; Type of Engines:</b>	2 CFM International SA LEAP-1A32 turbofan engines	
<b>Year of Manufacture:</b>	2020 (Serial no: 9422)	
<b>Date &amp; Time (UTC):</b>	3 January 2021 at 1450 hrs	
<b>Location:</b>	Bristol Airport	
<b>Type of Flight:</b>	Commercial Air Transport (Passenger)	
<b>Persons on Board:</b>	Crew - 7	Passengers - 58
<b>Injuries:</b>	Crew - None	Passengers - None
<b>Nature of Damage:</b>	None	
<b>Commander's Licence:</b>	Airline Transport Pilot's Licence	
<b>Commander's Age:</b>	40 years	
<b>Commander's Flying Experience:</b>	9,271 hours (of which 9,082 were on type) Last 90 days - 50 hours Last 28 days - 33 hours	
<b>Information Source:</b>	Aircraft Accident Report Form submitted by the pilot and information from the operator

**Synopsis**

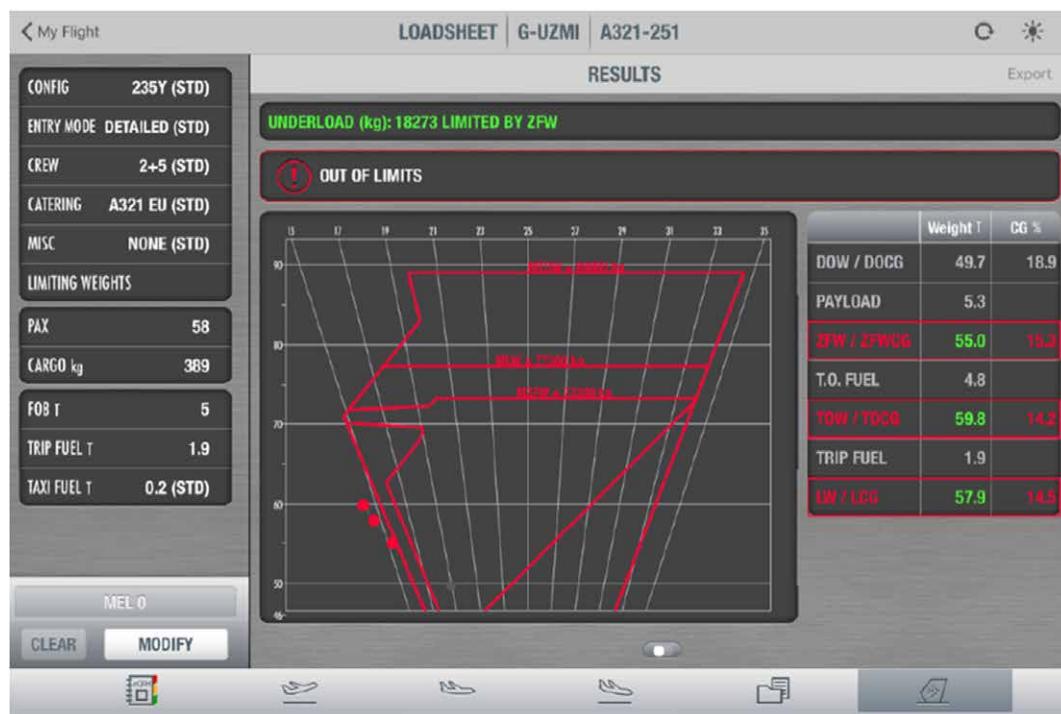
**Figure 1**

Following receipt of the commander's air safety report the operator conducted an investigation and found that, unknown to the crew, the sector from Bristol to Edinburgh had been flown outside of the operational CG envelope<sup>2</sup> (Figure 1). It was concluded that following the change of aircraft type on the day of operation, the aircraft type and registration had been updated on the aircraft management system, but that change had not been identified by the departure control system responsible for generating the information recorded on the LFCs. When the TCO arrived for duty, he was advised by the operations centre that the flight had been changed from an A320 to an A321-NEO. He prepared the LFC with the correct type and registration details. On arrival at the gate, he extracted the load details from the departure control system to complete the

EFB CG data produced in the operator's investigation using correct A321-NEO seating configuration for the Bristol to Edinburgh sector  
(reproduced with permission)
