ACCIDENT

Aircraft Type and Registration:	CAP 232, G-IITC	
No & Type of Engines:	1 Lycoming AEIO-580-B1A piston engine	
Year of Manufacture:	1998 (Serial no: 15)	
Date & Time (UTC):	12 June 2021 at 1220 hrs	
Location:	Wombledon Airfield, North Yorkshire	
Type of Flight:	Private	
Persons on Board:	Crew - 1	Passengers - None
Injuries:	Crew - None	Passengers - N/A
Nature of Damage:	Propeller, landing gear and aileron damaged	
Commander's Licence:	Private Pilot's Licence	
Commander's Age:	36 years	
Commander's Flying Experience:	324 hours (of which 50 were on type) Last 90 days - 18 hours Last 28 days - 7 hours	
Information Source:	Aircraft Accident Report Form submitted by the pilot

Synopsis

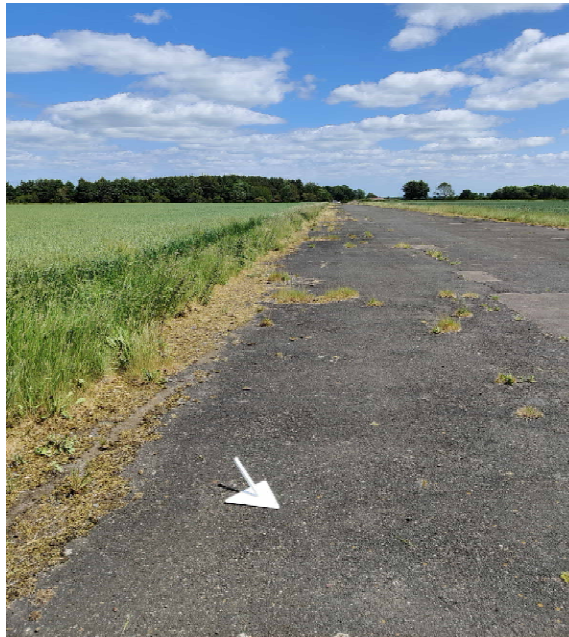
The pilot identified several contributory causes of this accident. The runway is narrow, 15 m wide, and has crops growing at its edges. Figure 1 shows the proximity of the crops. He normally configures the aircraft with a slipstream to improve forward visibility during landing but on this occasion, slipstream was not used. He described how he failed to observe the extent of the drift and when he realised and attempted to correct it, it was too late. He believed that, had he initiated an immediate go-around, it is likely the accident would have been averted.

Proximity of the crop to runway
(the object on the runway is a detached aileron spade)
