## Accident

| <b>Aircraft Type and Registration:</b> | Quik GTR, G-CHWO | |
| <b>Location:</b> | North of Cooling, Kent | |

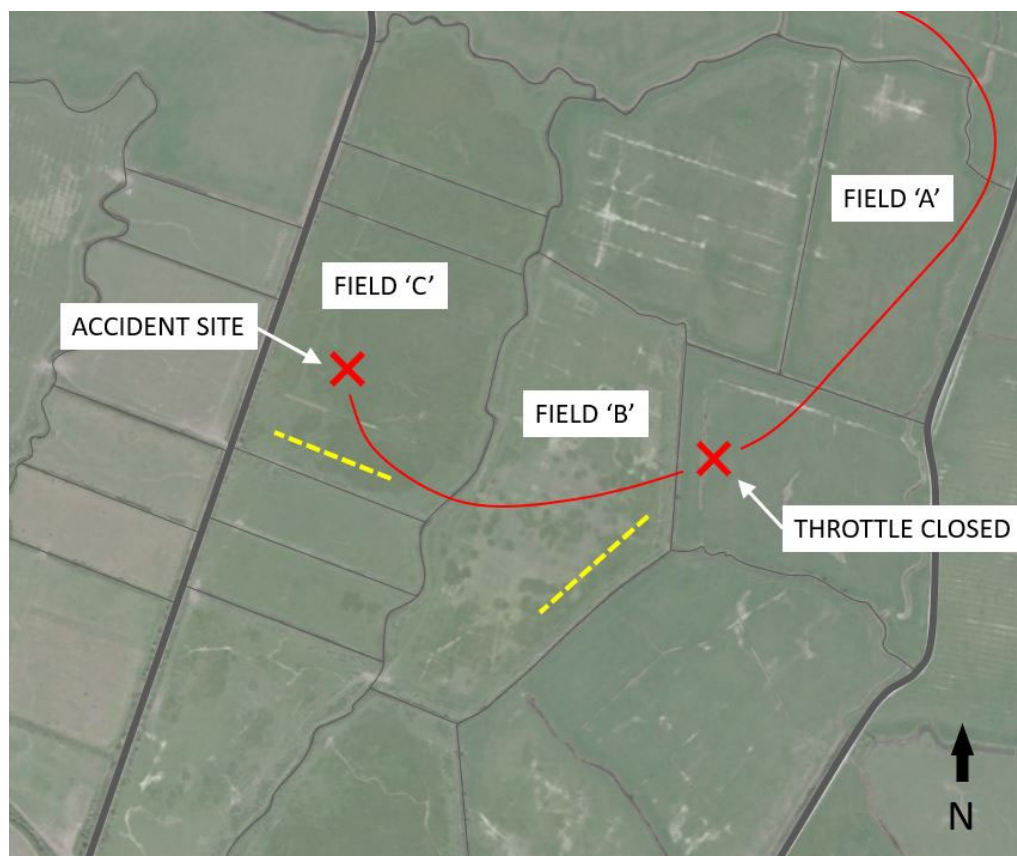
**Figure 1**

The commander was carrying out a general skills test with a student, which included performing a practice forced landing (PFL) in an area of open fields 0.6 nm north of Cooling, Kent. The student successfully flew a constant-aspect<sup>1</sup> PFL from 1,400 ft agl into Field A (Figure 1). At a height of approximately 250 ft during the climb-out the commander told the student "Close the throttle, the engine has stopped", simulating an engine failure after takeoff. The commander expected the student to promptly lower the nose and make an approach to Field B, which was directly ahead, however the student did not lower the nose decisively and entered a right turn towards Field C.

Reported accident flight path, with the commander's expectation of the student's approach paths to Fields B and C marked in yellow (image © 2021 Google)

The commander expected the student to roll out of the turn to approach Field C, parallel to the boundary fence, but the student continued to turn right and descend. The commander opened the throttle but there was insufficient time to prevent the right mainwheel contacting tall grass and the aircraft ground-looped in the field. The commander and student received minor injuries and the aircraft was damaged beyond economic repair.
