Report on the investigation of
the capsizing of the motor cruiser

Norma G

in the Camel Estuary, north Cornwall, England

on 25 May 2020

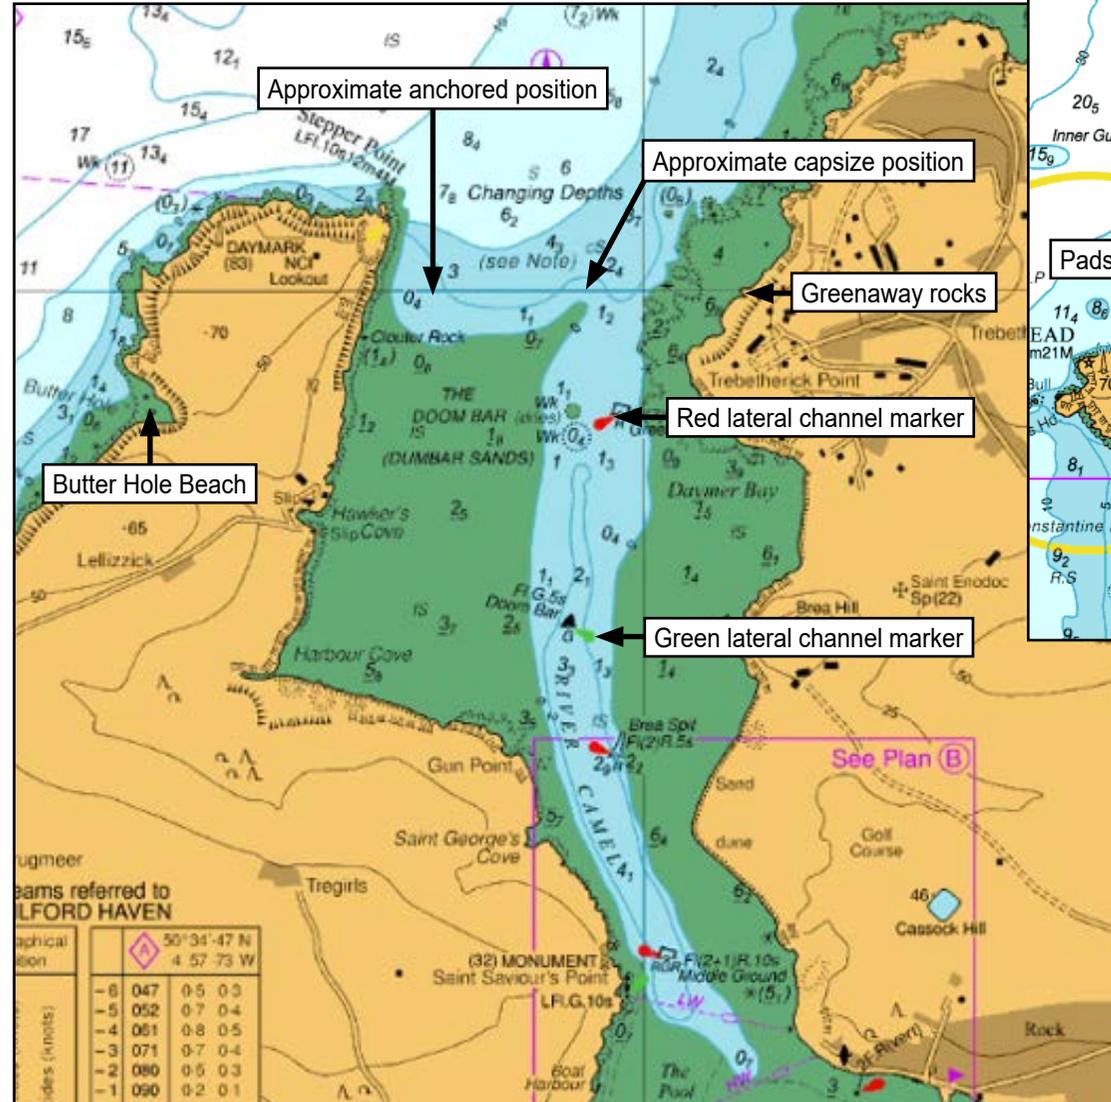
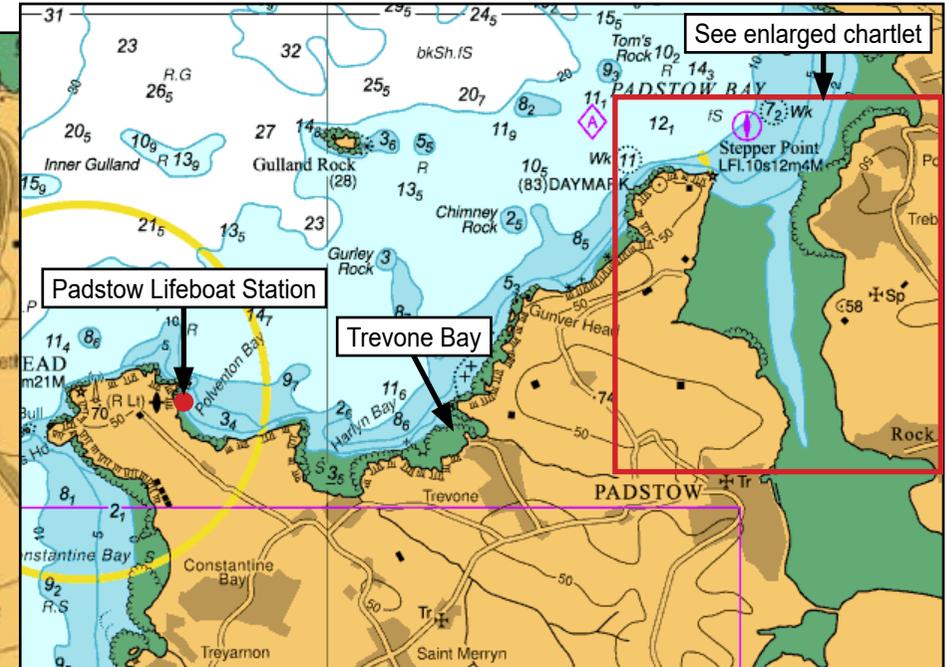
Figure 2: Extract from UKHO Admiralty Chart 1168, showing approaches to Padstow and (inset) chart extract 1156, showing Padstow Lifeboat Station and accident location

- The United Kingdom Hydrographic Office (UKHO) Admiralty Chart 1168 (**Figure 2**) and the Padstow harbour port passage plan (**Figure 7**) differed significantly in respect to showing the limits of the Doom Bar and the depths in the approach channel.
- On the Padstow harbour port passage plan (**Figure 7**) the Doom Bar was shown as the green 'drying' area to the west of the approach channel, yet the label referring to the hazards across the bar, which was also titled Doom Bar, pointed to east of the approach channel.
- The WBC new member chart (**Annex A**) made no mention of the hazards at the harbour entrance.

Notwithstanding the advice in numerous publications and on the PHC website for mariners not to attempt an entrance to the estuary in certain conditions of tide and swell, there could be benefits to marking the north-east corner of the Doom Bar (Dunbar Sands). To the east of such a mark, vessels entering would be following the port passage plan into the deeper water of the River Camel, whereas to the west of the mark they would be heading into shallowing water over the Dunbar Sands.

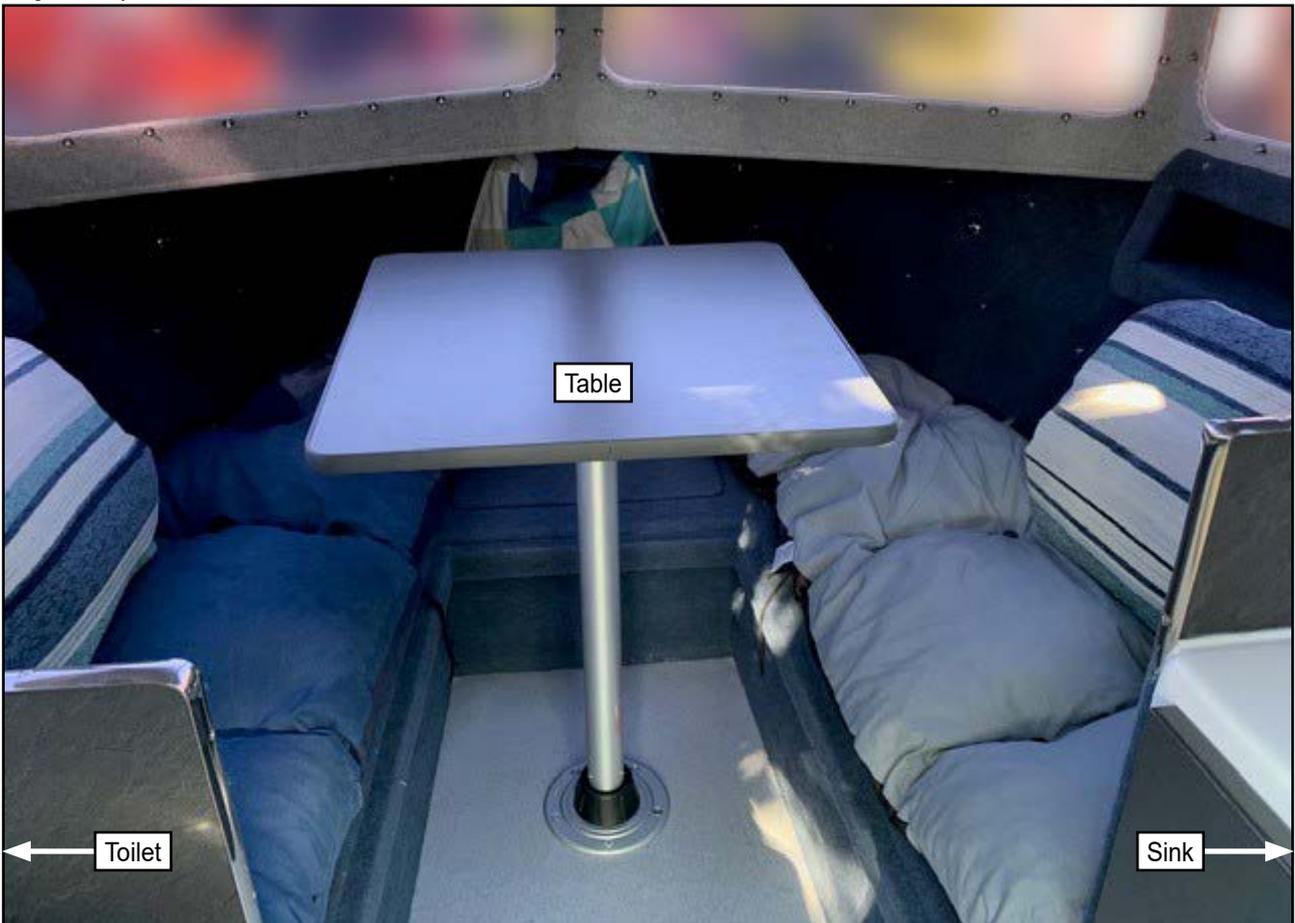
Figure 3: Inside *Norma G's* cabin

The owner and his son started fishing, while his wife and daughter went into the cabin to do some crafting. Once inside the cabin, both women removed their lifejackets and placed them on the seats next to them (**Figure 3**). After about 20 minutes of fishing, the owner decided to refill the main petrol fuel tank using an additional container carried on board. The vapours from the petrol, coupled with the boat's movement, made his daughter feel unwell in the cabin. Because of this, the owner decided to stop fishing and return to the River Camel to have lunch.

owner's wife was able to remove her lifejacket and swim down and out through the cabin door, surfacing next to the boat. Her daughter remained trapped in the cabin in the air pocket towards the bow; she was being kept afloat by her inflated lifejacket and was banging on the boat's hull.

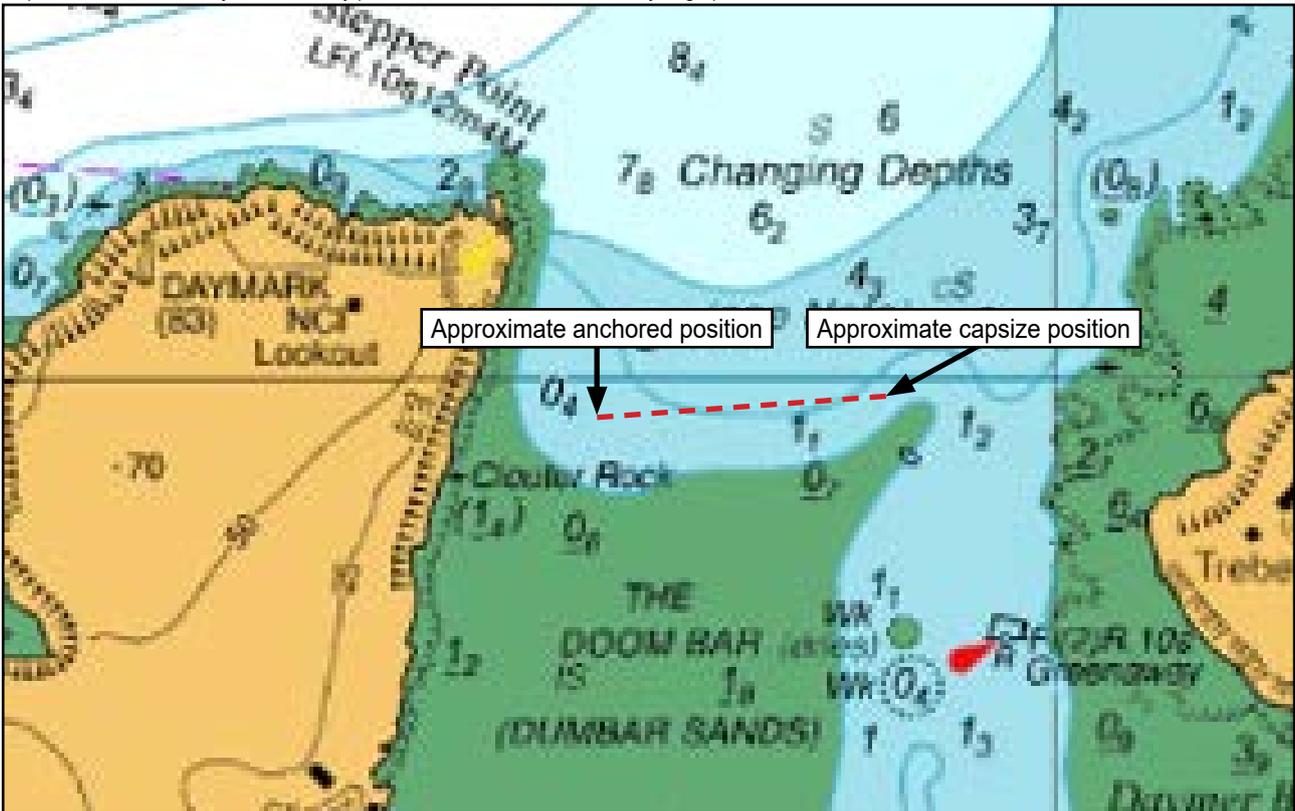
Figure 4: Extract from UKHO Admiralty Chart 1168 – track from anchored position to approximate capsizing position

After about one minute motoring eastwards, *Norma G* neared the end of the Doom Bar (**Figure 4**) and the owner started to make a turn to starboard to enter the channel. As he did so, he looked behind and saw a large steep wave rapidly approaching. He shouted a warning but, before he could increase speed or change direction, the wave picked up *Norma G*'s stern, broke onto the deck, and caused the boat to capsize. The owner and his son were thrown clear of the boat, but his wife and daughter became trapped in the forward cabin. Both women were tossed about in the cabin as the boat was hit by successive waves. They each grabbed their lifejackets and put them on. As further waves hit the boat, it sank by the stern, leaving the bow afloat. As the cabin filled with water, an air pocket remained in the bow, debris floated all around the cabin, and the owner's wife was hit by and trapped under the dislodged cabin table. Both of the women's lifejackets automatically inflated as the boat was tossed about. Although she had ingested a lot of water, the

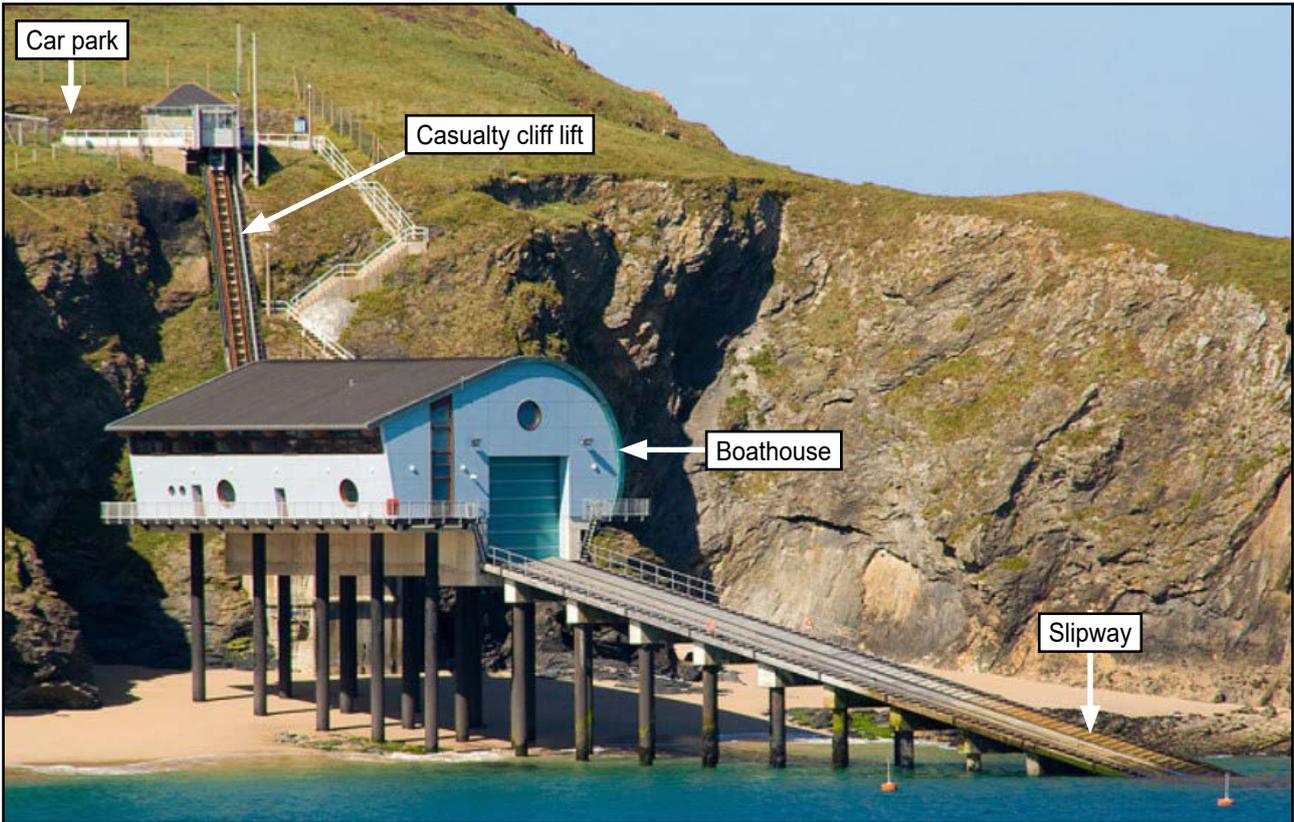
Figure 5: Padstow Lifeboat Station

D-class lifeboats had landed casualties at the Padstow Lifeboat Station slipway on previous occasions, but they had always been able to make their own way out of the boathouse and into the casualty cliff lift (**Figure 5**). It was not envisaged that an unconscious casualty on a stretcher would be landed to the slipway and need to be carried up the three flights of stairs to access the lift. There were no facilities to lift Gillian out of the boathouse that avoided use of the stairs, and her precarious medical condition required the paramedics to restabilise her before she was carried up each stair level. As a consequence, it took nearly two hours to transfer Gillian to the air ambulance while maintaining her in a stable condition.

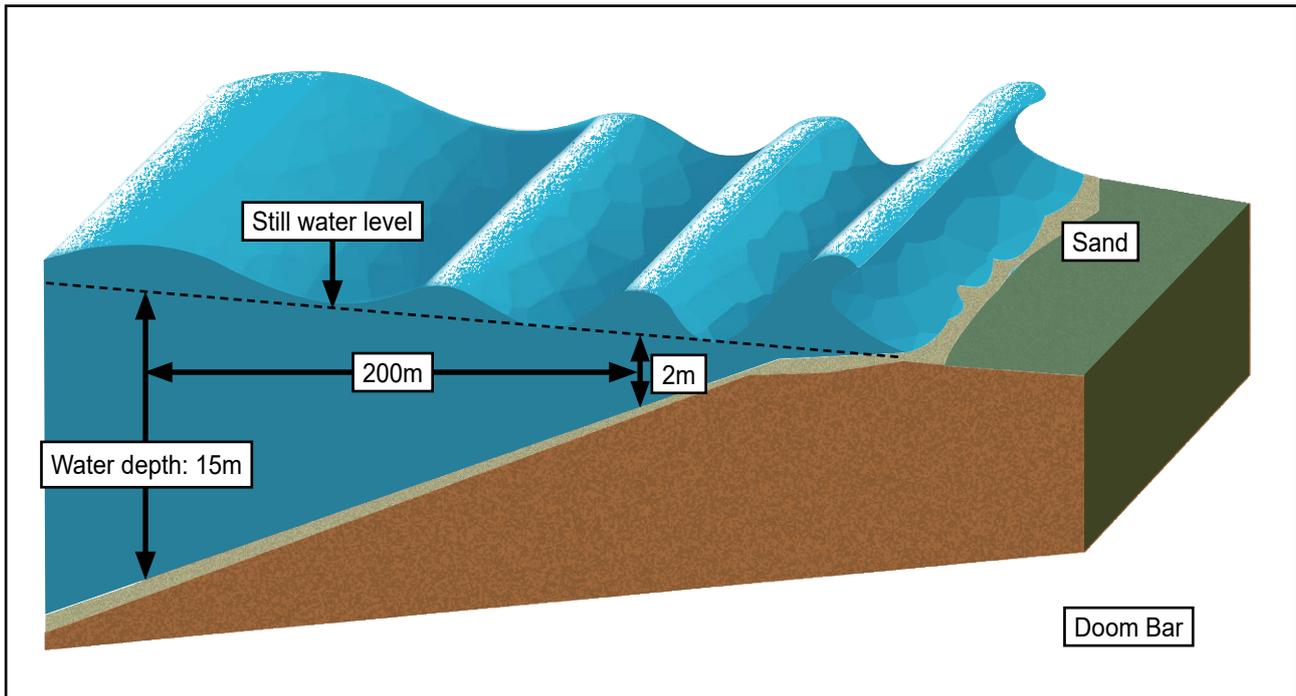
Figure 6: Change of wave dynamics due to shallowing of the water depth

to less than 2m over a 200m distance. The long ocean swell reaches the estuary and as the water depth reduces the wave period shortens, and each wave steepens, grows in height, and has a near vertical face before breaking (**Figure 6**).

The swell forecast on the day of the accident was between 1.5m and 2m in height from a west-north-west direction. A local wave buoy measured the significant wave height¹ at the time of the accident to be 1.5m, with a wavelength of about 150m from peak to peak, and a maximum wave height of 3m was recorded.
