ACCIDENT

Aircraft Type and Registration:	Corby CJ-1 Starlet, G-CBHP	
No & Type of Engines:	1 Jabiru 2200A piston engine	
Year of Manufacture:	2005 (Serial no: PFA 134-12498)	
Date & Time (UTC):	2 July 2021 at 1605 hrs	
Location:	Bluebutts Farm, Slaidburn, Lancashire	
Type of Flight:	Private	
Persons on Board:	Crew - 1	Passengers - None
Injuries:	Crew - 1 (Serious)	Passengers - N/A
Nature of Damage:	Beyond economic repair	
Commander's Licence:	Private Pilot's Licence	
Commander's Age:	81 years	
Commander's Flying Experience:	1,141 hours (of which 332 were on type) Last 90 days - 2 hours Last 28 days - 2 hours	
Information Source:	Aircraft Accident Report Form submitted by the pilot

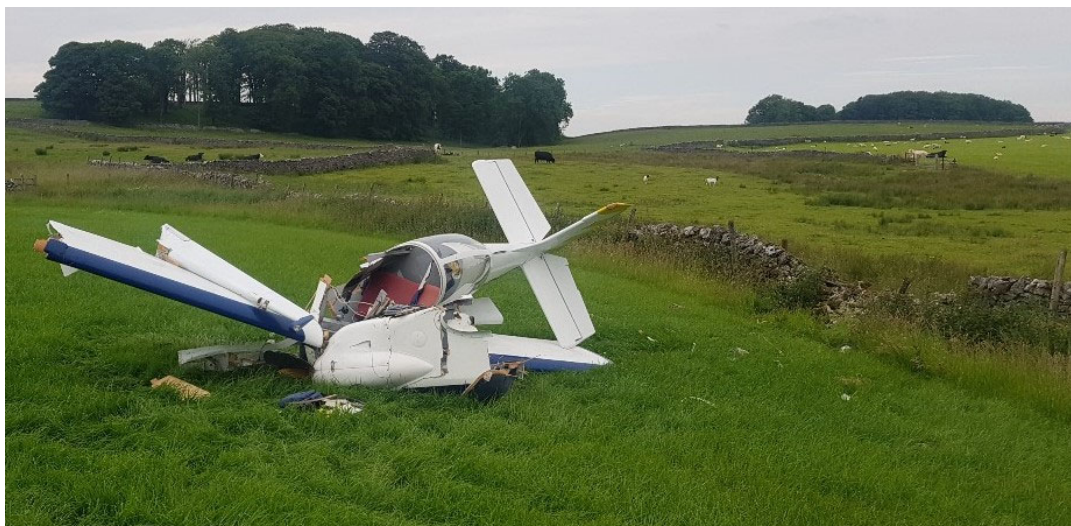
Figure 1

The pilot reported that the aircraft encountered sinking turbulent air very late on finals. The pilot added full power but the aircraft struck a boundary wall causing significant damage to the aircraft and serious injuries to the pilot.

The pilot assessed the cause of the accident as sinking turbulent air encountered very late on finals.

Accident site and damaged boundary wall shown on the right
