ACCIDENT

Aircraft Type and Registration:	Grob G109, G-CLIA	
No & Type of Engines:	1 Limbach L 2000-EB1AA piston engine	
Year of Manufacture:	1982 (Serial no: 6108)	
Date & Time (UTC):	28 May 2021 at 1630 hrs	
Location:	Husbands Bosworth, Leicester	
Type of Flight:	Private	
Persons on Board:	Crew - 1	Passengers - 1
Injuries:	Crew - None	Passengers - None
Nature of Damage:	Extensive damage. The starboard wing and fuselage broke in two, the left wing broke but remained attached. Propeller damaged	
Commander's Licence:	Private Pilot's Licence	
Commander's Age:	59 years	
Commander's Flying Experience:	169 hours (of which 38 were on type) Last 90 days - 5 hours Last 28 days - 5 hours	
Information Source:	Aircraft Accident Report Form submitted by the pilot

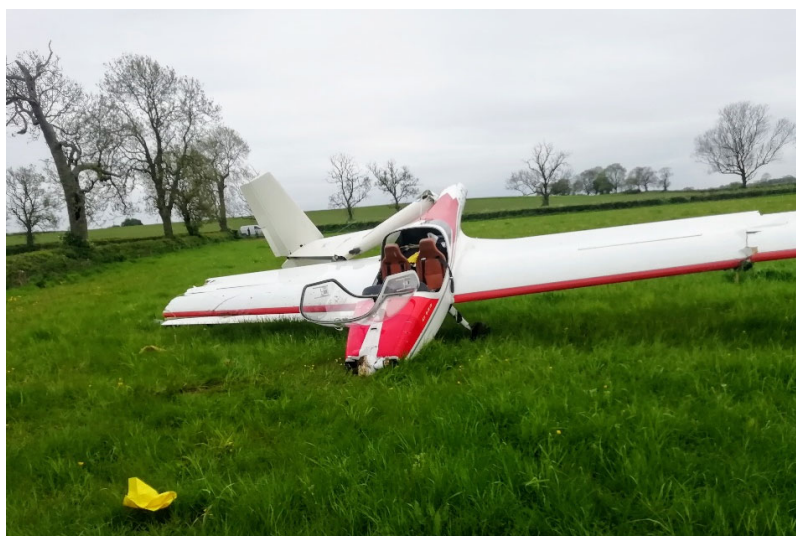
The pilot described the aircraft as sluggish on the takeoff roll and, as the aircraft approached the half-way point of the runway, he checked that the airbrakes were stowed, and the rpm was within normal limits as he was expecting to be airborne by this point. Seeing the yellow winch caravan at the end of the runway approaching, the pilot called out his intentions to abort the takeoff and stop. The passenger in the right seat, then called out that he had control and the pilot let go of the controls. Shortly afterwards the aircraft became airborne, although it was immediately clear that it was not climbing away as expected. The aircraft reached approximately 100 ft agl before beginning to descend. The pilot called to the passenger, who was now flying the aircraft, that there was a suitable field to their left. The aircraft banked left but struck a tree with the right wing as it descended. It turned through 180° before pitching down and striking the ground nose first. The canopy flew open and forward, and both occupants were able to vacate the aircraft without injury. The aircraft was extensively damaged. Figure 1 shows it in its final position.

G-CLIA after the accident (used with permission)

The propeller and hub were removed from the aircraft and examined by the AAIB. The examination of the pitch control guides within the hub showed damage that was consistent with the propeller being in coarse pitch when it struck the ground.

Examination of the propeller and hub showed that the propeller was in coarse pitch when it struck the ground. Given the deficiency in takeoff performance demonstrated by the long takeoff roll and the inability of the aircraft to climb away, it was considered that the takeoff was attempted with the propeller in coarse pitch. Although the pilot in command recalled completing the engine start and post start checks from the checklist, the position of the propeller was not picked up. Due to a glider on finals, the pilot did not perform the

Using a decision point on the runway would have given both occupants a good understanding of where it was possible to abort the takeoff rather than continue with insufficient performance. Discussions amongst pilots before the flight can also ensure that should an emergency or unexpected event occur, both pilots know what their roles are to be and what responsibilities they have in controlling the aircraft.
