ACCIDENT

Aircraft Type and Registration:	Robinson R44 II, G-OPDG
No & Type of Engines:	1 Lycoming IO-540-AE1A5 piston engine
Year of Manufacture:	2007 (Serial no: 11815)
Date & Time (UTC):	22 July 2021 at 2025 hrs
Location:	Maghera, County Londonderry
Type of Flight:	Private
Persons on Board:	Crew - 1 Passengers - None
Injuries:	Crew - None Passengers - N/A
Nature of Damage:	Damaged beyond economic repair
Commander's Licence:	Private Pilot's Licence
Commander's Age:	34 years
Commander's Flying Experience:	79 hours (of which 18 were on type) Last 90 days - 10 hours Last 28 days - 4 hours
Information Source:	Aircraft Accident Report Form submitted by the pilot

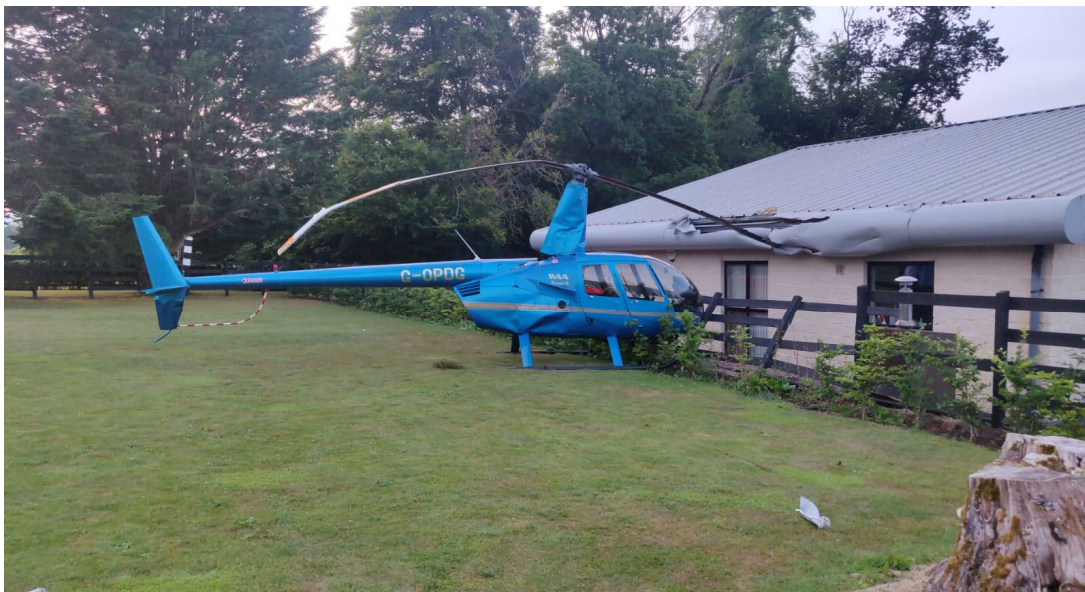
Figure 1
The accident site

The pilot was considering purchasing G-OPDG and had arranged to fly it from its owner's private site near Dromore, to another private site at Maghera, where he intended to further evaluate the helicopter. The landing area was a grassed area measuring about 30 m x 30 m and was surrounded by a wooden fence of about 1.5 m in height, with an adjacent low rise building. Near one corner of the grassed area was a large tree stump. The landing area is shown in Figure 1. The pilot had previously landed at the site in a Robinson R22.

As the helicopter touched down, its tail boom hit the adjacent fence, and the helicopter yawed right, turning it towards the adjacent building, which the main rotors subsequently struck before the helicopter came to a stop. The pilot, who was uninjured, shutdown the helicopter. The helicopter was damaged beyond economic repair.

Although the pilot had landed uneventfully at the same location before, the site had a number of obstacles which increased the risk of contact with the helicopter if a problem was encountered when close to the ground. The pilot stated that that he would look to reduce this risk in the future by reviewing his landing site selection criteria.
