Published 11 November 2021

<b>Aircraft Type and Registration:</b>	Bell 407, N120HH	
<b>No &amp; Type of Engines:</b>	1 Rolls-Royce M250-C47B turboshaft engine	
<b>Year of Manufacture:</b>	2005 (Serial no: 53661)	
<b>Date &amp; Time (UTC):</b>	24 June 2020 at 1219 hrs	
<b>Location:</b>	Long Marston, Stratford-upon-Avon, Warwickshire	
<b>Type of Flight:</b>	Private	
<b>Persons on Board:</b>	Crew - 1	Passengers - 1
<b>Injuries</b>	Crew - None	Passengers - None
<b>Nature of Damage:</b>	Helicopter destroyed by post-impact fire	
<b>Commander's Licence:</b>	Private Pilot's Licence (Helicopter)	
<b>Commander's Age:</b>	45 years	
<b>Commander's Flying Experience:</b>	16,900 hours (of which 475 were on type) Last 90 days - 7 hours Last 28 days - 2 hours	
<b>Information Source:</b>	AAIB Field Investigation

The investigation found that the engine suffered an uncontained failure of the gas producing turbine disc due to insufficient oil reaching the bearings as a result of an oil leak. Due to the extensive damage to the helicopter it was not possible to determine the cause of the oil leak.

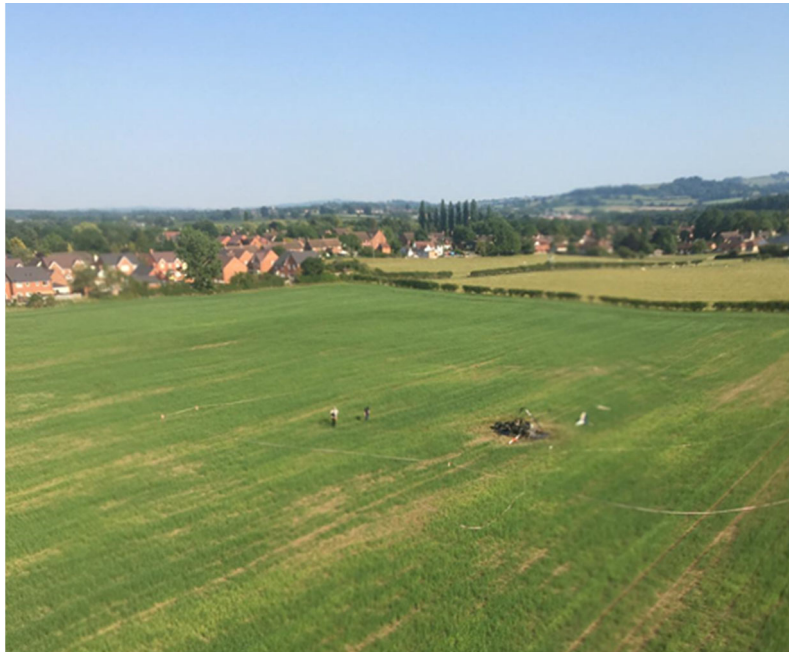
**Figure 7**

The accident site was contained in a relatively small area within a crop field (Figure 7). There were no indications on the ground that the helicopter had slid or struck the ground prior to its final position. The fire service advised that the wreckage had been covered in a precautionary layer of foam due to the magnesium fire in the gearbox casing.

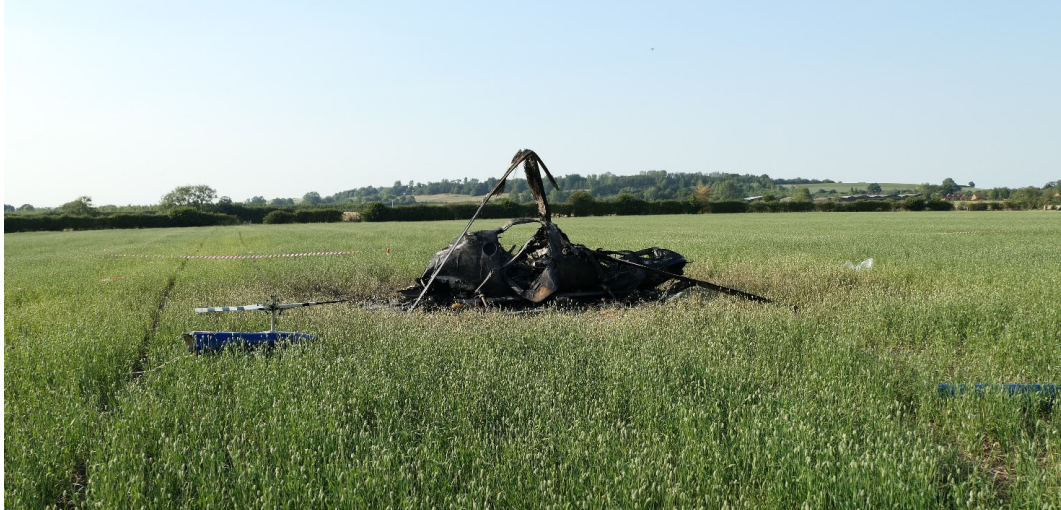
**Figure 8**  
Main wreckage

The helicopter landed upright into wind and was destroyed by the ensuing fire (Figure 8). While the ground around the accident site was firm, the area around the wreckage was wet as a result of the fuel leaking from the helicopter and the foam applied by the fire service. The tail boom had separated from the helicopter and was lying in four sections distributed over an area to the right side of the helicopter. The tail boom was not fire damaged and was covered in oil.

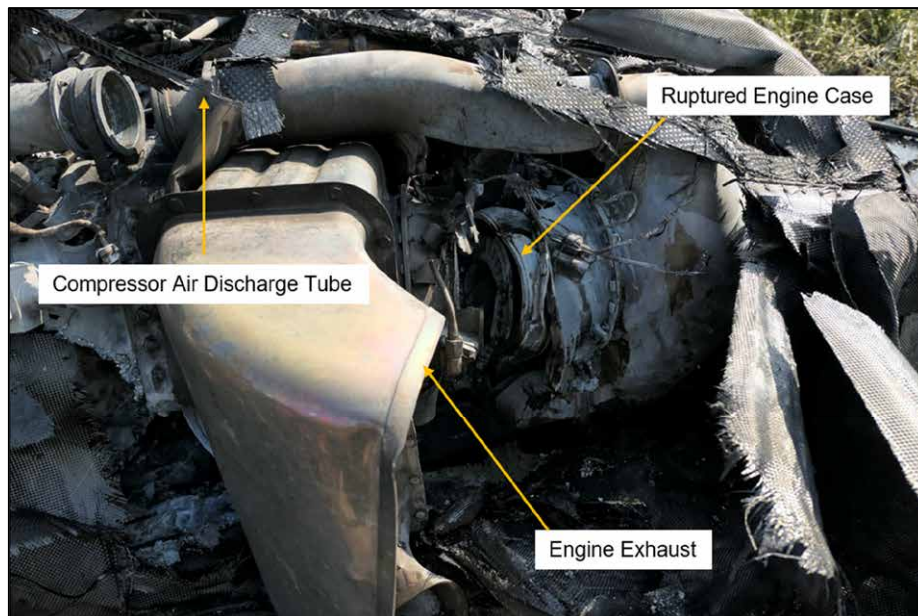
**Figure 18**  
Engine at the accident site

The engine casing was ruptured and inspection of the interior of the engine showed that the GP turbine shaft had sheared and that both GP rotor discs had burst (Figure 18). Parts of GP1 had been retained but other parts had escaped the energy absorbing ring and were located both within the engine bay and on the ground near the wreckage.

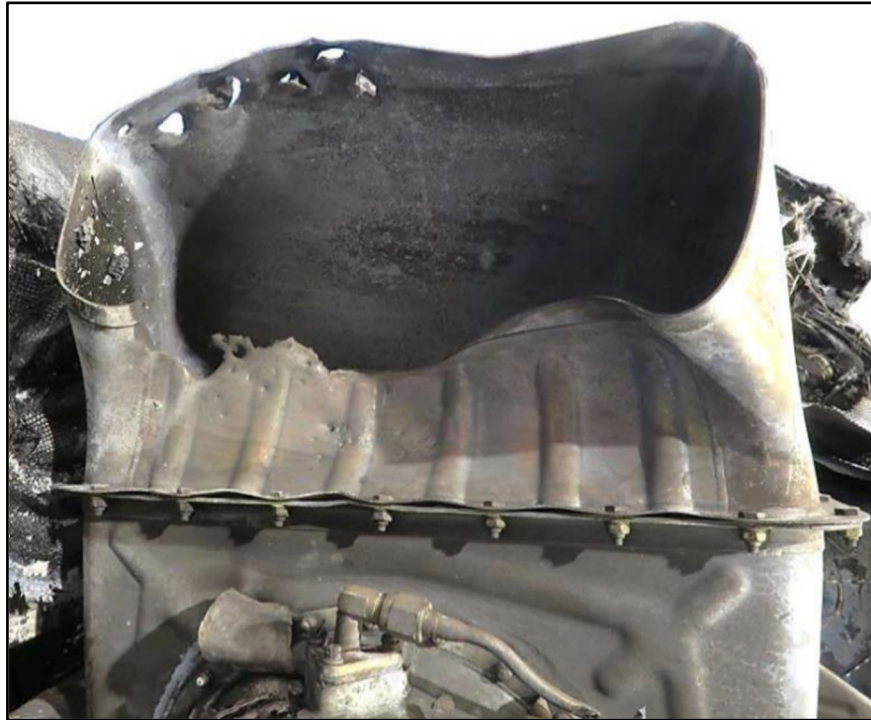
**Figure 20**  
Exhaust damage

The exhaust duct was significantly deformed, with evidence of impact holes (Figure 20). This damage was consistent with the release of blades from the GP turbine rotor disc which escaped via the exhaust duct.

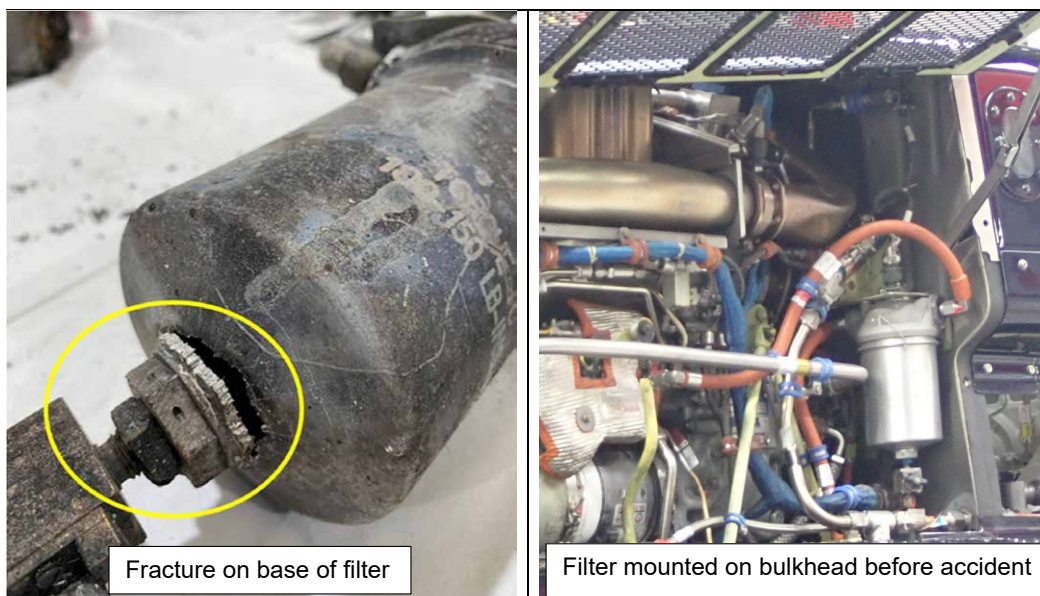
**Figure 21**  
Damage to airframe mounted fuel filter

The airframe mounted fuel filter had fractured, which metallurgy showed was not caused by impact from the disc burst fragments but was more consistent with a failure due to heat and overload (Figure 21).

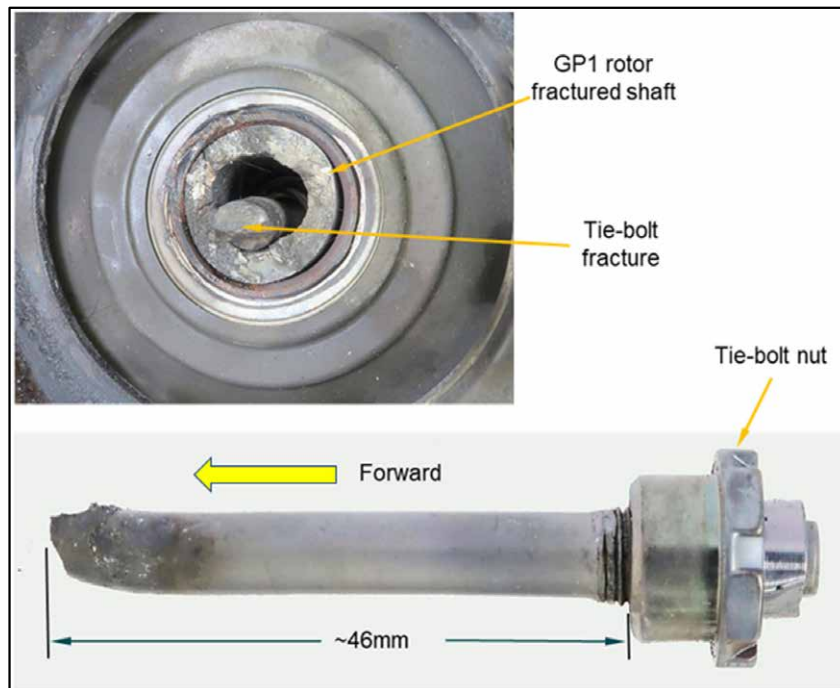
**Figure 24**  
GP turbine tie-bolt fracture  
(Image used with permission of Rolls-Royce PLC)

The GP1 rotor shaft had fractured and the tie-bolt which locates the GP turbine rotors had sheared (Figure 24) in overload in line with the GP1 disc and shaft, separating the curvic couplings in the process. A small middle section of the tie-bolt was not found.

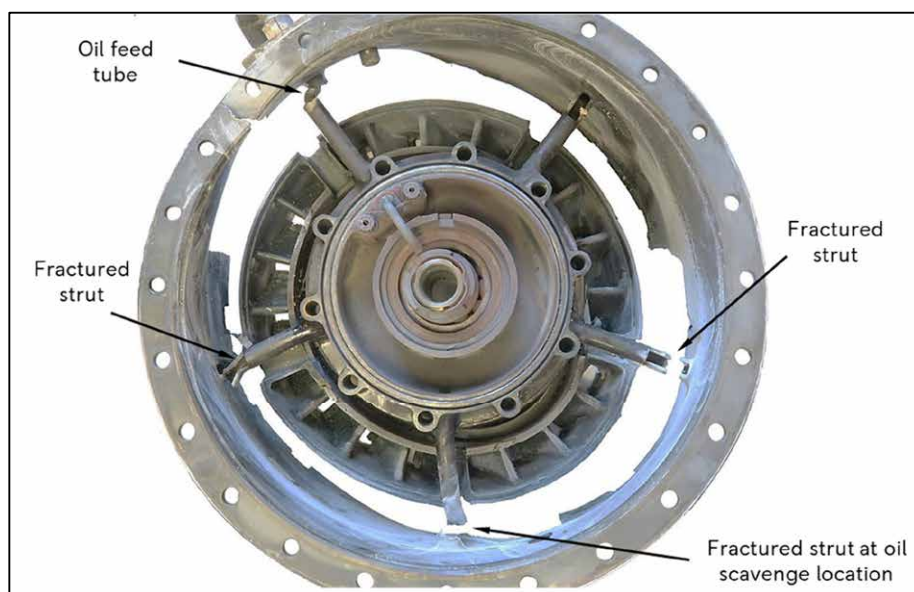
**Figure 25**

Assessment of the No 8 bearing support structure showed that four of the radial struts had fractured adjacent to the outer casing (Figure 25). The oil feed tube into the No 8 bearing chamber exhibited significant deformation caused by displacement between the hub and the outer case. The strut fractures were assessed as secondary damage as a result of high rotor loads during the engine breakup sequence with no evidence of the oil pipe having failed beforehand.

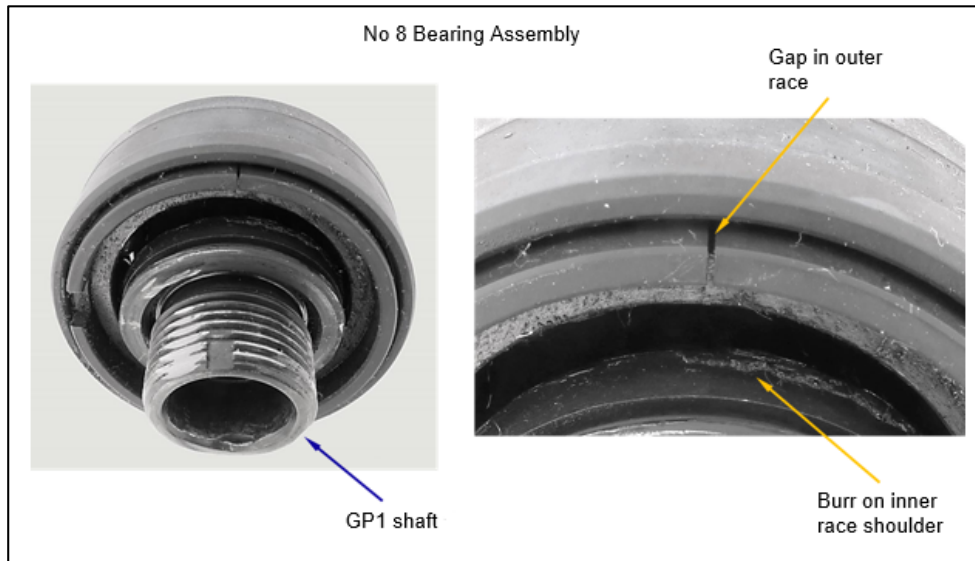
**Figure 26**

The No 8 bearing was found to be dry with no evidence of oil or carbon residues (Figure 26)<sup>23</sup>. The bearing outer race is designed with an axial split to enable the loading of the balls during assembly. The split in the race had opened indicating that the assembly is likely to have been subjected to significant loads during the event. The rear shoulder of the inner race also exhibited a large burr, which had formed from redistributed material from the raceway.

Damage to No 8 bearing assembly  
(Image used with permission of Rolls-Royce PLC)

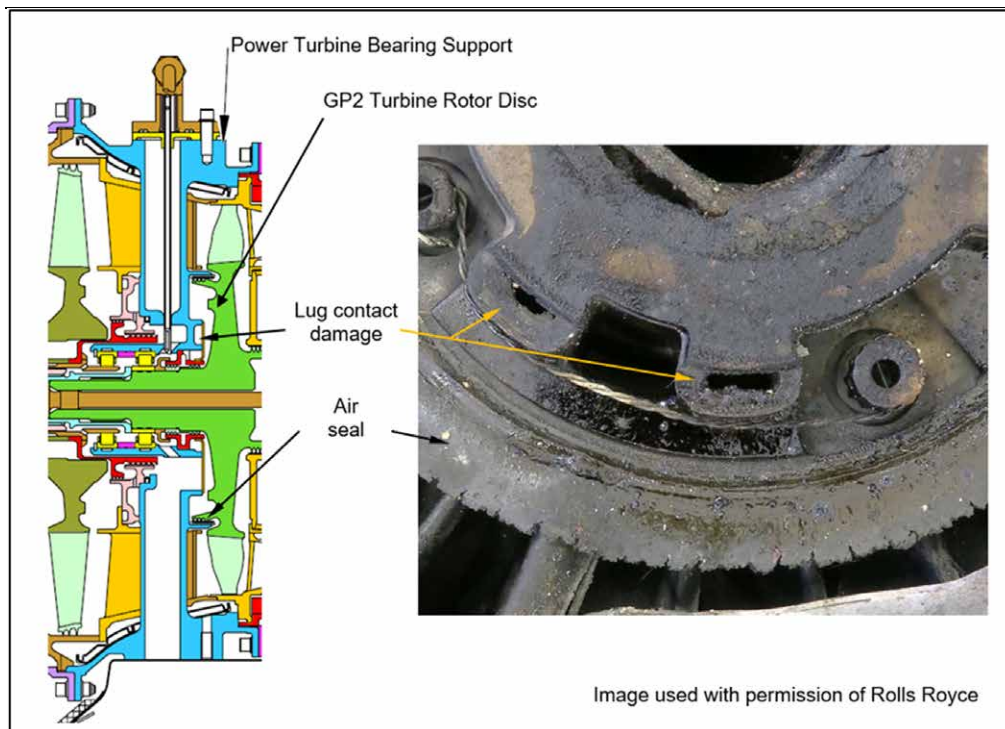
**Figure 28**

The PT bearing support structure showed contact damage on its hub face. The axial aligned labyrinth air seal was displaced radially (Figure 28) from axial movement and orbiting of the rotating GP rotors. Both the No 6 and No 7 roller bearings had disintegrated, with no distinguishable material remaining other than remnants of the inner and outer race.

Power turbine support contact damage
