Air Quality and Dust Monitoring Monthly Report – August 2021 **Stratford-on-Avon District** Council

A report prepared by EWCs and MWCCs on behalf of HS2 Ltd.

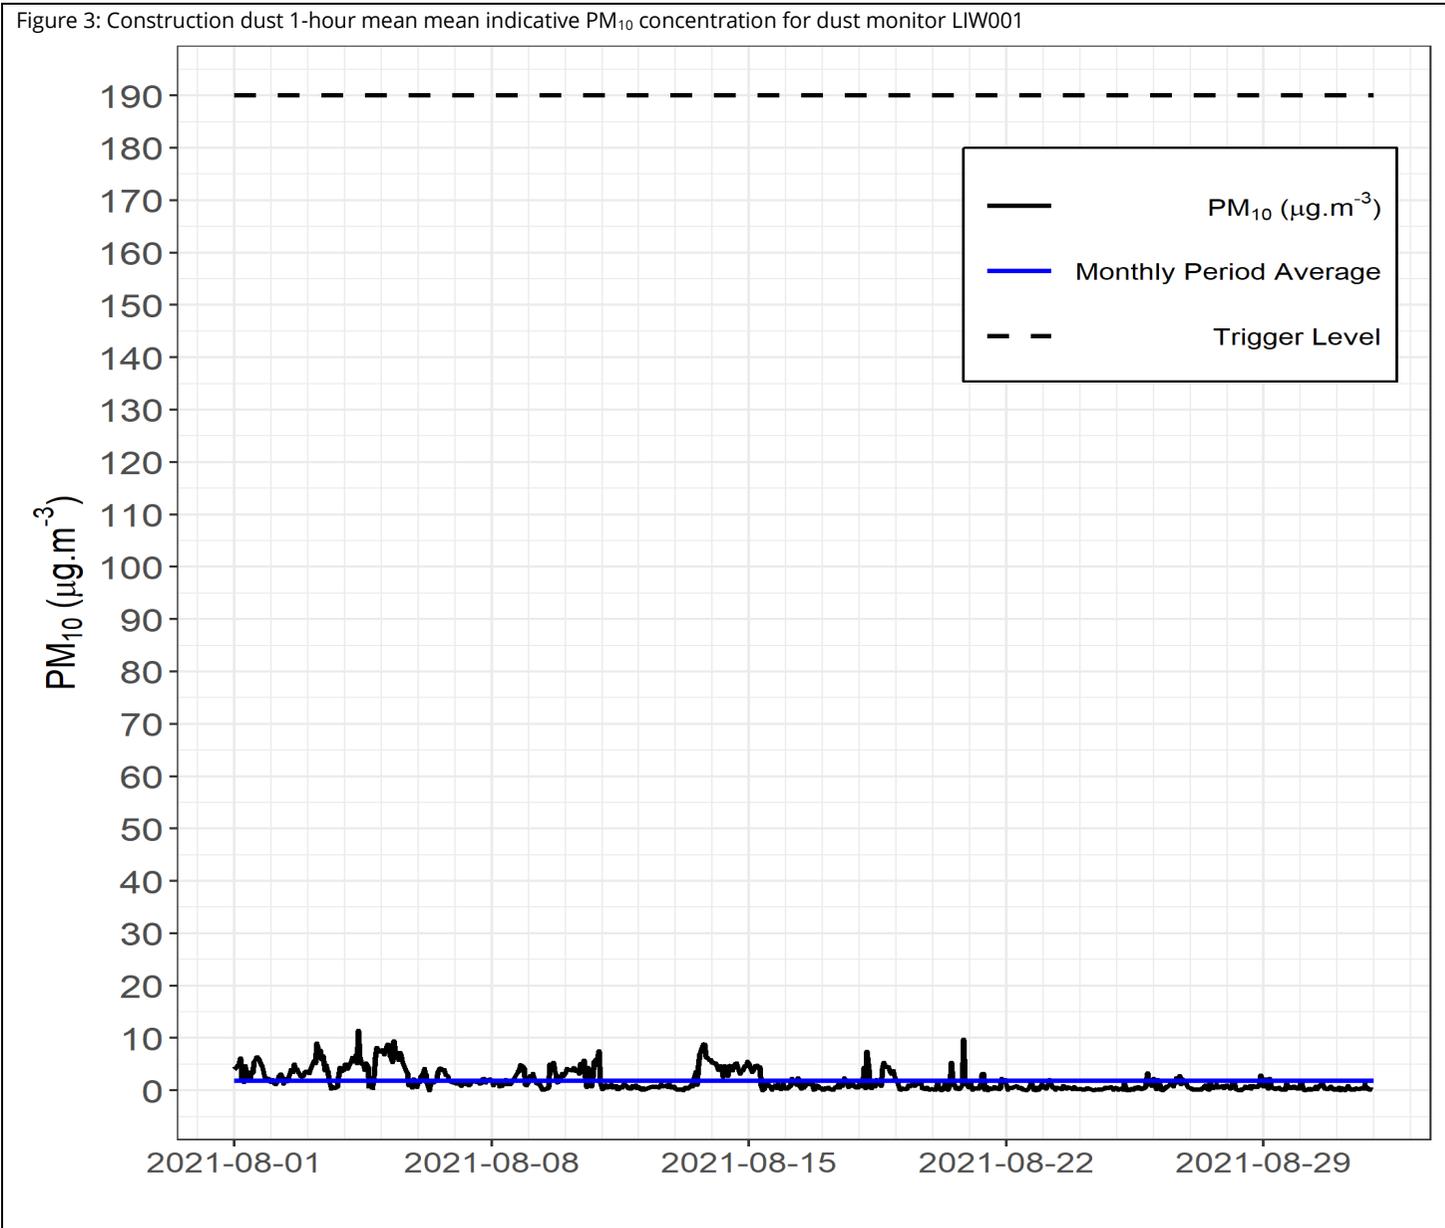
| Monitoring site ID | Coordinates (X,Y) | Location description | Dust risk rating for site | Monitoring site active during period | Change to site since previous period report | Mean 1-hour PM ₁₀ concentration (µg/m ³) | Minimum 1-hour PM ₁₀ concentration (µg/m ³) | Maximum 1-hour PM ₁₀ concentration (µg/m ³) | Number of 1-hour periods exceeding trigger level of 190 µg/m ³ | Data capture (%) |
|---|---|---|---|---|---|---|--|--|---|---|
| LIW001 | 438656, 263180 | Long Itchington Wood North Portal, at boundary with Long Itchington and Ufton Woods SSSI. | M | Yes | No | 1.9 | 0.1 | 11.4 | 0 | 99.7 |

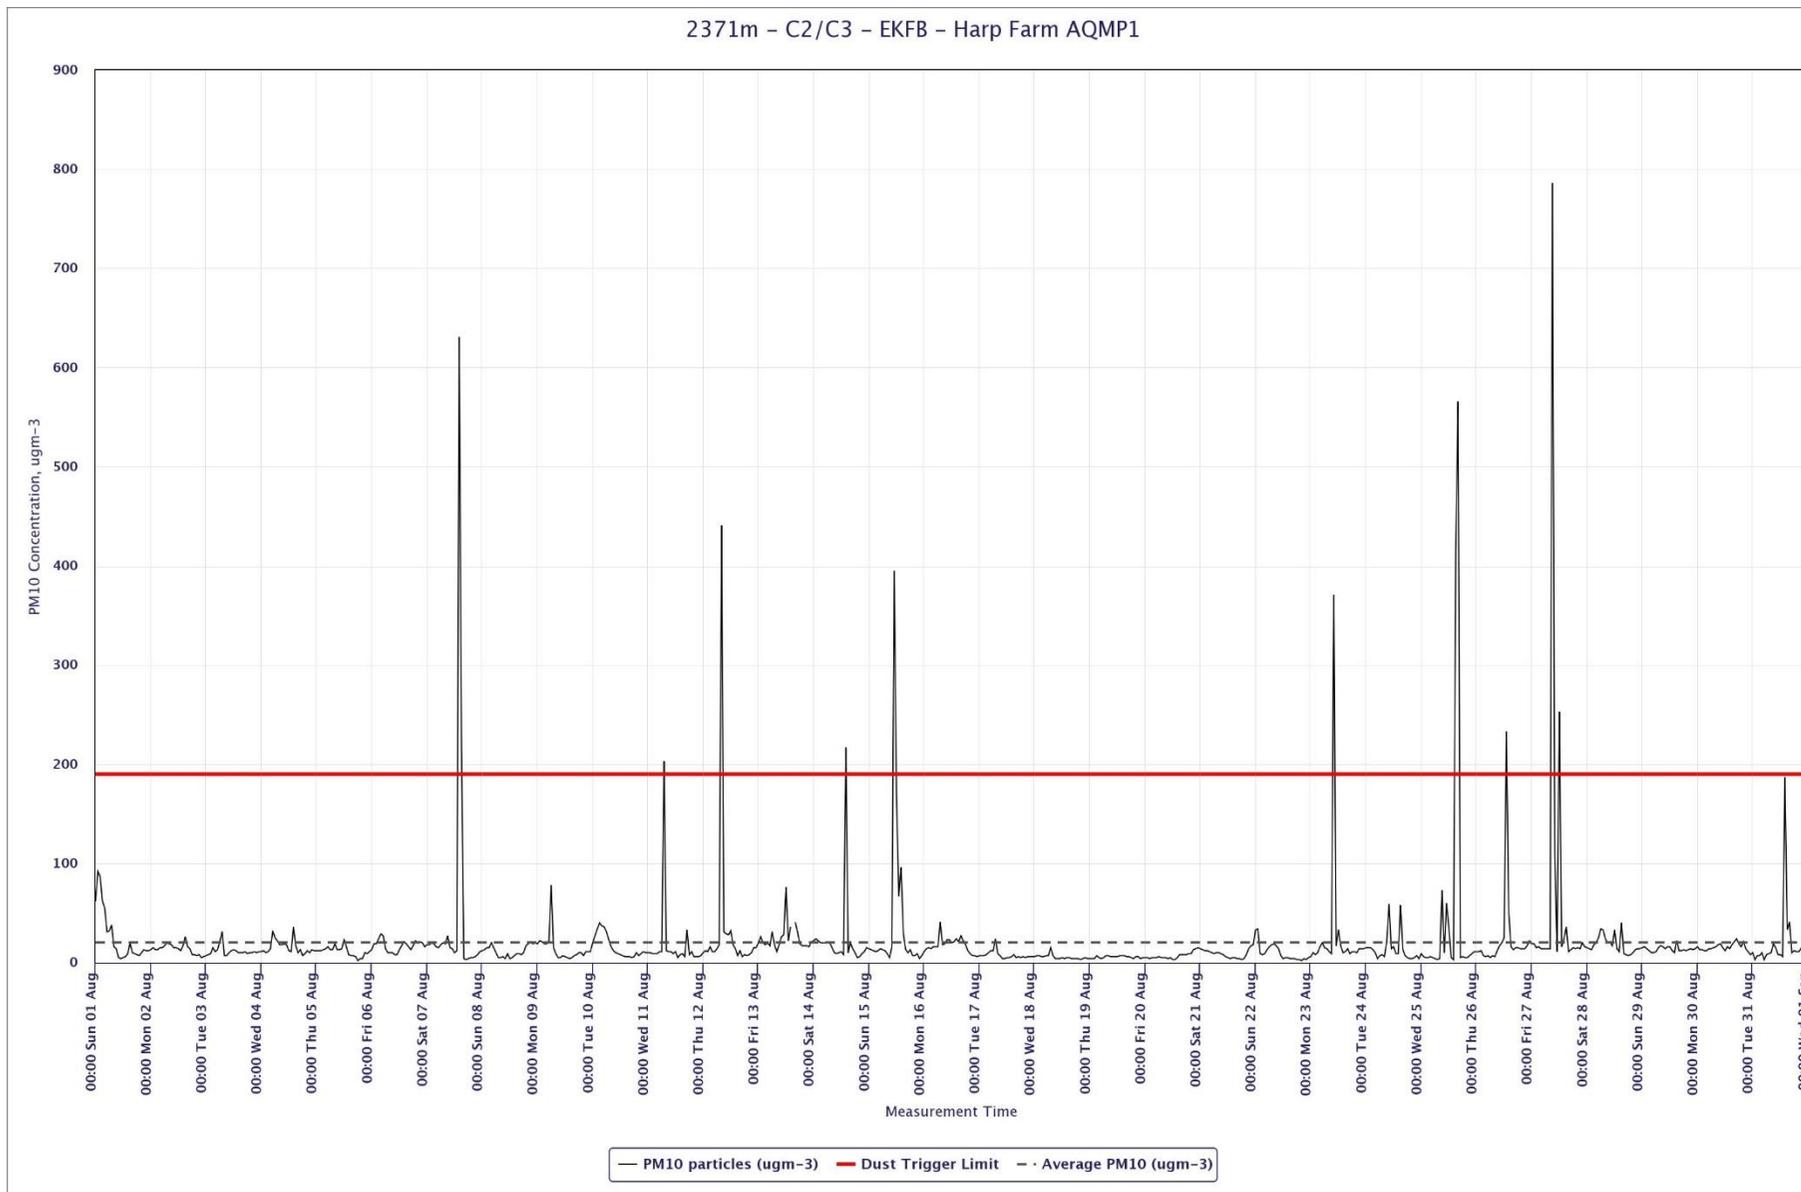
Figure 4: Continuous dust 1-hour mean indicative PM₁₀ concentration for Harp Farm-AQMP1 for August 2021

| Monitoring site ID | Coordinates (X,Y) | Location description | Dust risk rating for site | Monitoring site active during period | Change to site since previous period report | Mean 1-hour PM ₁₀ concentration (µg/m ³) | Minimum 1-hour PM ₁₀ concentration (µg/m ³) | Maximum 1-hour PM ₁₀ concentration (µg/m ³) | Number of 1-hour periods exceeding trigger level of 190 µg/m ³ | Data capture (%) |
|---|---|---|---|---|---|---|--|--|---|---|
| Harp Farm-AQMP1 | 52.23729, 1.39022 | Site boundary adjacent property on Harp Farm | M | Yes | Yes | 20.3 | 2.0 | 786.2 | 12 | 99.9 |

| Monitoring Site ID | Period of trigger alert & Concentration recorded | Investigation | Outcomes / Resolution / Remedial measures implemented |
|---|--|---|--|
| Harp Farm-AQMP1 | 07/08/2021 13:01-14:00 631.4 µg/m ³ 14:01-15:00 223.9 µg/m ³ | Upon immediate investigation it was noted that the landowner was working in close proximity to the dust monitor and was not related to any EKFB works in the area. | Landowner was contacted and was assured they would try to work further away from the monitor. After the landowner tried to reduce works in close proximity, there was a reduction in the amount of dust being produced but it still caused this additional trigger. They shortly finished works and no more alerts were received. |
| | 23/08/2021 09:00-10:00 371.0 µg/m ³ | On investigation it was noted that the demolition activities were being carried out, and while dust suppression was in place, the activities were within close proximity to the dust monitor. These activities comprised of breaking out and moving concrete rubble with an excavator and dumper. | The site team increased the dust suppression measures on site, including the use of additional dust cannons and ensuring the agreed methodologies to manage dust were implemented. Furthermore, the NRMM on site was relocated closer within the site boundary. Demolition activities continued in line with the above, and no further trigger alerts were received. |

| Monitoring Site ID | Period of trigger alert & Concentration recorded | Investigation | Outcomes / Resolution / Remedial measures implemented |
|---|--|--|--|
| | 25/08/2021 14:00-15:00 414.8 µg/m ³ 15:00-16:00 566.0 µg/m ³ | EKFB's subcontractor were operating the crusher (as part of demolition works), while dust suppression was in place, on investigation it was noted that it was not functioning to its full capacity as a result of poor water pressure. | EKFB Environmental Advisor attended site and advised the Supervisor to reduce the crushing rate and alter the location of the plant. No complaints were received. Works were stopped until additional measures below could be implemented the following day: <ul style="list-style-type: none"> - Working area will be moved further away - Speed of the crusher will be reduced - The crusher's built-in the dust suppression unit has been connected to work correctly as intended. - The pressure of the existing dust suppression unit has been fixed to its correct standard. |
