SERIOUS INCIDENT

Aircraft Type and Registration:	Tekever AR5 Evolution Mk 2, G-TEKV	
No & Type of Engines:	2 3W 2-stroke piston engines	
Year of Manufacture:	2019 (Serial no: E505)	
Date & Time (UTC):	29 December 2020 at 1446 hrs	
Location:	Lydd Airport, Kent	
Type of Flight:	Commercial operations (UAS)	
Persons on Board:	Crew - None	Passengers - None
Injuries:	Crew - None	Passengers - N/A
Nature of Damage:	None	
Commander's Licence:	Other	
Commander's Age:	33 years	
Commander's Flying Experience:	1,514 hours (of which 665 were on type) Last 90 days - 105 hours Last 28 days - 34 hours	
Information Source:	Field Investigation

Synopsis

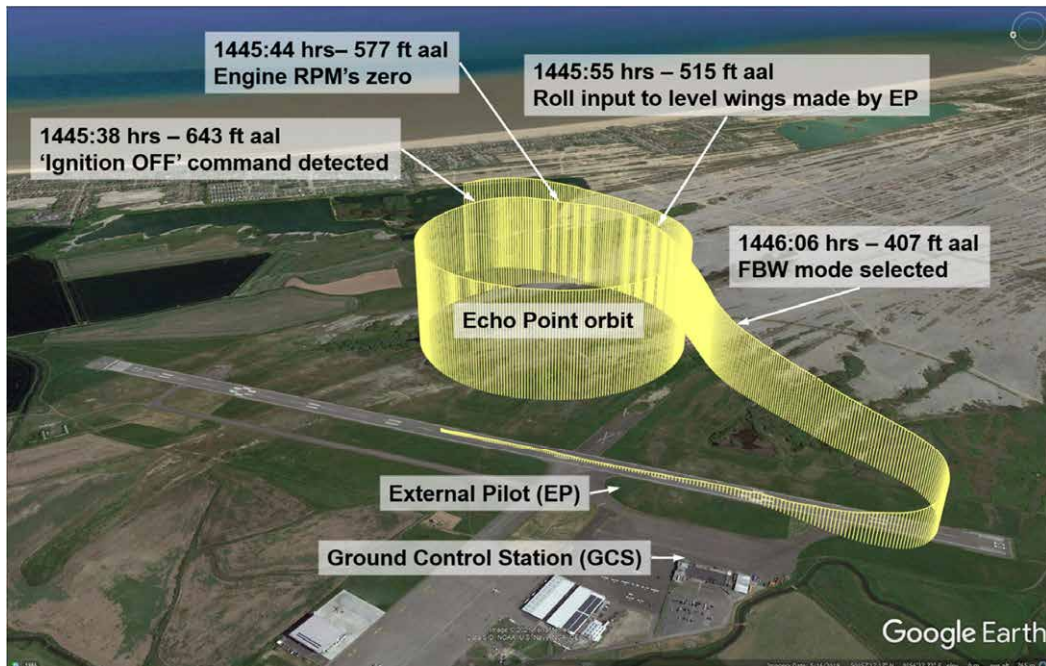
Figure 2 shows the flight track of the aircraft from the last of six orbits around Echo Point through to the landing. The aircraft came into radio range of the EP's controller at 1437:30 hrs near Echo Point and commenced the orbits at about 750 ft. From the flight log it was determined that during the last orbit an engine 'Ignition OFF' command was detected by the autopilot after which the engines shut down. The EP started making roll control inputs to level the wings 17 seconds after the 'Ignition OFF' command (overriding the autopilot) before switching to FBW mode 11 seconds later.

Aircraft flight path during the event

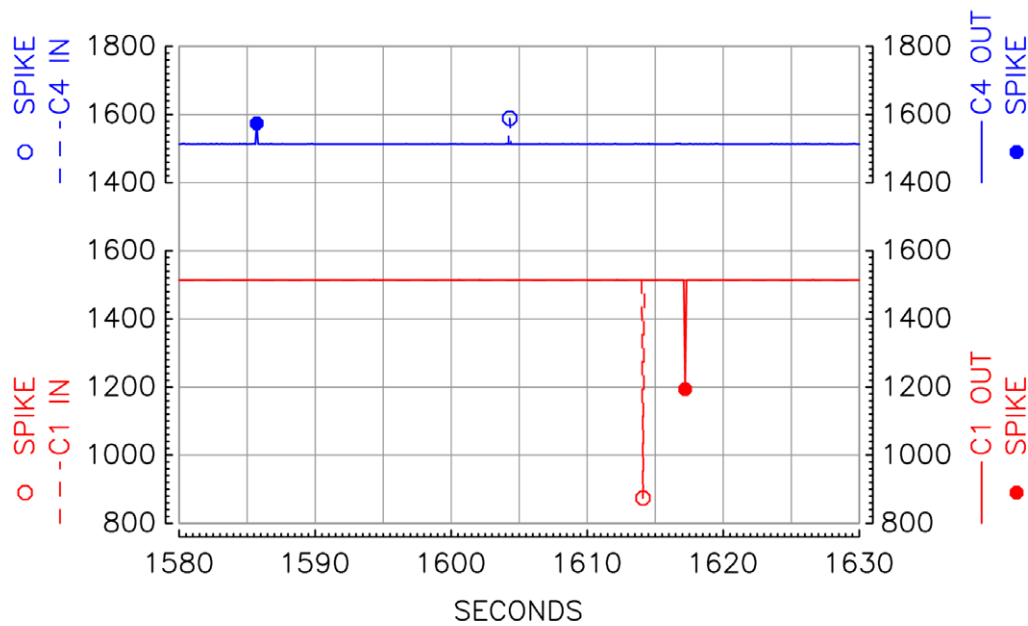
Figure 7

After further testing, the operator identified erroneous values, in the form of bit errors, within the data passed from the multiplexer via the ACE to the autopilot (Figure 7) and began an investigation to understand how and where these signal errors were being introduced.

Data from the aircraft log file showing spikes on the control channels in and out of the autopilot for Aileron (C1) and Rudder (C4) for the June 2020 event

1. A new SBUS multiplexer hardware revision was released in June 2020 that fine-tuned the internal PCB design and some components to minimise the impact of external interference. It was noted that it was '*not fully protected against noise*'; however, the inadvertent engine shutdown event could not be reproduced during tests. This revision was embodied on the entire AR5 fleet, including G-TEKV which was modified in June 2020.
2. The GPU was redesigned to reduce Electromagnetic Interference (EMI) emissions. The GPU redesign was based on the standards of STANAG 4703, and tests were performed to comply with CISPR25 – Class 1.⁹ This work was completed in the second quarter of 2021 and the new GPUs are being installed on new build aircraft and on those returned to the factory for maintenance.
