ACCIDENT

Aircraft Type and Registration:	Cirrus SR22, G-CTAM	
No & Type of Engines:	1 Teledyne Continental IO-550-N piston engine	
Year of Manufacture:	2007 (Serial no: 2740)	
Date & Time (UTC):	31 May 2020 at 1345 hrs	
Location:	Calshot Spit, Hampshire	
Type of Flight:	Private	
Persons on Board:	Crew - 1	Passengers - 1
Injuries:	Crew - None	Passengers - None
Nature of Damage:	Damaged beyond economical repair	
Commander's Licence:	Private Pilot's Licence	
Commander's Age:	56 years	
Commander's Flying Experience:	587 hours (of which 89 were on type) Last 90 days - 11 hours Last 28 days - 6 hours	
Information Source:	AAIB Field Investigation

Synopsis

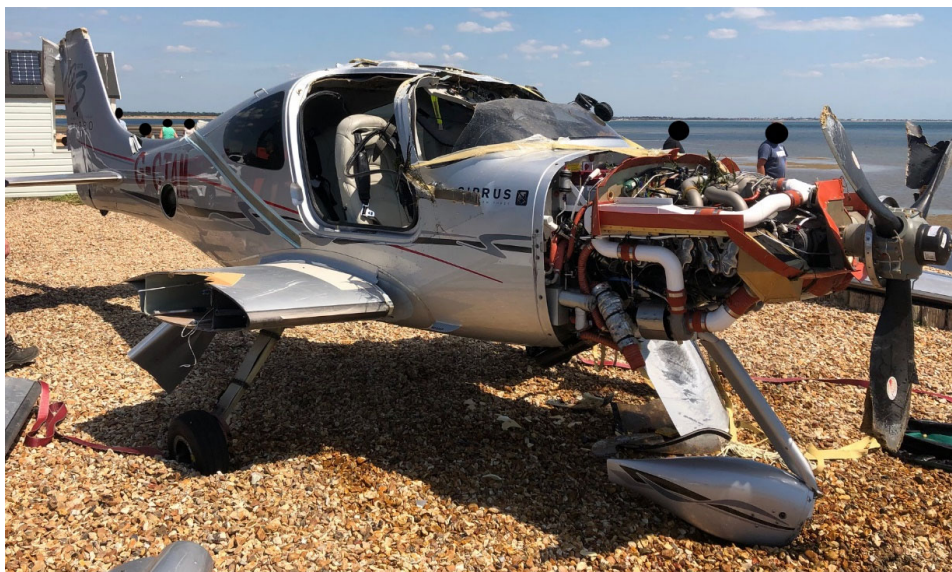
Figure 2

The aircraft's wings were cut off and the aircraft was transported to a secure facility. The aircraft had suffered significant damage to its upper fuselage structure and windscreen from being dragged up the beach inverted (Figure 2).

Aircraft after it was righted, the engine cowling removed, and the wings cut off

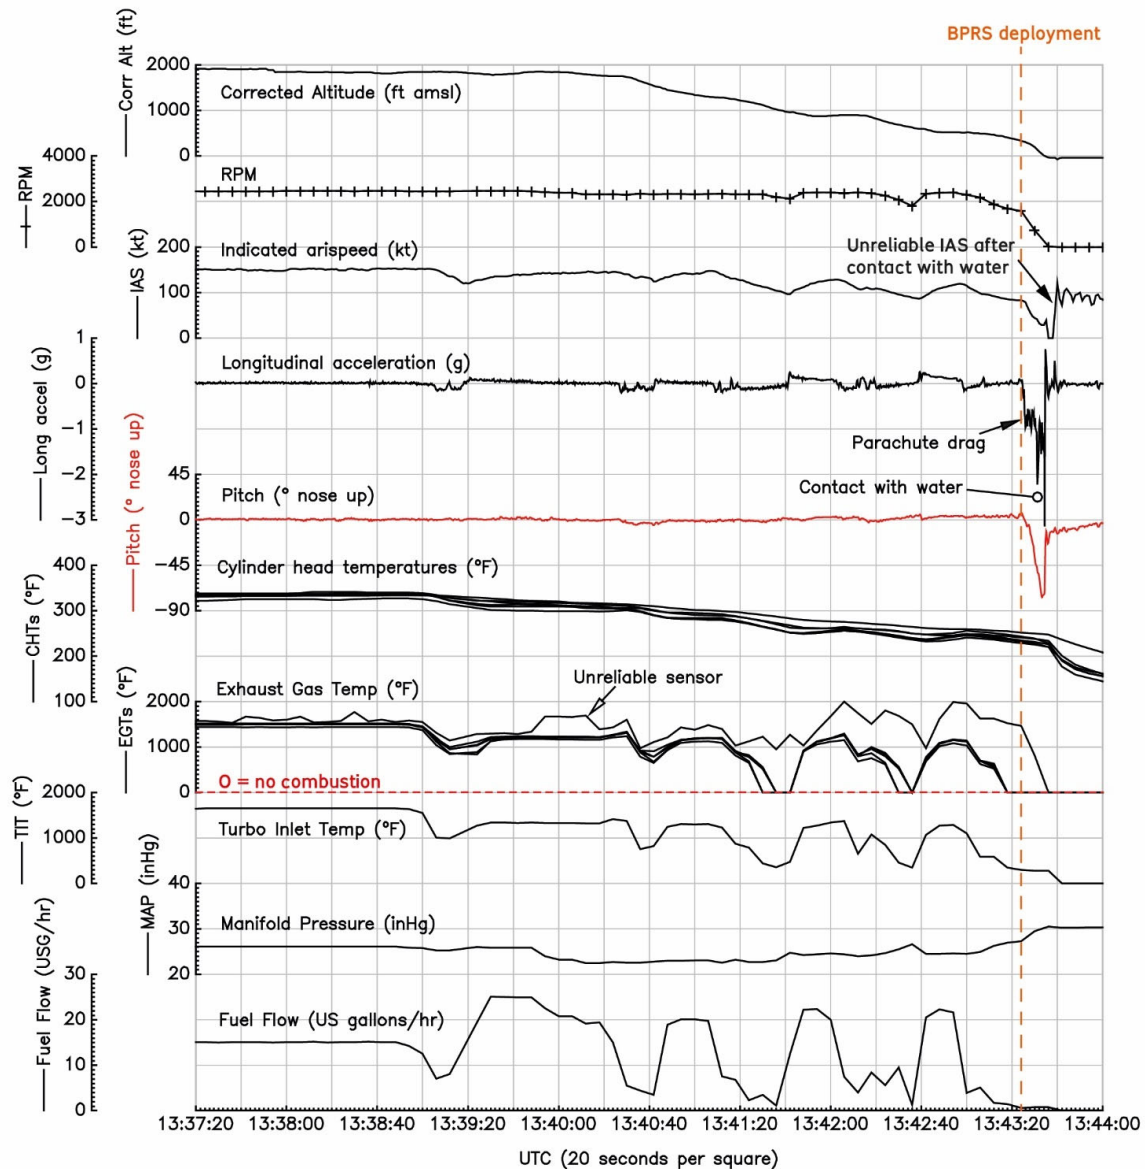
Figure 7

The combined PFD and MFD data for the final part of the accident flight is shown in Figure 7. There was a sensor issue with one of the engine cylinder EGTs which is not believed to be relevant to the investigation. The fuel flow data shows an initial dip in fuel flow followed by a transition to a rich fuel mixture (fuel flow of 25 USG/hr) prior to the descent towards Lee-on-Solent. In the descent, there was a decrease to 4 USG/hr, which would have been insufficient to sustain combustion, followed by a recovery of the fuel flow. The decrease occurred again 20 seconds later and this time the EGTs reduced to zero indicating that no combustion was taking place. The fuel flow recovered again for about another 20 seconds before it dropped again and the EGTs reduced to zero again. There was a final recovery and drop-off before the BPRS was activated below 400 ft amsl.

The data was analysed and discussed with the aircraft manufacturer, the engine manufacturer and the turbocharger manufacturer. The consensus view was that the engine's performance was following the fuel flow. When the fuel flow was sufficiently high combustion was occurring and power was being produced, and when the fuel flow dropped sufficiently combustion ceased. The engine-driven fuel pump had been tested and functioned normally and therefore the consensus was that the loss of fuel flow was indicative of fuel starvation, ie the demanded fuel was not always reaching the fuel pump.

Extracts of PFD and MFD data at the end of the accident flight.

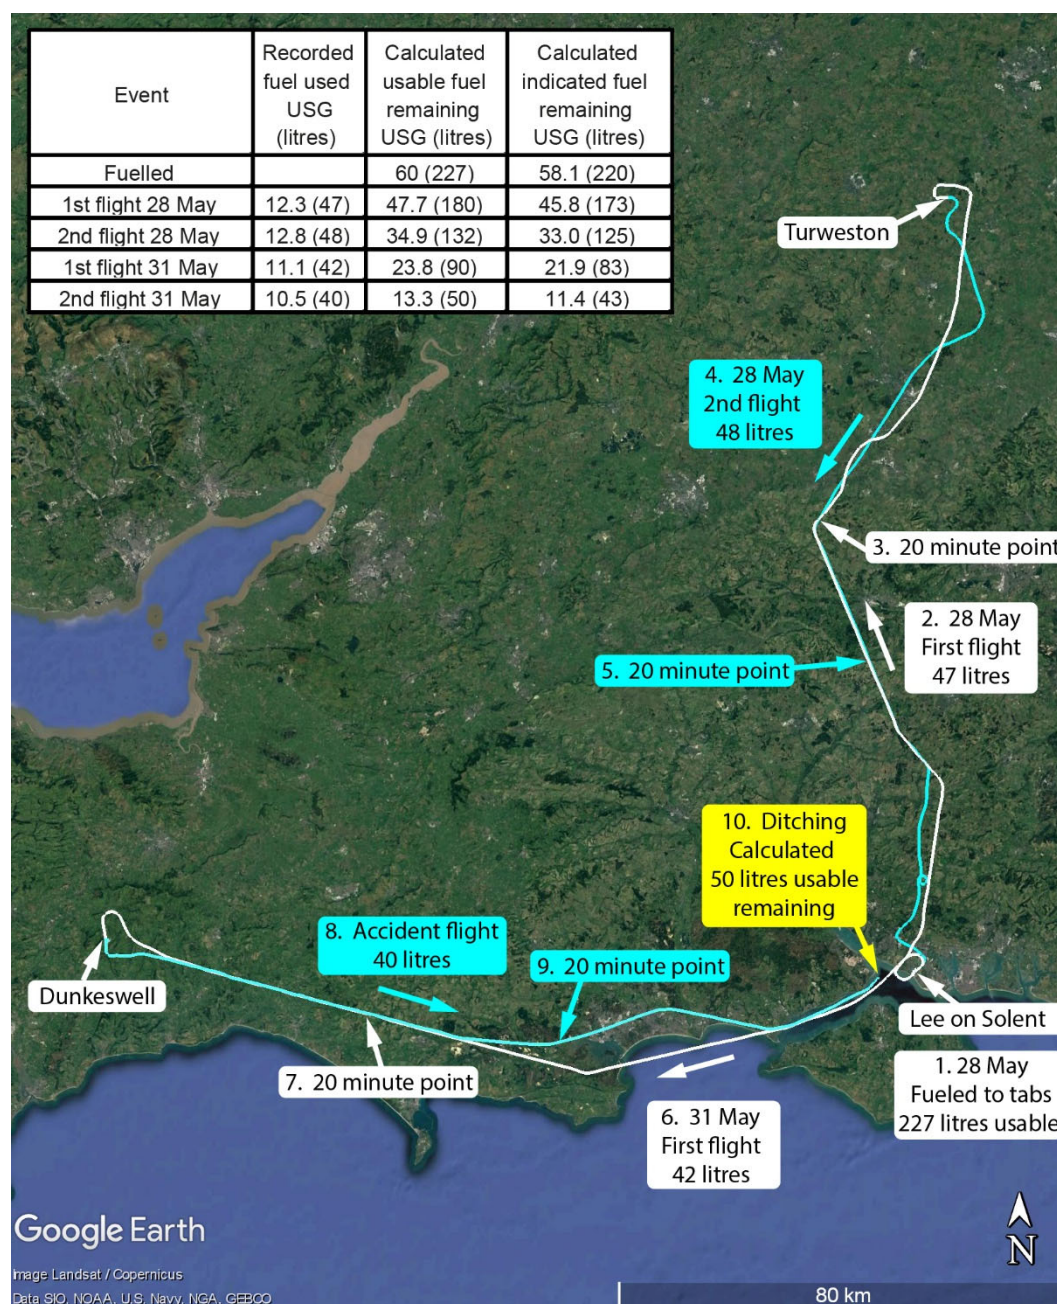
Figure 8
Fuel usage since refuelling

The recorded fuel usage for the four flights flown since refuelling are shown in Figure 8.

Spot checks of engine rpm, manifold pressure, altitude, airspeed and fuel flow from the recorded data compared favourably to the data in the performance tables in the POH, which indicated that the recorded fuel flow data and derived fuel usage data was reliable, assuming no leaks. If fuelling to tabs was accurate (60 USG / 227 litres) and the recorded fuel flow and fuel used values were accurate, there should have been 13.3 USG (50 litres) of usable fuel available at the time the aircraft ditched.

Applying the fuel flow figures to the tank switching method described meant that at the time of the engine problems there should have been approximately 6.6 USG (25 litres) of usable fuel in each tank. The pilot did not believe that he had missed an in-flight switch. However, if one of the in-flight switches had been missed during one of the flights on 28 May, then calculations showed that the tank in use at the time of the engine problems would have run dry and the other tank would have been close to the nominal 14 USG alert level in the location of the engine problems (plus or minus less than 2 USG). 20 minutes into the first flight on 28 May coincided with the transition from a longer stable flight leg to a turn onto a new heading, with multiple corrections afterwards. 20 minutes into the second flight on 28 May was approximately halfway along a stable flight leg. There are potential sources of error with these calculations, such as assuming the nominal 'tabs' fuel quantity was accurately achieved and imprecision in the timing for the remaining fuel tank switch-overs.
