ACCIDENT

Aircraft Type and Registration:	Bell 407, N120HH	
No & Type of Engines:	1 Rolls-Royce M250-C47B turboshaft engine	
Year of Manufacture:	2005 (Serial no: 53661)	
Date & Time (UTC):	24 June 2020 at 1219 hrs	
Location:	Long Marston, Stratford-upon-Avon, Warwickshire	
Type of Flight:	Private	
Persons on Board:	Crew - 1	Passengers - 1
Injuries	Crew - None	Passengers - None
Nature of Damage:	Helicopter destroyed by post-impact fire	
Commander's Licence:	Private Pilot's Licence (Helicopter)	
Commander's Age:	45 years	
Commander's Flying Experience:	16,900 hours (of which 475 were on type) Last 90 days - 7 hours Last 28 days - 2 hours	
Information Source:	AAIB Field Investigation

Synopsis

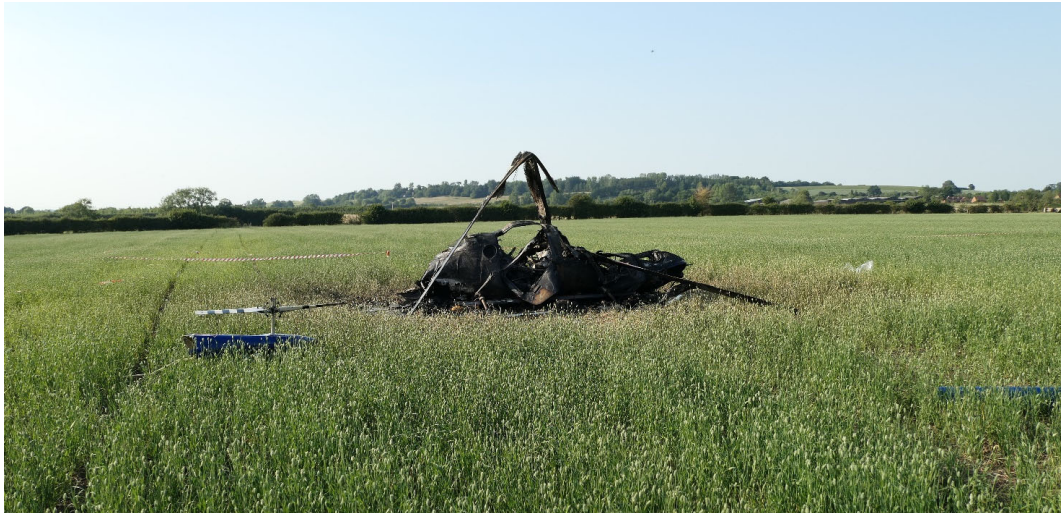
Figure 8
Main wreckage

The helicopter landed upright into wind and was destroyed by the ensuing fire (Figure 8). While the ground around the accident site was firm, the area around the wreckage was wet as a result of the fuel leaking from the helicopter and the foam applied by the fire service. The tail boom had separated from the helicopter and was lying in four sections distributed over an area to the right side of the helicopter. The tail boom was not fire damaged and was covered in oil.

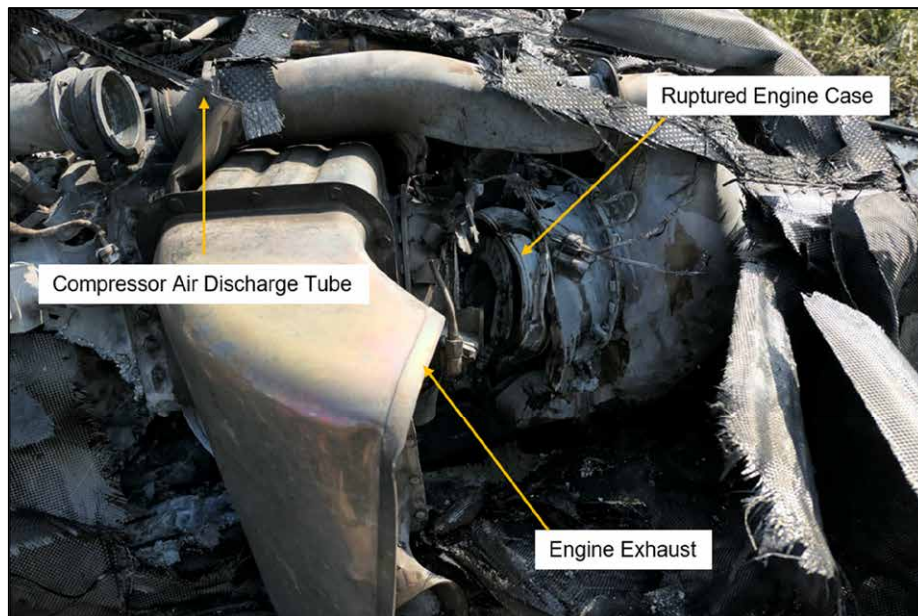
Figure 18
Engine at the accident site

The engine casing was ruptured and inspection of the interior of the engine showed that the GP turbine shaft had sheared and that both GP rotor discs had burst (Figure 18). Parts of GP1 had been retained but other parts had escaped the energy absorbing ring and were located both within the engine bay and on the ground near the wreckage.

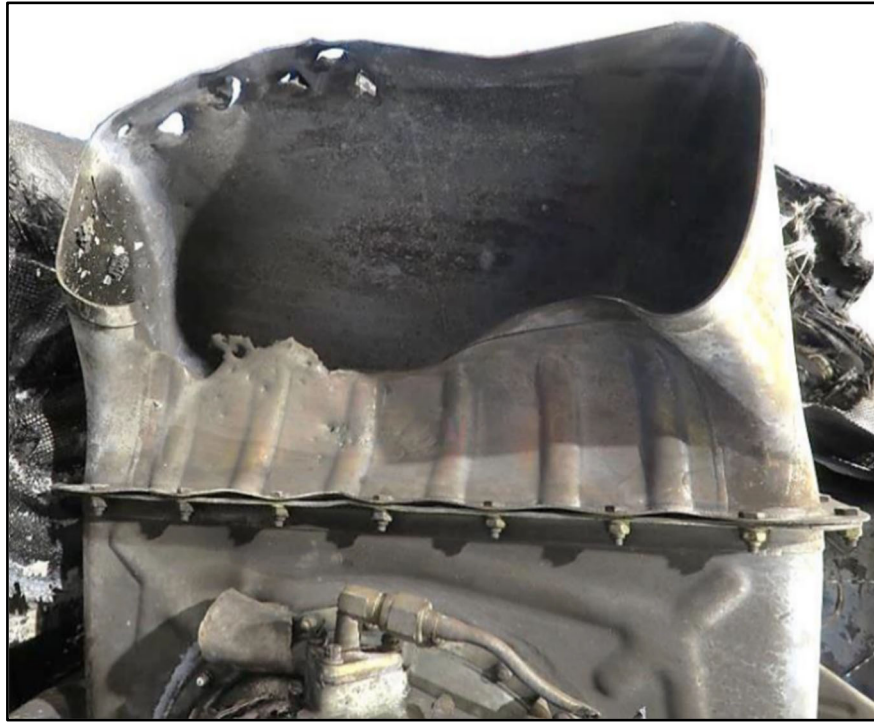
**Figure 20**

The exhaust duct was significantly deformed, with evidence of impact holes (Figure 20). This damage was consistent with the release of blades from the GP turbine rotor disc which escaped via the exhaust duct.

Exhaust damage

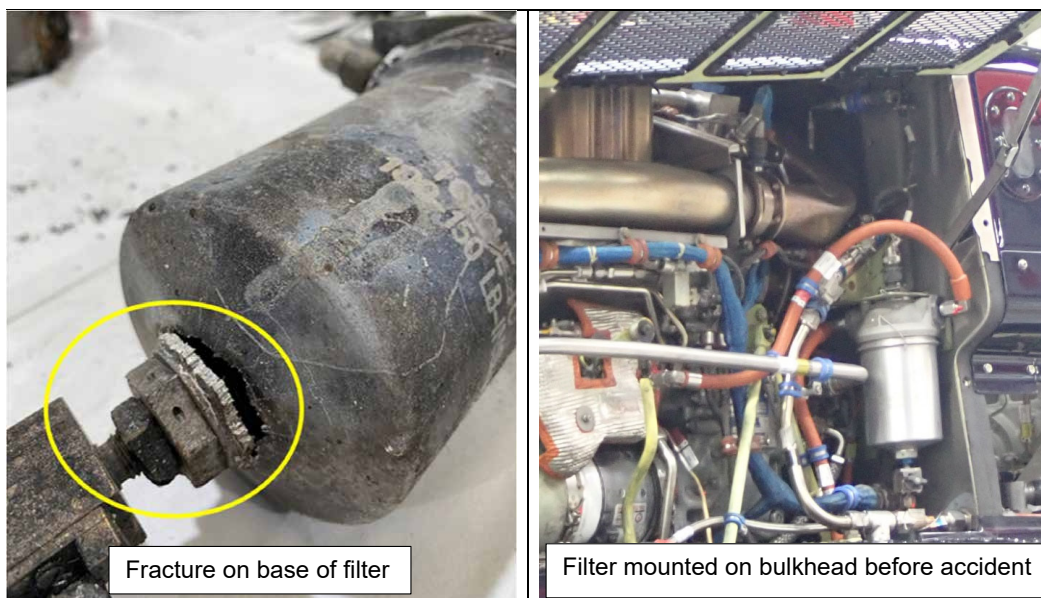
**Figure 21**

The airframe mounted fuel filter had fractured, which metallurgy showed was not caused by impact from the disc burst fragments but was more consistent with a failure due to heat and overload (Figure 21).

Damage to airframe mounted fuel filter

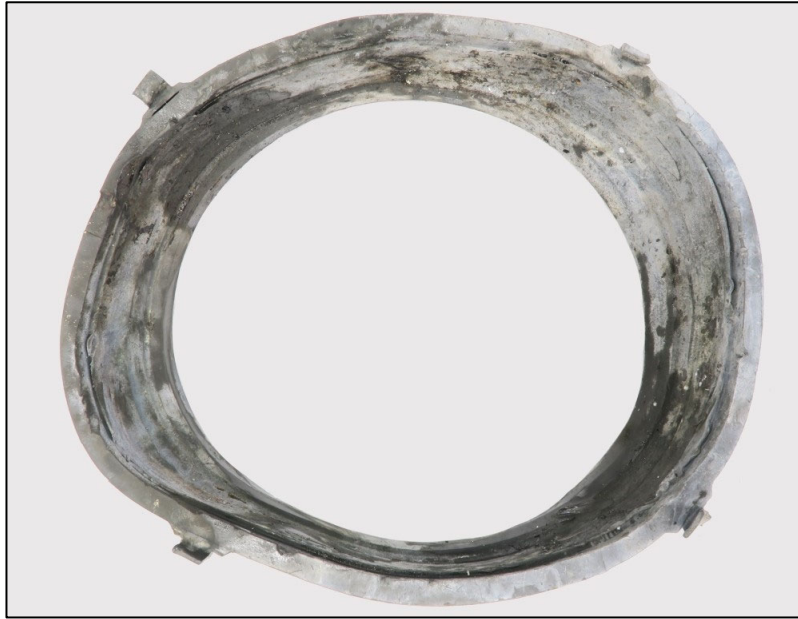
Figure 23

The energy absorbing ring around the GP1 rotor was significantly deformed (Figure 23). There was no deformation to the casing around the PT turbine.

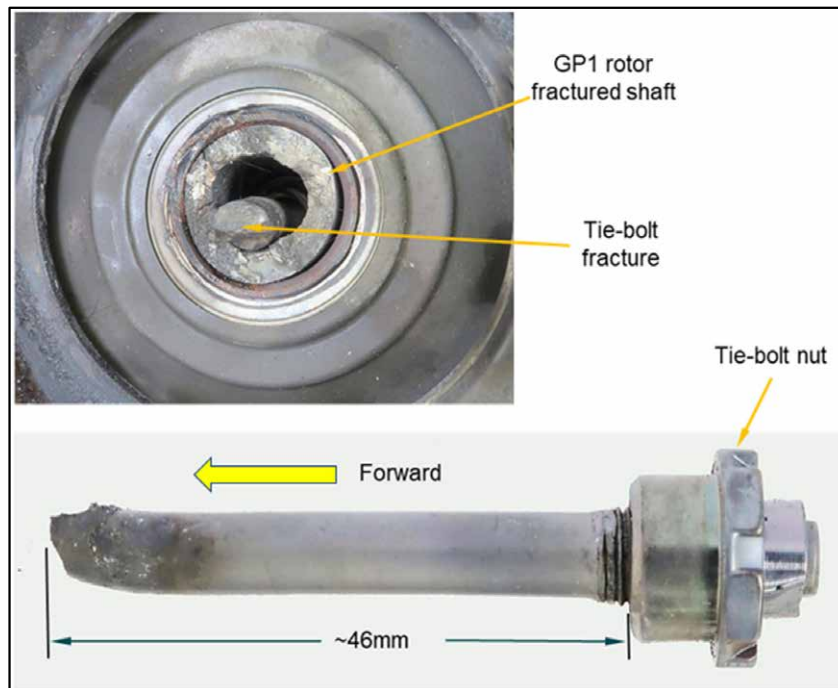
Figure 24

The GP1 rotor shaft had fractured and the tie-bolt which locates the GP turbine rotors had sheared (Figure 24) in overload in line with the GP1 disc and shaft, separating the curvic couplings in the process. A small middle section of the tie-bolt was not found.

GP turbine tie-bolt fracture
(Image used with permission of Rolls-Royce PLC)

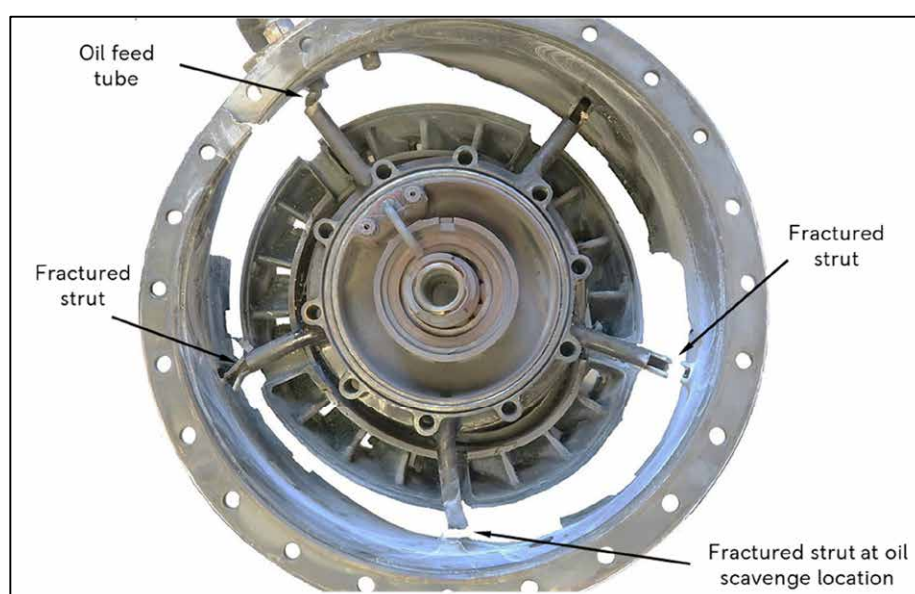
Figure 25

Assessment of the No 8 bearing support structure showed that four of the radial struts had fractured adjacent to the outer casing (Figure 25). The oil feed tube into the No 8 bearing chamber exhibited significant deformation caused by displacement between the hub and the outer case. The strut fractures were assessed as secondary damage as a result of high rotor loads during the engine breakup sequence with no evidence of the oil pipe having failed beforehand.

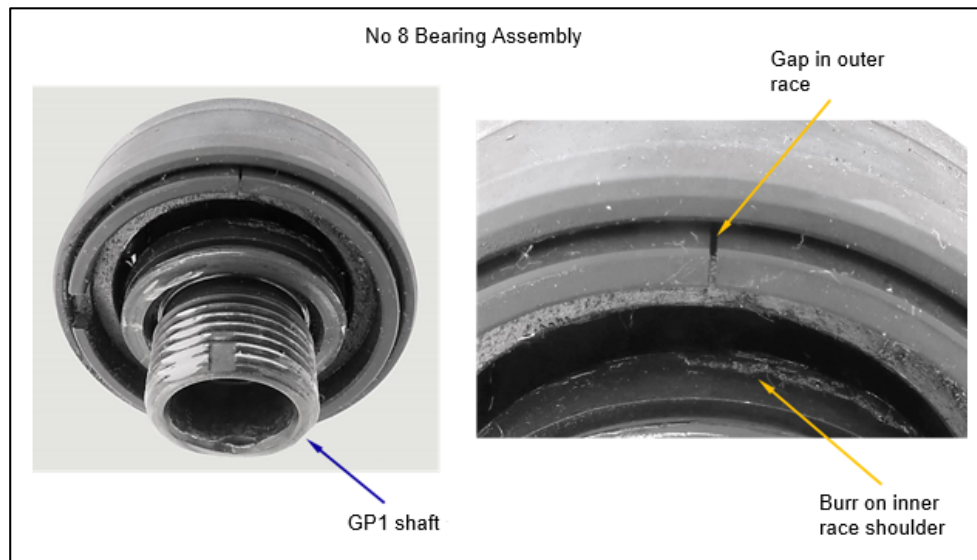
**Figure 26**

The No 8 bearing was found to be dry with no evidence of oil or carbon residues (Figure 26)²³. The bearing outer race is designed with an axial split to enable the loading of the balls during assembly. The split in the race had opened indicating that the assembly is likely to have been subjected to significant loads during the event. The rear shoulder of the inner race also exhibited a large burr, which had formed from redistributed material from the raceway.

Damage to No 8 bearing assembly
(Image used with permission of Rolls-Royce PLC)

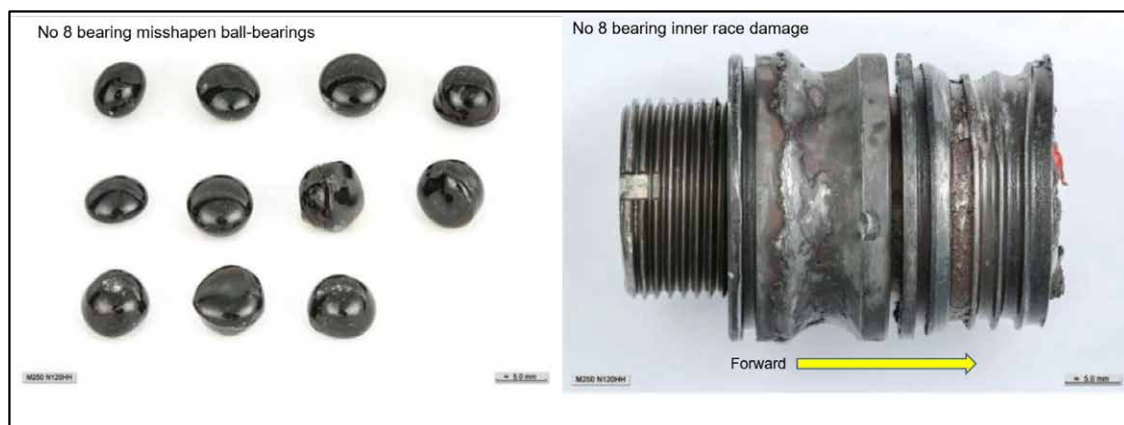
**Figure 27**

The bearing was removed with the remaining GP1 rotor shaft section seized in place. Detailed inspection found the cage had seized onto the outer race due to overheating. This type of damage typically occurs when the cage expands into the race while it is rotating. The designed split in the outer race was noted to gape, and likely to indicate excessive hoop stresses from the thermal expansion of the cage. The assembly was stripped to inspect the ball bearings. All the balls were misshapen with none of the original contact surface remaining. The inner race exhibited smearing on the rear lip indicating the balls were sliding rather than rolling over the circumference (Figure 27). Inspection of the outer race also noted a circumferential burr to the front lip. This would also correlate with the condition of the bearing degrading prior to the disc fragmentation.

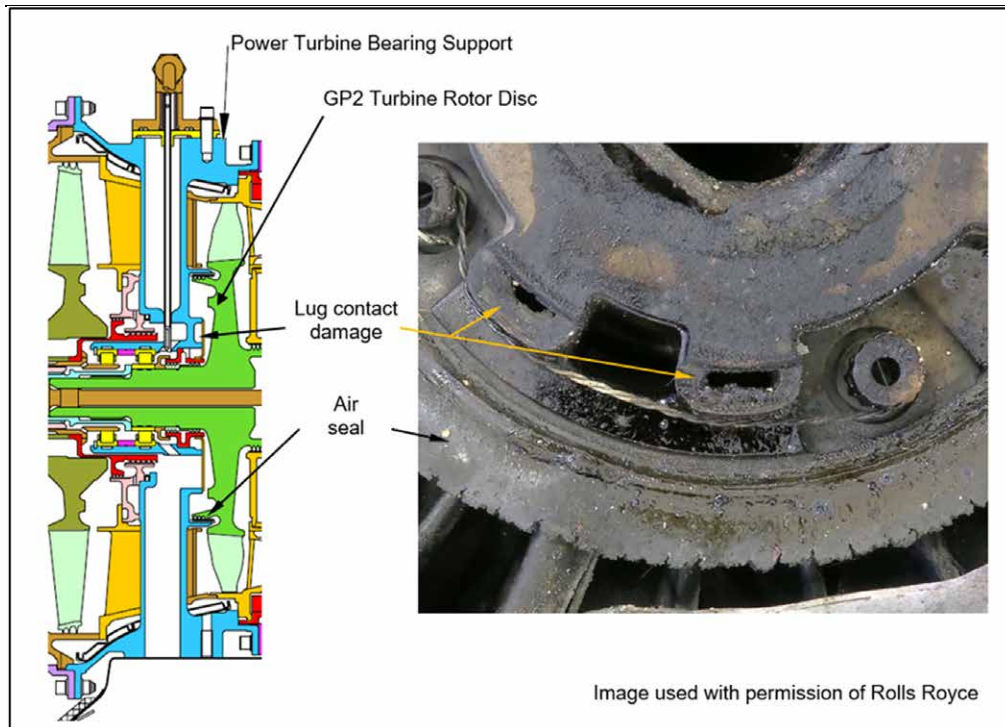
Figure 28

The PT bearing support structure showed contact damage on its hub face. The axial aligned labyrinth air seal was displaced radially (Figure 28) from axial movement and orbiting of the rotating GP rotors. Both the No 6 and No 7 roller bearings had disintegrated, with no distinguishable material remaining other than remnants of the inner and outer race.

Power turbine support contact damage

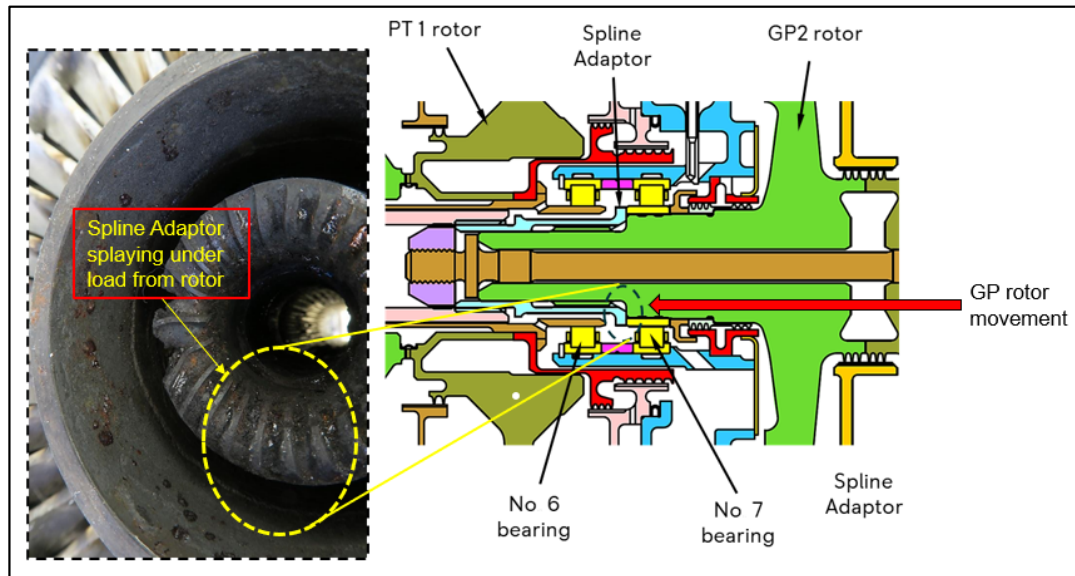
Figure 29

Spline adaptor damage
(Image used with permission of Rolls Royce)

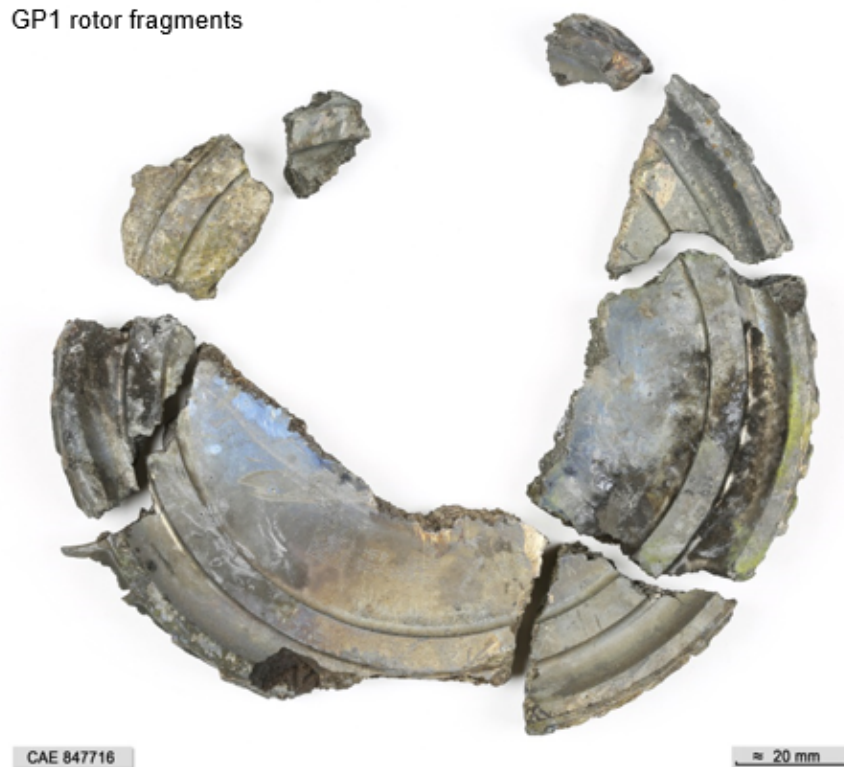
Figure 30

Approximately half of the GP1 disc was recovered from the engine bay, which comprised of eight separate fragments (not including the shaft) of varying sizes (Figure 30).

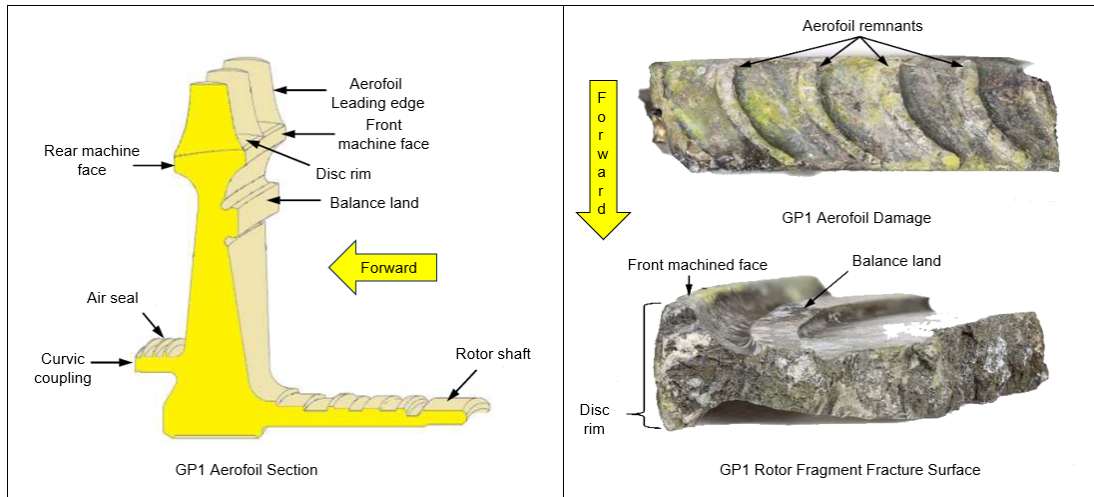
**Figure 31**

A part of the disc extending over five blade sections was examined, although little of the blades remained and the surfaces were heavily smeared from contact with the surrounding static structures (Figure 31). Detailed inspection of the disc showed the features of failure to be those associated with overload only with no evidence of structural degradation due to overheating. Further analysis of the turbine blades showed evidence of grain structure degradation due to overheating induced by friction which is indicative of a heavy rub against another structure. The heat affected structure indicated frictional temperatures in the rub region were in excess of 1,150°C which was high enough to cause plastic deformation in the aerofoil structure.

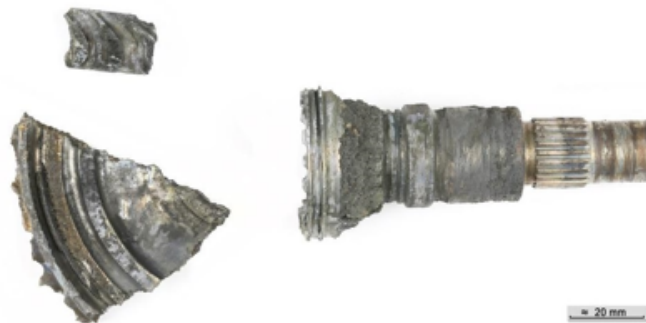
Figure 32

Approximately one eighth of the GP2 disc was recovered (Figure 32). The largest fragment of rotor was examined and found to have failed in overload, with multiple radial cracks in the machined face of the rotor rim. The remnants of the turbine blade were found to have experienced similar heating effects to the blades on GP1.
