Acton 24th June 2008 – A little bit of history

How did we investigate? Margam 019

Margam rail deaths: 'No safe system' when workers killed

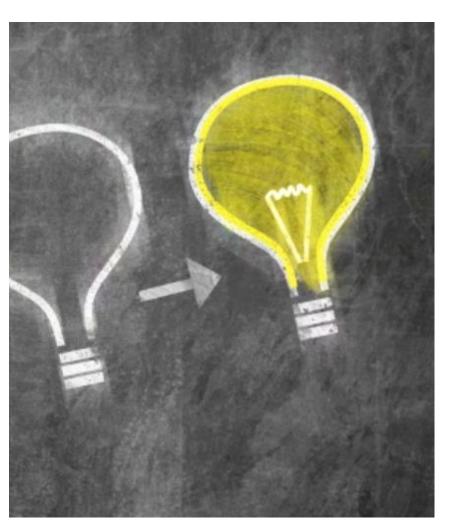
- Back in 2008 RAIB made a recommendation following the welding trolleys being struck at Acton.
- The Recommendation was to reinforce existing arrangements within Network Rail for COSS packs to be prepared and implemented by staff with adequate geographical knowledge of the locality.
- NR/OHS/L2/019 is a NR standard that defines how we access or work near the track and appropriate protection to keep us safe.

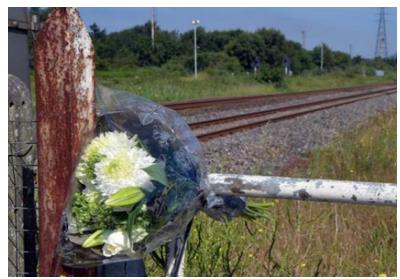
- RAIB undertook a review of the packs NR had collected from Port Talbot Depot.
- NR then did an in-depth analysis of a small sample of those packs and found 50% to have significant issues of compliance.
- This included: planned use of lookouts, tip-ex, signing the pack before its verified, no involvement of PIC, different times......
- We also found gaps in local 019 assurance activities.

When we checked - 019 v9 had not been briefed fully and a shorter version had been approved for use.
