Collision between fishing vessel *Achieve* (HL257) and general cargo ship *Talis*, resulting in the sinking of *Achieve* off Tynemouth, England on 8 November 2020

SUMMARY

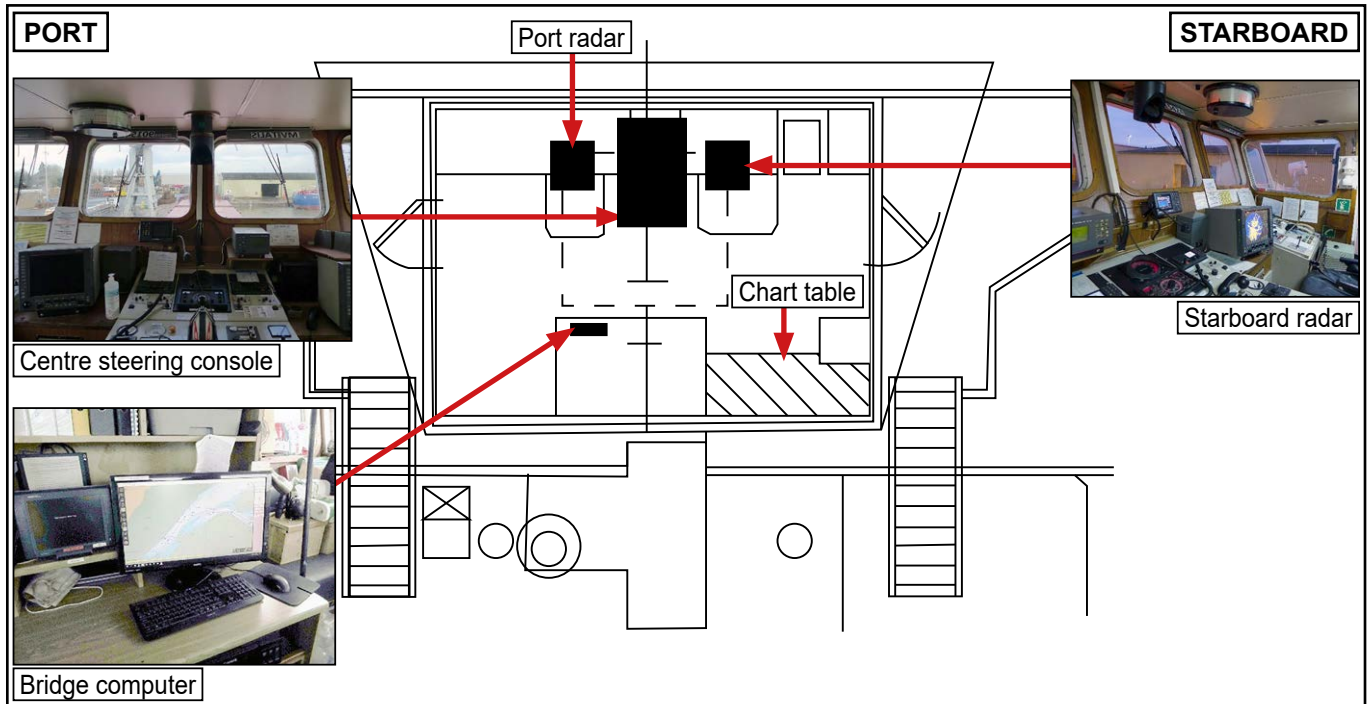
Figure 2: Plan of *Talis's* wheelhouse

Talis's C/O carried out administrative navigation duties at the chart table and the bridge computer (**Figure 2**). The AB was on the port side between the closed bridge wing door and the centre steering console. The starboard radar was set to the 6 nautical mile (nm) range scale, head-up display, with 1.5-minute trails active. The port radar was in standby mode.

Once *Talis*'s C/O had taken the con from the master, he checked the radar and AIS and saw no traffic to concern him. Consequently, his distraction at the computer and chart table, while undertaking administrative duties, meant that he missed the detection of *Achieve*'s radar return until it was less than 1nm away. At that range, and with a closing speed of about 11kts, it gave the C/O about five minutes to assess the risk of collision and take avoiding action.

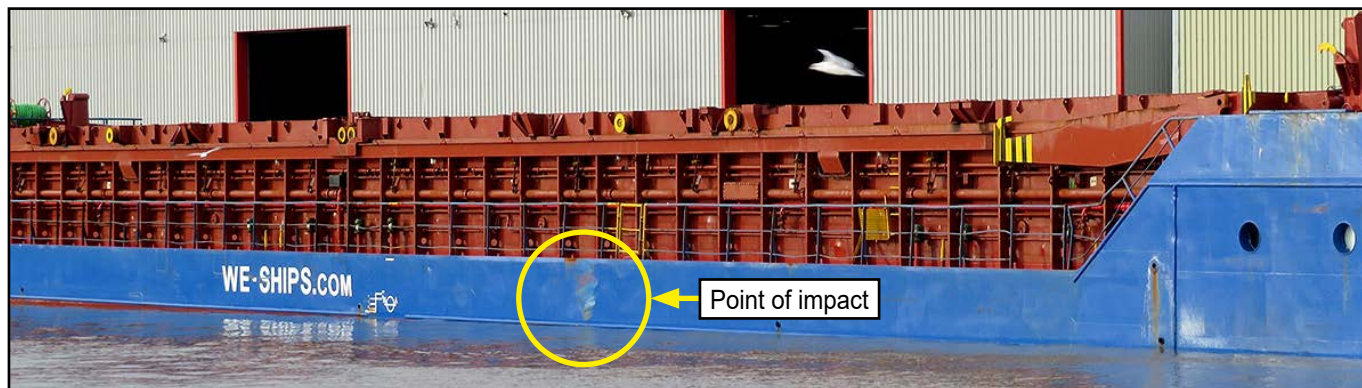
Figure 3: Damage to *Talis's* port side

Talis's heading had not appreciably changed when, at 1541, *Achieve* struck the cargo vessel's port side. *Achieve's* skipper and deckhand were thrown to the deck by the force of the collision. The skipper went to the wheelhouse and immediately saw *Talis* disappear into the fog on his starboard side.

On board *Talis*, the C/O immediately put the helm to midships, switched to autopilot, and telephoned the master. The AB watched the fishing vessel drift past the stern until he lost sight of it in the fog. The master arrived on the bridge, pulled the engine control telegraph back to dead slow ahead, and was briefed by the C/O. *Talis's* master followed the guidance in the company emergency response card for a vessel involved in a collision. *Talis* continued on passage at reduced speed while the master made a damage assessment. The hull had suffered minor indentation and handrail damage (**Figure 3**) where *Achieve* had struck the hull. The crew checked the ballast tanks and confirmed to the master that watertight integrity had not been compromised.

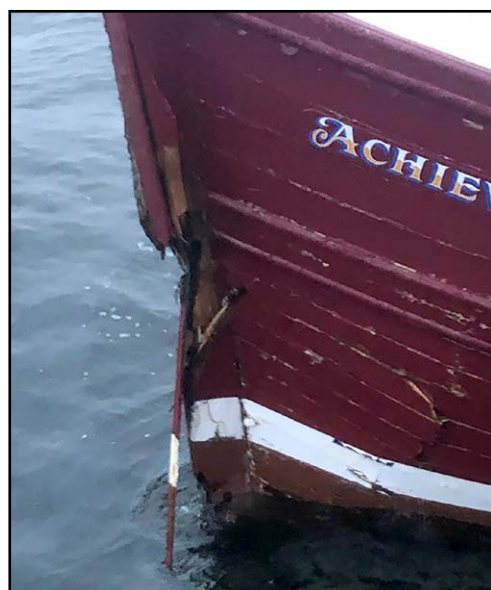
Figure 4: Damage to *Achieve's* stem

On *Achieve*, the bilge alarms sounded shortly after the collision and both crew checked for water ingress. The deckhand discovered water in the engine compartment at the forward end of the vessel and entered the space to assess the damage. He saw several sprung planks around the stem (**Figure 4**) where water was flowing in. He considered starting the engine-driven bilge pump, but decided not to because its control was at the aft end of the space and he feared being trapped by the flood.

At 1544, *Achieve's* skipper called Humber Coastguard on very high frequency (VHF) radio channel 16 and advised them he had been in a collision and was taking on water. The VHF call was overheard by the *Talis* bridge team. The coastguard immediately tasked the Tynemouth RNLI all-weather lifeboat (ALB) to attend. Meanwhile, the deckhand considered reducing the water ingress by affecting temporary repairs at the stem but assessed it as impractical.

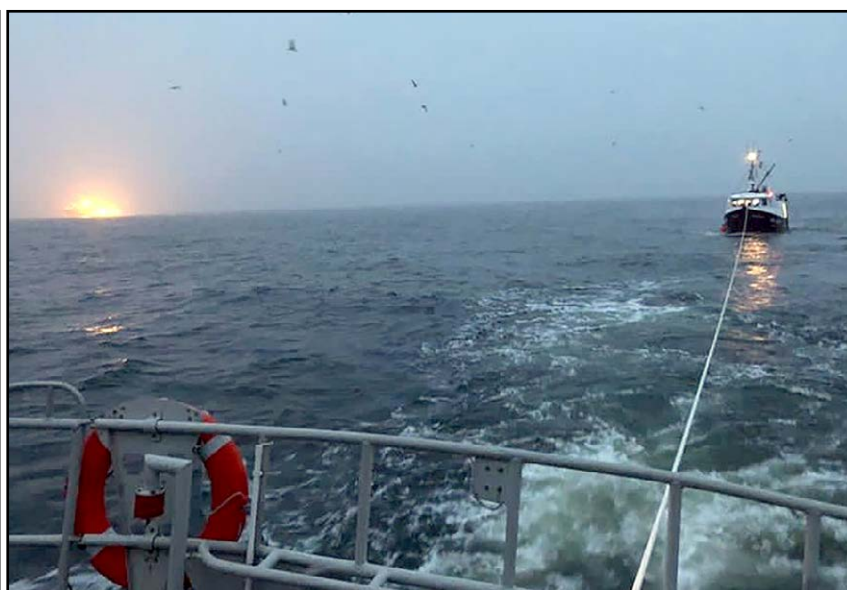
Figure 5: *Achieve* being towed by RNLI all-weather lifeboat

At 1605, the ALB arrived on-scene and transferred a salvage pump to *Achieve*. By 1610, the ALB crew and fishing vessel's skipper had secured a towline to the fishing vessel's bow (**Figure 5**). The ALB then headed to Tynemouth at slow speed with *Achieve* in tow. After about an hour, the fishing boat became unstable as more water flooded the hull and the skipper and deckhand abandoned to the ALB. The lifeboat released the towline and remained close to *Achieve* until, at 1810, it sank, 0.25 miles from the Tynemouth north breakwater in 18m depth of water. The ALB then returned to Tynemouth and landed the skipper and deckhand.

Achieve's skipper and the ALB coxswain's decision to tow the vessel was understandable given the port's proximity, and towing from the bow was the quickest method. However, this may have increased the water inflow, which resulted in the vessel sinking.

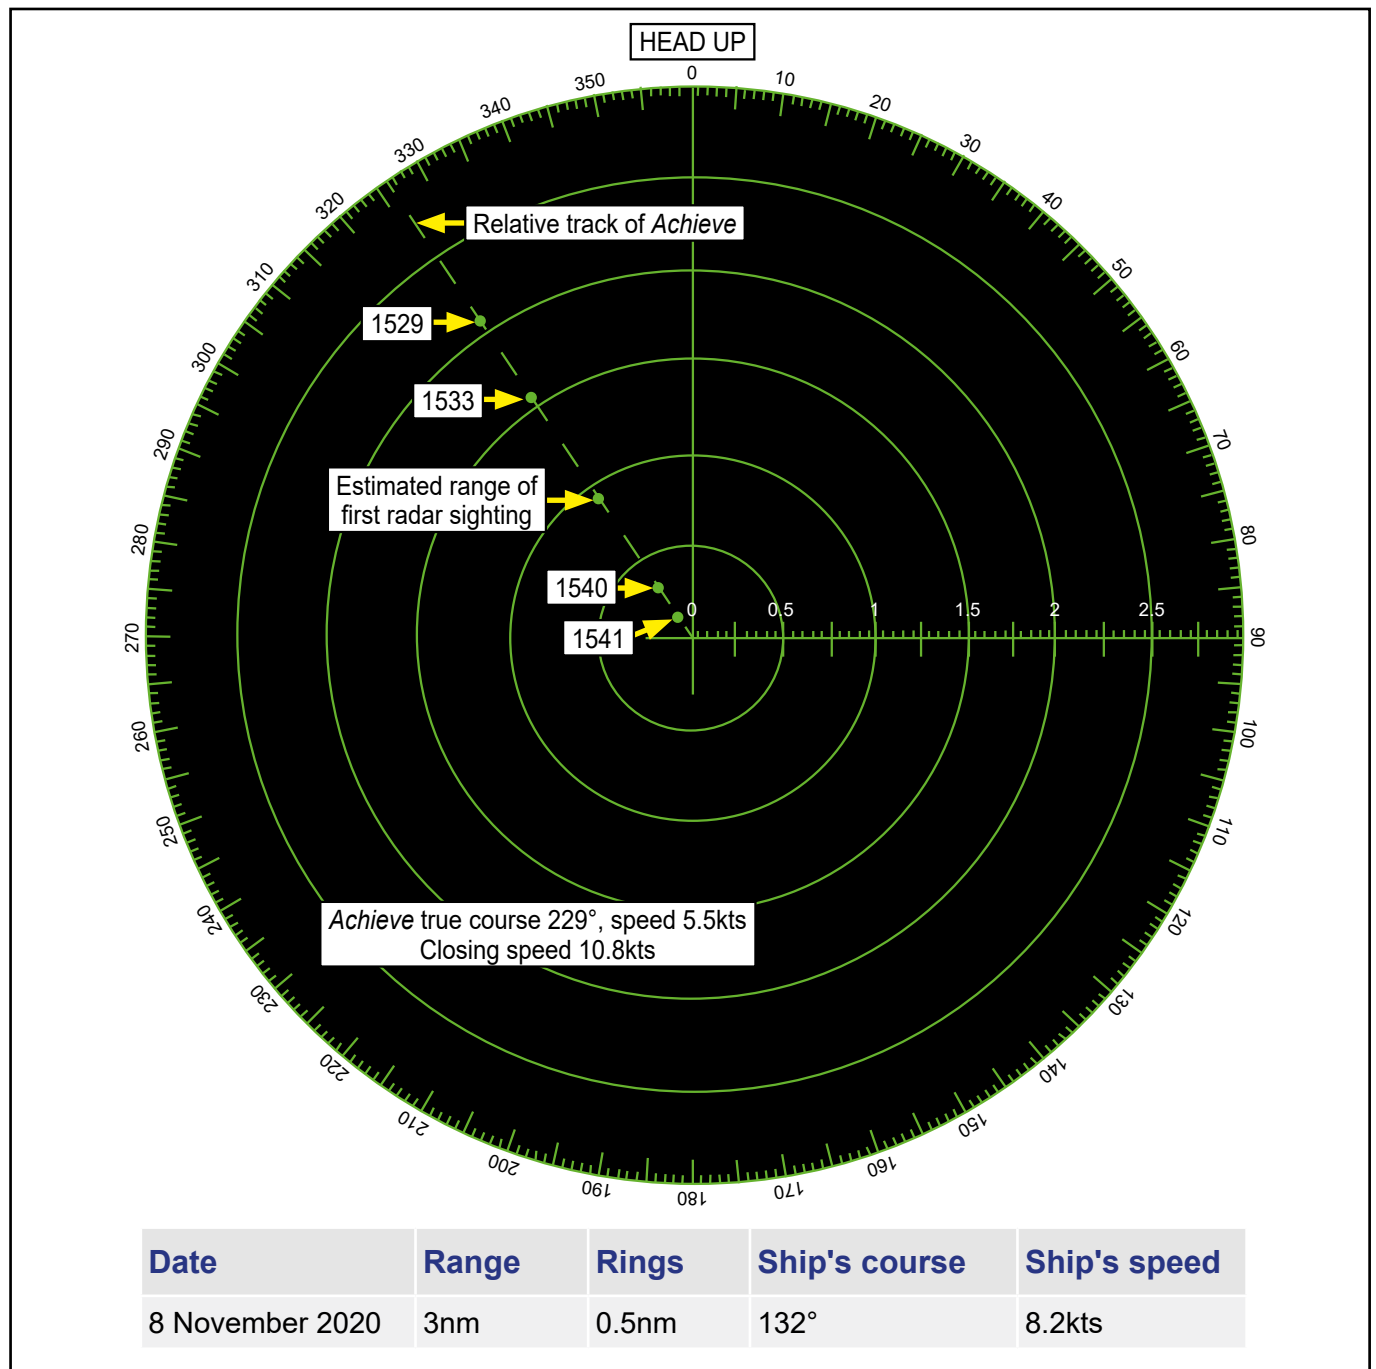
Figure 6: Plot of *Achieve*'s positions relative to *Talis*, recreated from third party VDR

A bulk carrier anchored off Tynemouth, 1nm away from the accident position, was fitted with a voyage data recorder (VDR)⁶, and MAIB recovered its data for analysis. Radar information was recorded and used to determine *Talis* and *Achieve*'s positions before the collision. MAIB plotted the positions (**Figure 6**) to determine the vessels' aspect and *Achieve*'s relative movement, as seen from *Talis*, prior to the collision.

Talis's bridge team estimated that *Achieve* was sighted at 0.4nm and about 30° to 40° off *Talis*'s port bow. The combined closing speed of the two vessels was about 11kts and would have allowed less than two minutes to consider the collision risk. In the mistaken belief that the fishing vessel would alter its course, the C/O continued to look at the vessel with binoculars rather than take immediate action to avoid the collision.

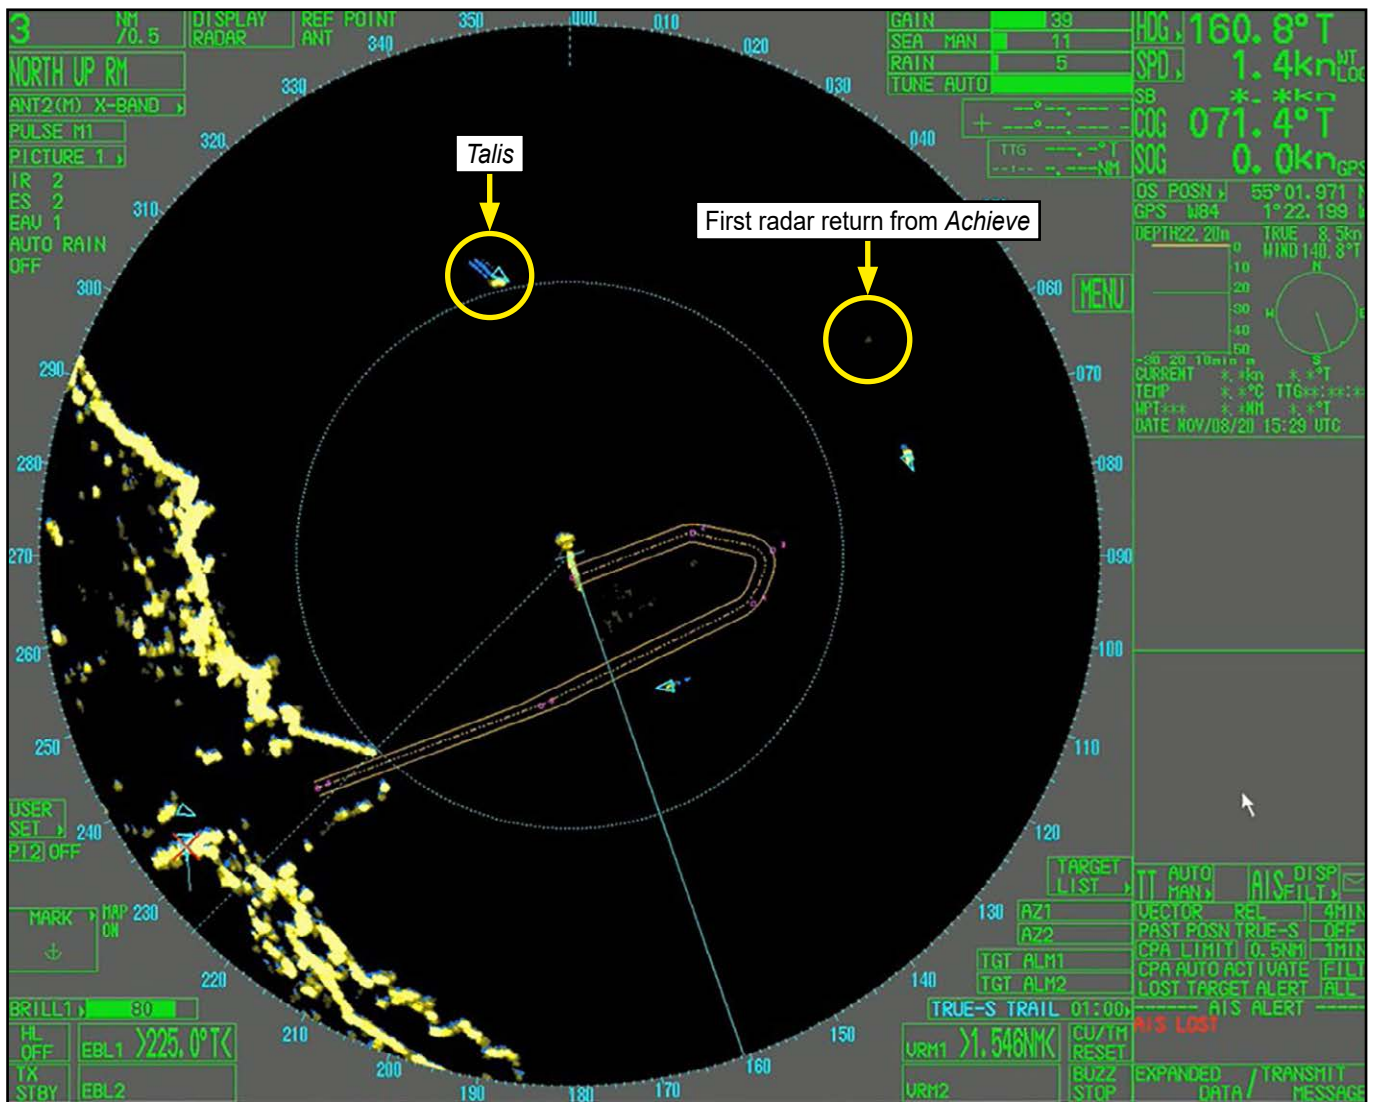
Figure 7: VDR radar image, showing first radar return of *Achieve* at 1529 UTC

A faint radar return appeared on the bulk carrier's radar at a range of 2nm (**Figure 7**) and sporadic returns were subsequently seen. Following the collision, *Achieve's* radar return became much stronger as its aspect to the bulk carrier changed.

Achieve was detected by the radar on board the bulk carrier at anchor off Tynemouth at a range of 2nm at that time when the fishing vessel's aspect provided for the weakest radar signal echo reception. The aspect that *Achieve* presented to the approaching *Talis* should have provided a better radar return on *Talis*'s radar, so detection at a range greater than 2nm should have been possible. *Achieve* was a wooden fishing vessel, so it is probable that, had the portable radar reflector on board been mounted on the vessel's mast, it would have increased the strength of the returning echo signal to *Talis*, thereby improving the chance of earlier detection.
