AAIB Bulletin S2/2021

SPECIAL

SERIOUS INCIDENT

Aircraft Type and Registration:	Boeing 737-8K5, G-FDZF
No & Type of Engines:	2 CFM56-7B27/3 turbofan engines
Year of Manufacture:	2008 (Serial no: 35138)
Date & Time (UTC):	11 September 2021 at 1240 hrs
Location:	Aberdeen Airport
Type of Flight:	Commercial Air Transport (Passenger)
Persons on Board:	Crew - 6 Passengers - 67
Injuries:	Crew - None Passengers - None
Nature of Damage:	None
Commander's Licence:	Airline Transport Pilot's Licence
Commander's Age:	56 years
Commander's Flying Experience:	15,490 hours (of which 1,524 were on type) Last 90 days - 67 hours Last 28 days - 62 hours
Information Source:	AAIB Field Investigation

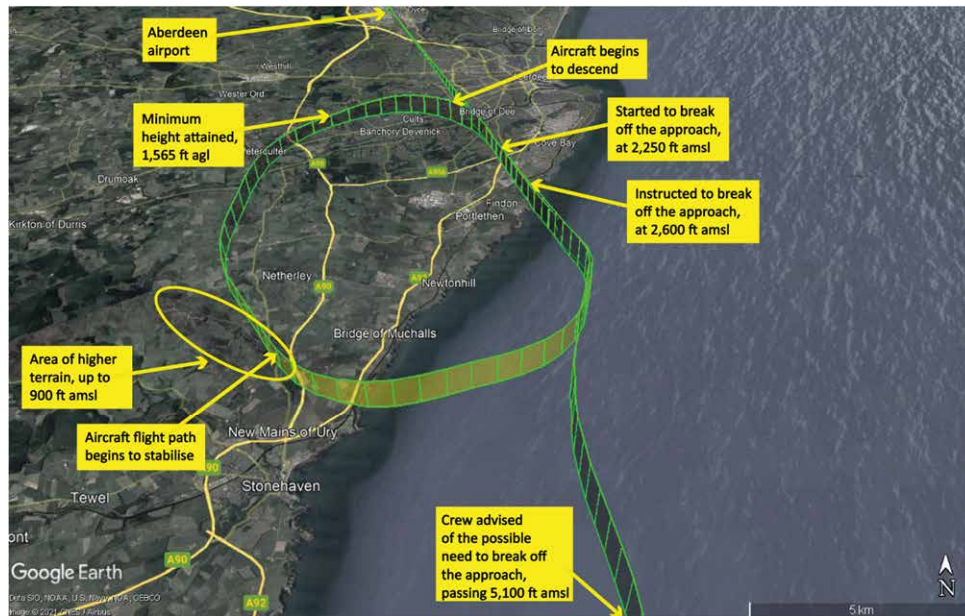
The crew established the aircraft on the localiser and glideslope at 3,000 ft amsl with the aircraft configured with the gear down and flap 15. A single autopilot was engaged, as was the autothrottle. At 2,600 ft amsl the aircraft was instructed by the radar controller to break off the approach, climb to 3,000 ft and turn left onto a heading of 270°. Eighteen seconds later, at 2,250 ft amsl, the aircraft began to climb towards the cleared altitude and began a left turn towards the heading. As the aircraft approached 3,000 ft amsl, the aircraft began to descend before the criteria were met for the flight director to transition from ALT ACQ¹ to ALT HOLD². Further heading instructions were passed by ATC while the aircraft descended to a minimum altitude of 1,780 ft amsl, corresponding to 1,565 ft agl, after which a climb was re-established. The descent rate peaked at 3,100 ft/min as the aircraft passed 2,160 ft amsl. Figure 1 shows the aircraft's flightpath.

G-FDZF's flightpath into Aberdeen and the unintended descent

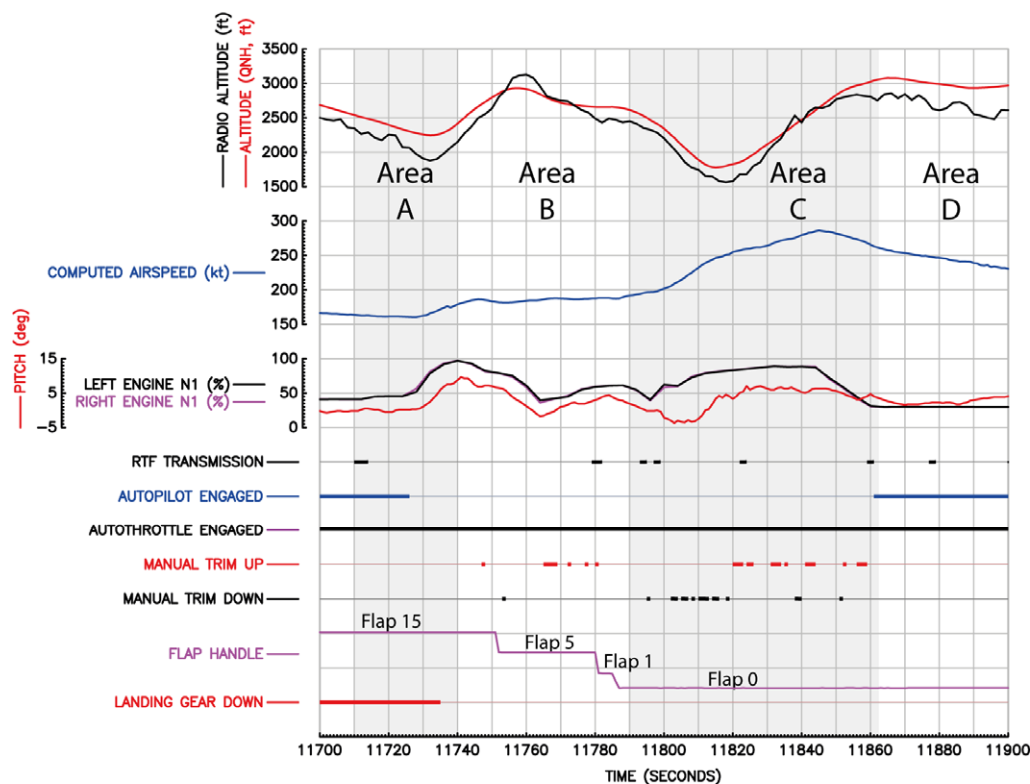
Figure 2

Flight data for the approach and subsequent unintended descent

Area A shows the flightpath from when the crew responded to the ATC instruction to break off the approach and shows the disconnection of the autopilot as the TO/GA mode was activated. It shows that the landing gear was retracted, the thrust increased towards the full go around N1 limit and the aircraft's pitch attitude increased as the aircraft climbed. Note the strong correlation between the changes in the pitch of the aircraft and engine power setting. No manual pitch trim inputs were observed in the data.

Area B shows that as the aircraft approached the selected altitude of 3,000 ft, the pitch of the aircraft decreased and the autothrottle reduced the engine power setting in anticipation of the level-off being commanded by the flight director. As the aircraft reached this point, the flaps were retracted from flap 15 to flap 5 and the aircraft then descended having failed to meet the criteria for the flight director to transition to ALT HOLD. The flaps were then further retracted from flap 5 to flap 1 and from flap 1 to flap 0 during the descent."

Area C shows the lowest altitude reached by the aircraft before it climbed again, and the peak airspeed. The climb occurred at about the same time as the crew replied to the ATC instruction to climb.

Area D shows the autopilot re-engagement and the flight path of the aircraft stabilising.
