Collision between a train and lorry stabiliser leg at Penistone, South Yorkshire, 27 August 2021

Summary of the accident

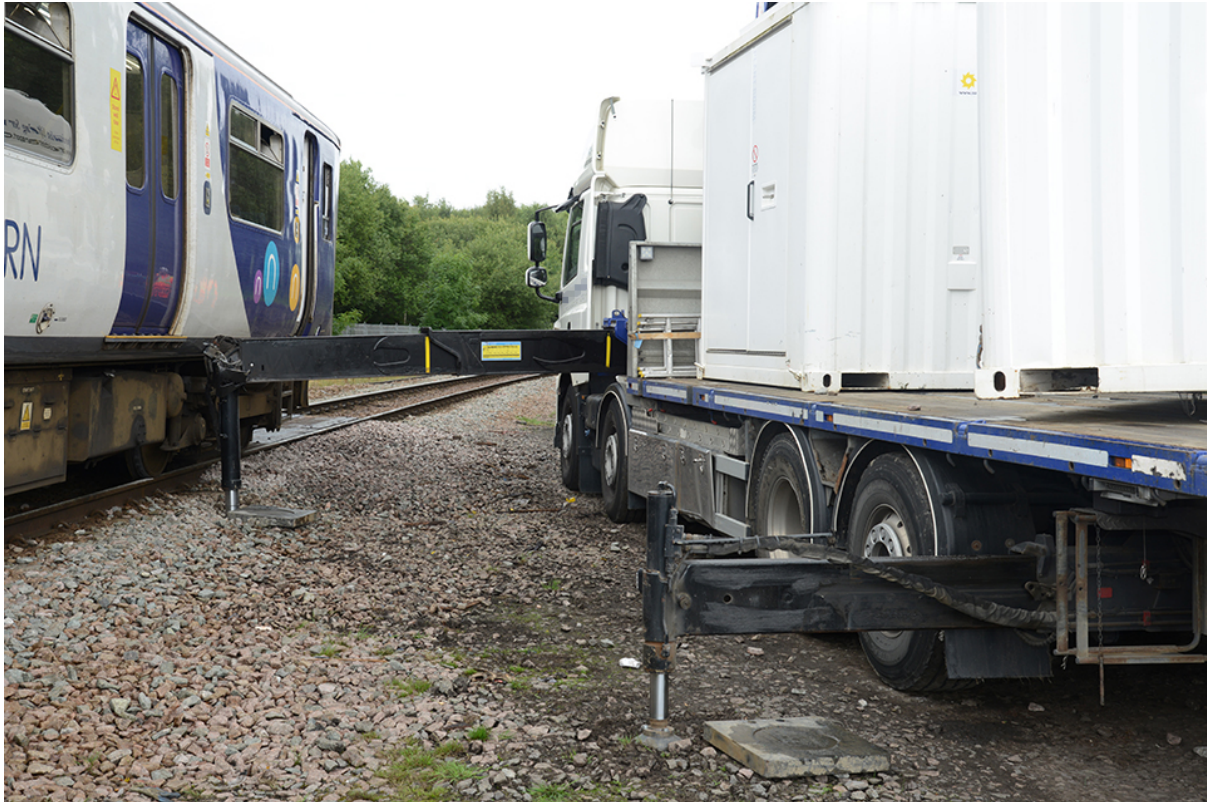
The train had been accelerating after departing from Penistone station, and had reached 27 mph (43 km/h) when the lorry came into view. The driver saw a person near to the lorry and sounded the train's horn to give a warning. Although the driver saw the person and lorry, the stabiliser legs were not clearly visible, and the driver continued accelerating. As the train got closer, the driver then noticed one of the stabiliser legs was very close to the track, so he applied the train's brakes. The train struck the lorry five seconds later. The train crew and 25 passengers on board the train were unhurt by the collision. The lorry's stabiliser leg was damaged and there was also some damage to the front and side of the train.

The position of the train and lorry after the accident (image courtesy of British Transport Police)

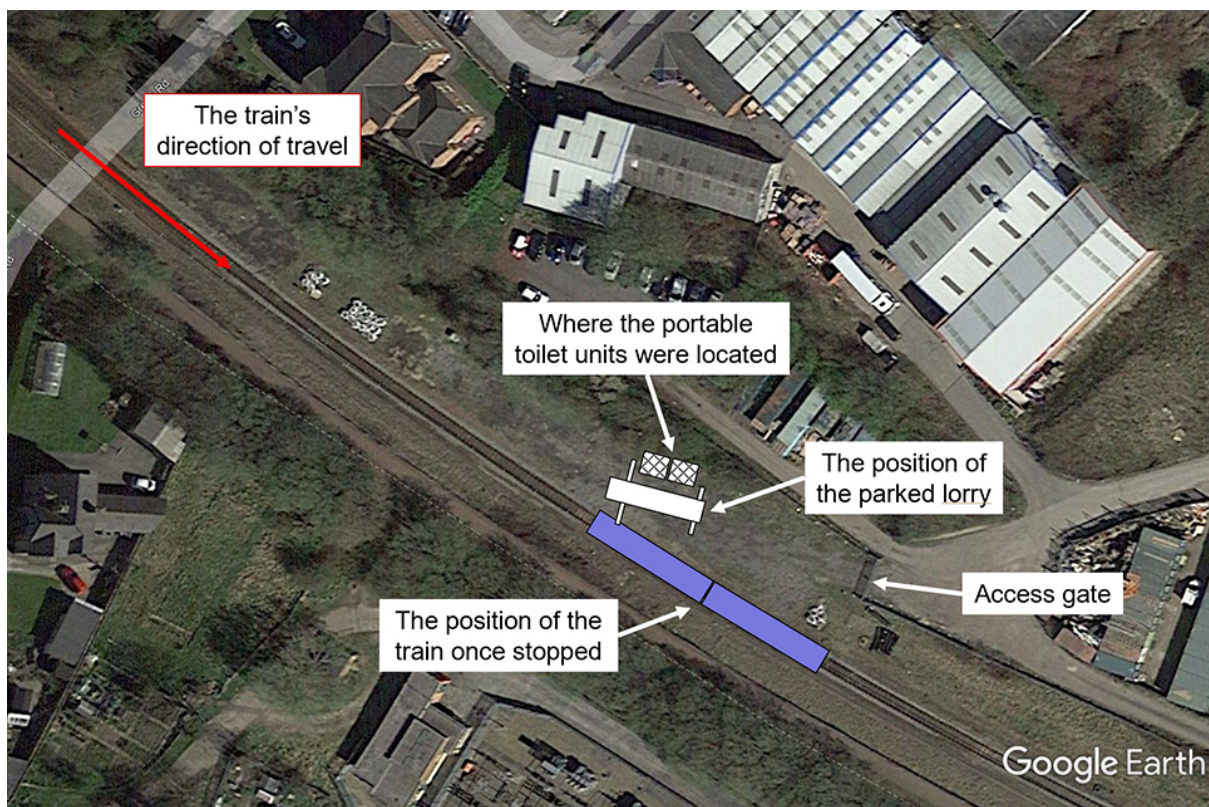
Site layout showing where the lorry was parked within the site

The lorry driver did not consider how close the stabiliser leg was to the nearest running line when he positioned the lorry and set it up for the lifting operation. Measurements and witness marks on the ground indicate the base of the stabiliser leg was at the end of the sleepers, about 0.5 metres from the nearest rail. The lorry driver had no experience of working next to an open railway line and thought that no trains were running because he had been let straight into the site by the CRSA member of staff. The lorry driver had not confirmed his understanding that no trains were running.

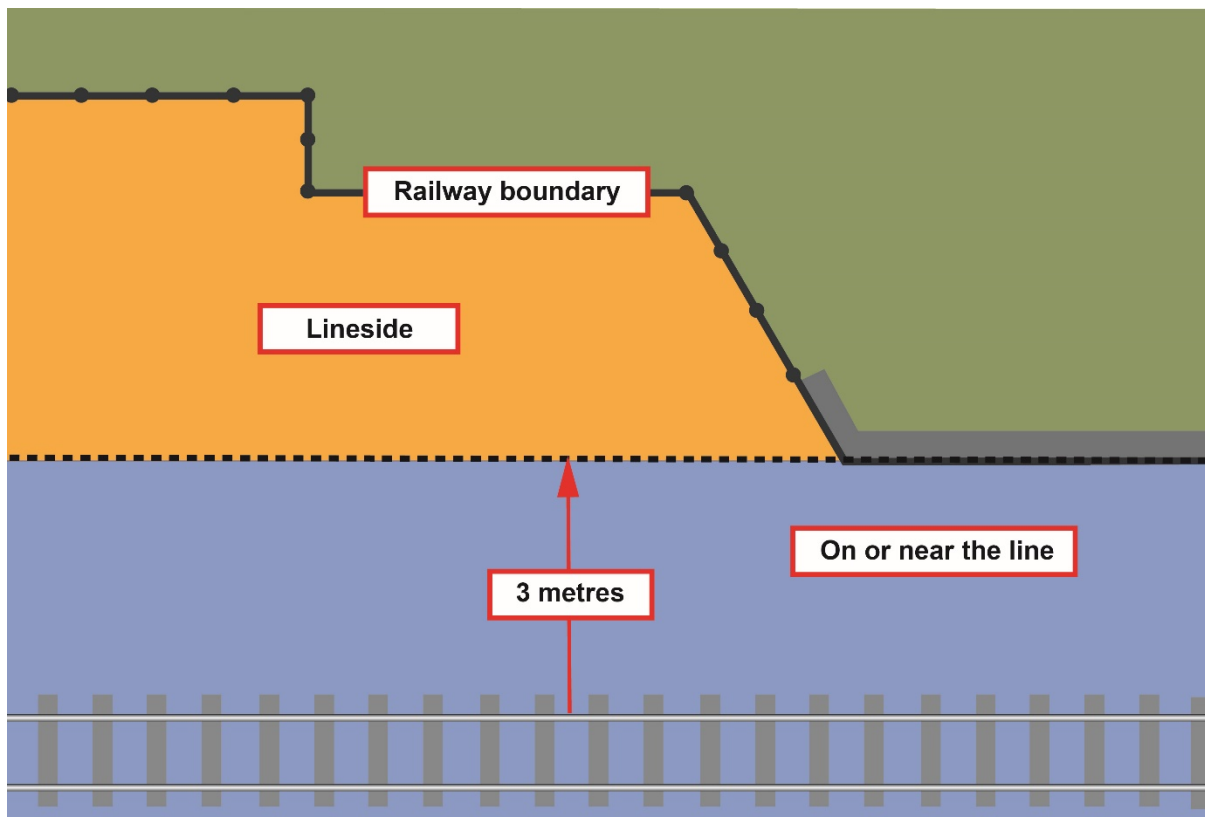
Rule Book definitions of lineside and on or near the line

The position where the lorry had been parked to lift the units meant that it was on or near the line. The Rule Book requires a controller of site safety (COSS) to be present before a road vehicle can go on or near the line, but, while the CRSA member of staff held a personal track safety competency (PTS), no one who held the COSS competency was present on this occasion. The Rule Book also states that no part of a road vehicle should be allowed within two metres of any line on which a train might approach. In this case, however, one of the lorry's stabiliser legs was much closer than two metres and was in fact foul of the nearest running line.
