ACCIDENT

Aircraft Type and Registration:	Cessna FRA150L, Aerobat, G-CIIR	
No & Type of Engines:	1 Rolls-Royce Continental O-240-A piston engine	
Year of Manufacture:	1973 (Serial no: 187)	
Date & Time (UTC):	11 October 2020 at 1342 hrs	
Location:	Troutbeck Airfield, Cumbria	
Type of Flight:	Private	
Persons on Board:	Crew - 1	Passengers - None
Injuries:	Crew - 1 (Fatal)	Passengers - N/A
Nature of Damage:	Destroyed	
Commander's Licence:	Private Pilot's Licence	
Commander's Age:	44 years	
Commander's Flying Experience:	69 hours (of which 52 were on type) Last 90 days - 3 hours Last 28 days - 2 hours	
Information Source:	Field Investigation

Synopsis

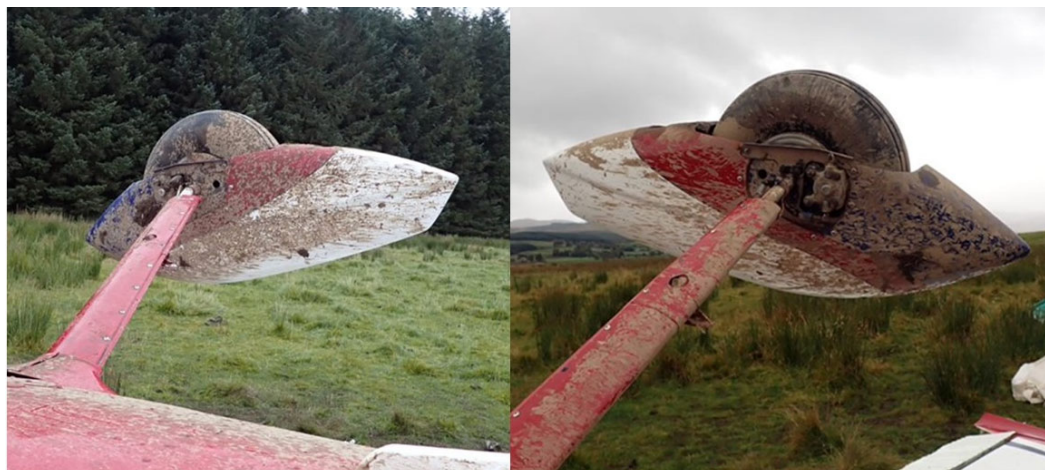
Figure 3

The nose landing gear was severely displaced and had bent rearwards, and its wheel fairing had detached. The main wheels and fairings were intact but were heavily contaminated with mud (Figure 3).

Left and right mainwheel mud contamination (aircraft inverted)

Of note, the right main wheel brake appeared to be binding whilst the left mainwheel was free to rotate.

The inside of the wheel fairings was also covered in mud in the same way. At the accident site the left wheel, although stiff, could be rotated by hand whereas the right wheel was seized and could not be rotated. It was eventually freed with the application of a small amount of lubricant on the disc surfaces. Both tyres were found to be correctly inflated and the treads were well defined. The brake callipers and pads were also covered in a layer of liquified mud but underneath were generally in a good, unworn condition. Despite the mud contamination the pistons had not seized in their callipers. However, mud had been smeared onto the disc friction surfaces during wheel rotation and had accumulated on the leading face of the pad friction material.

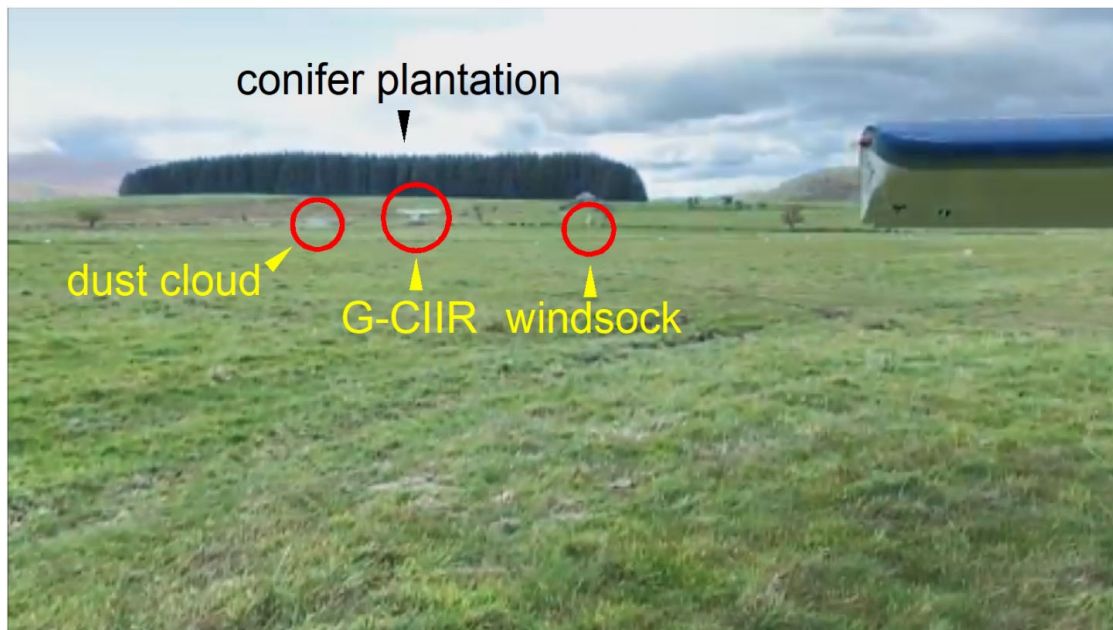
Figure 5

Image of G-CIIR shortly before takeoff

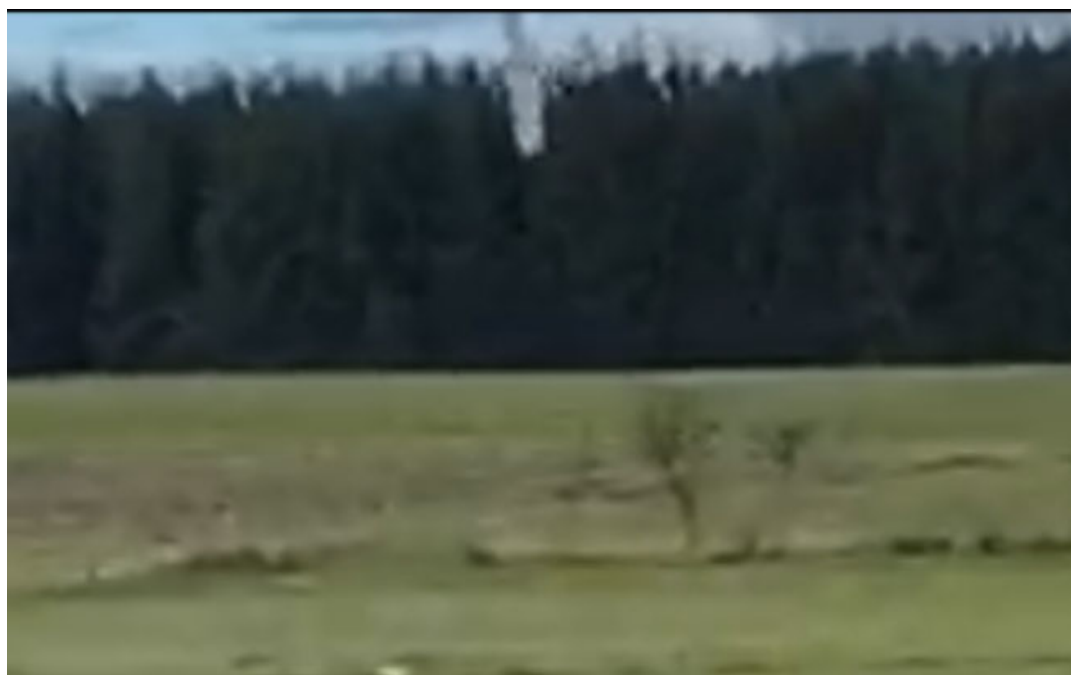
Figure 8

During the next few seconds, the aircraft was observed to climb gradually whilst maintaining a predominantly wings level attitude heading towards the conifer plantation, but as it reached a height of about 50 ft agl, the aircraft proceeded to roll quickly to the left whilst also starting to pitch nose-down whilst descending (Figure 7). The final image of the aircraft (Figure 8), captured less than two seconds later, showed the aircraft's nose was 20° below the horizon and the bank angle had reached nearly 90°. A sound consistent with the aircraft striking the ground was recorded 1.6 seconds later, which coincided with the sound of the engine stopping. The estimated elapsed time from the aircraft becoming airborne to it striking the ground was just over 10 seconds.

Image of aircraft before striking the ground

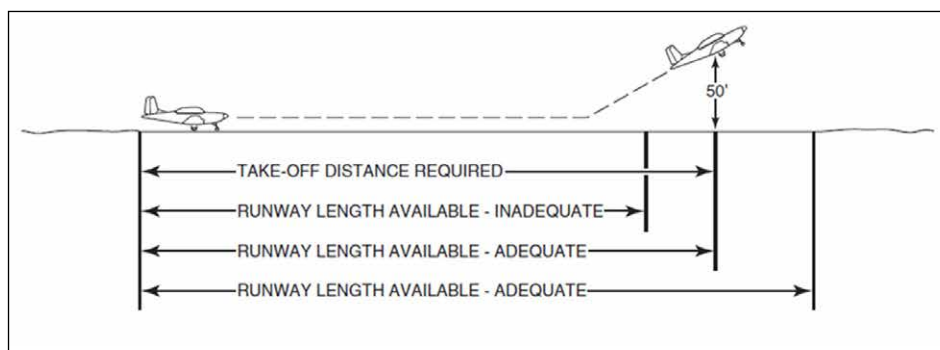
**Figure 10**

Depiction of TODR and runway length available
